Concow Fire
September 19-20, 2000

John R. Hawkins
Assistant Chief
California Department of Forestry and Fire Protection
Butte County Fire Rescue
6640 Steiffer Road, Magalia, CA 95954-9778
Bus (530) 873-0330 FAX (530) 873-1473
Email <john_Hawkins@fire.ca.gov>

October 6, 2001

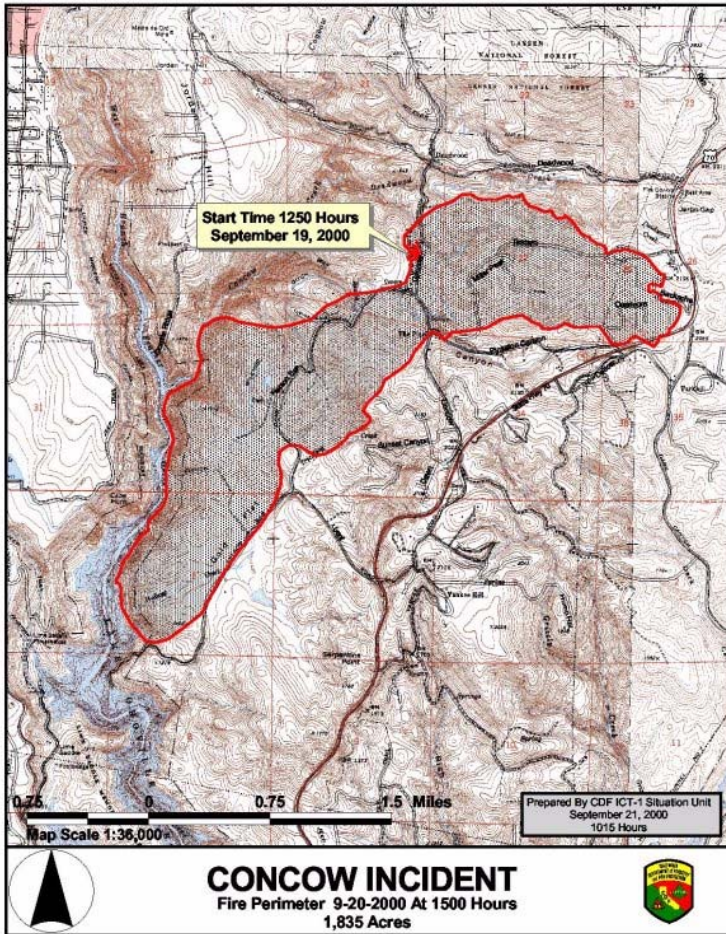
Figure 1. Map of the Concow Fire, August 19-20, 2002, showing both fire spread directions. The first spread direction was to the east from the origin. The second spread direction was from just southeast of the Concow School to the southwest (Concow Fire documentation report).

The first, destructive phase burned two miles from the origin to the east toward State Route 70 (800 acres burned). The second, more destructive phase burned a distance of five miles just southeast of the origin to the southwest all the way to Lake Oroville (1,100 more acres and 14 structures burned).

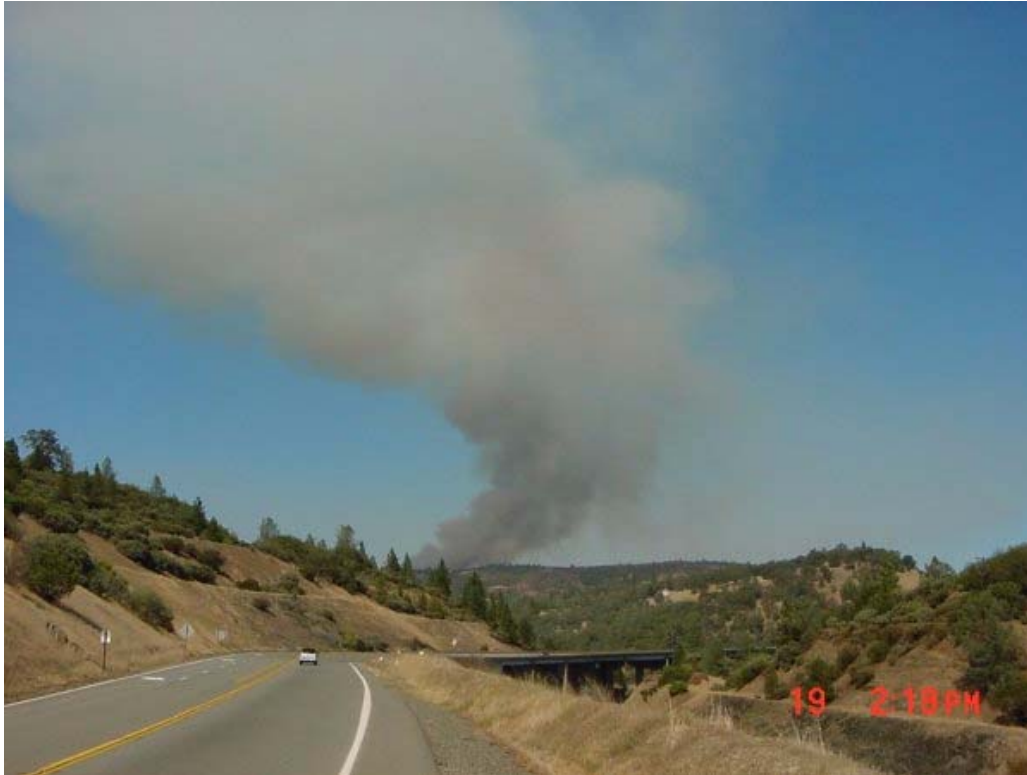
Figure 2. Picture of the Concow Fire taken September 19, 2000, 1418 hours. The picture was taken about four miles southwest of the fire. Note the fractured smoke column indicating an east wind aloft (Wilson 2000).

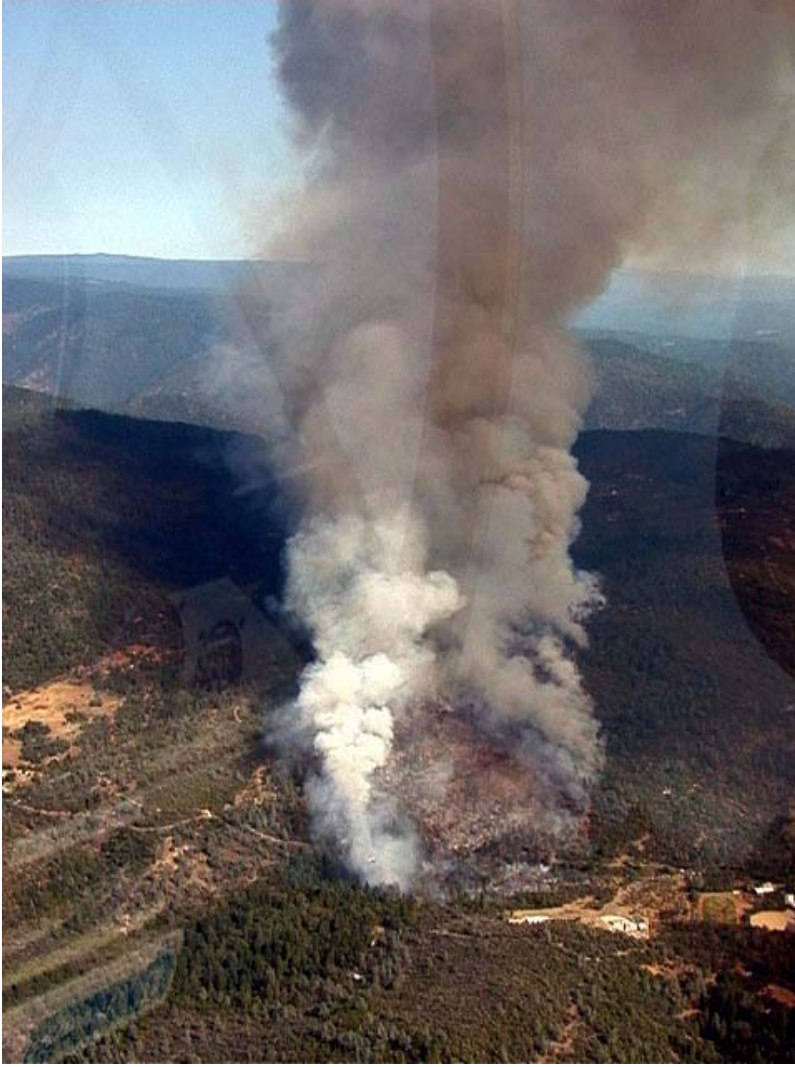
Figure 3. Picture of the Concow Fire, August 19, showing the initial fire spread to the east from the vicinity of the Concow School (Iverson 2000).

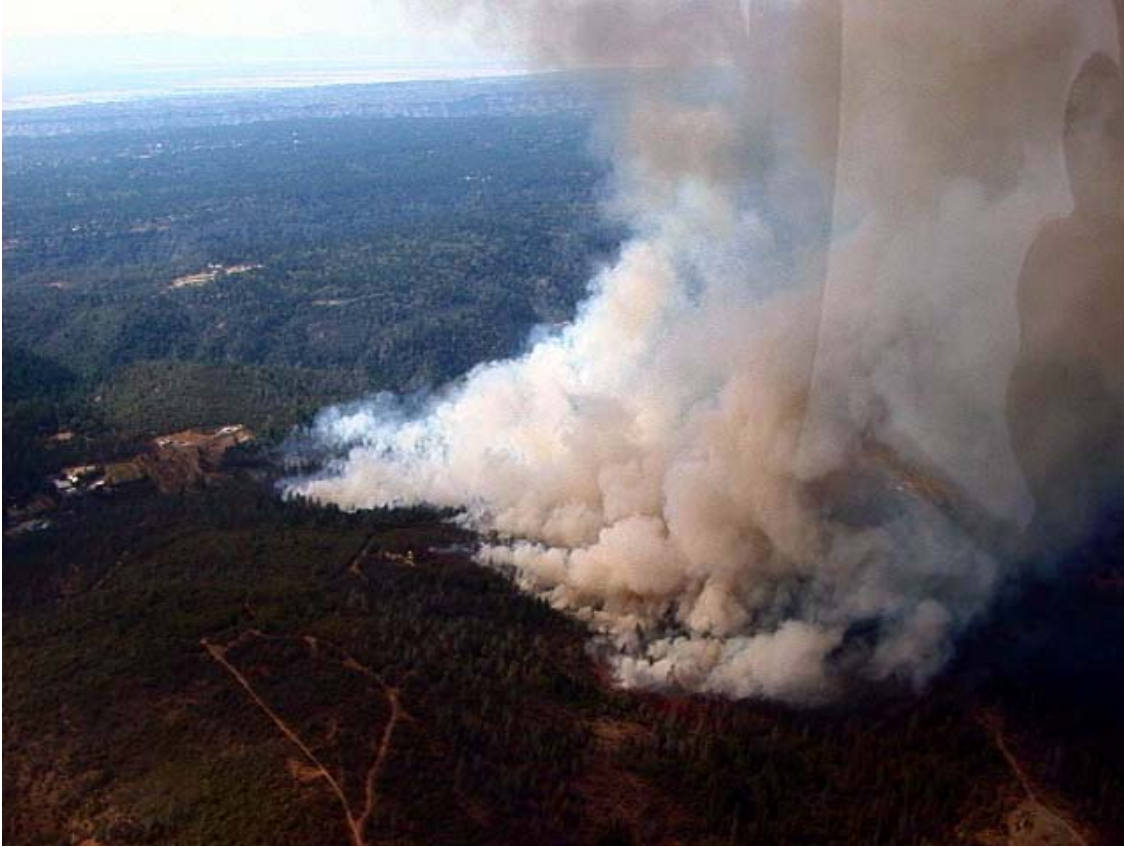
Figure 4. Picture of the Concow Fire, August 19, approximately 1500 hours as it ran over Miller Peak and towards Tim Tam Lane. The Concow School is visible just to the left of the rear of the fire (Iverson 2000).

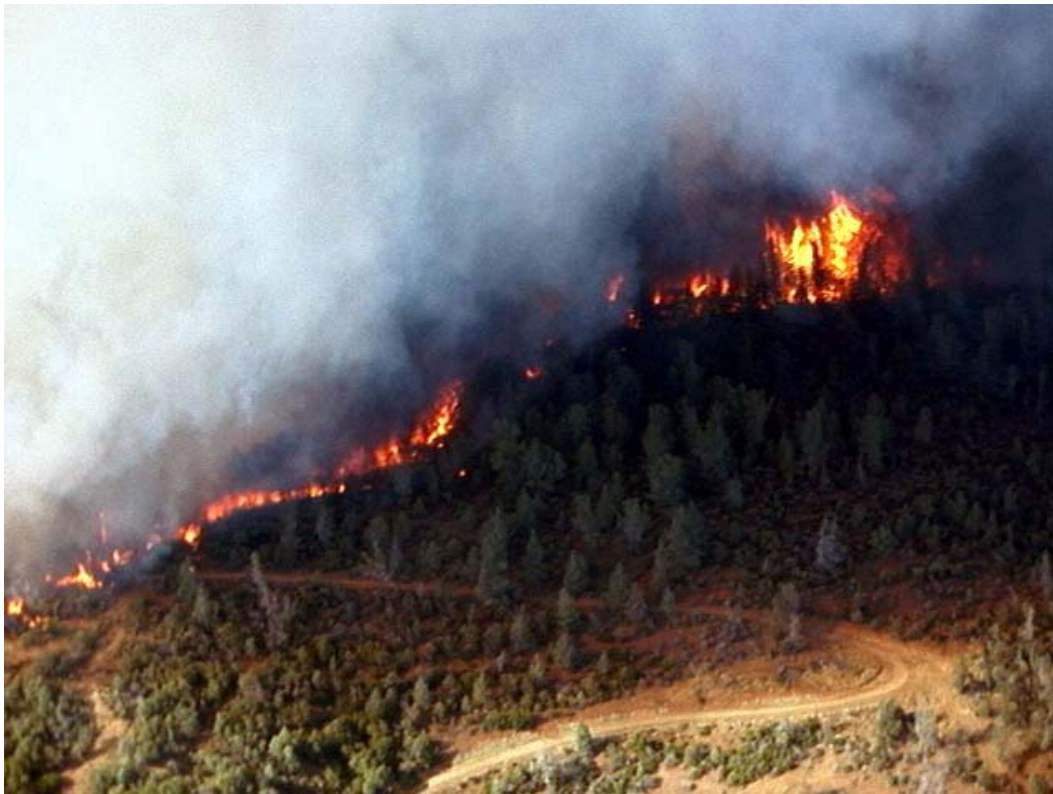
Figure 5. Picture of the Concow Fire, August 19, approximately 1500 hours, near Miller Peak showing extreme burning conditions at the head and right flank of the fire (Iverson 2000).

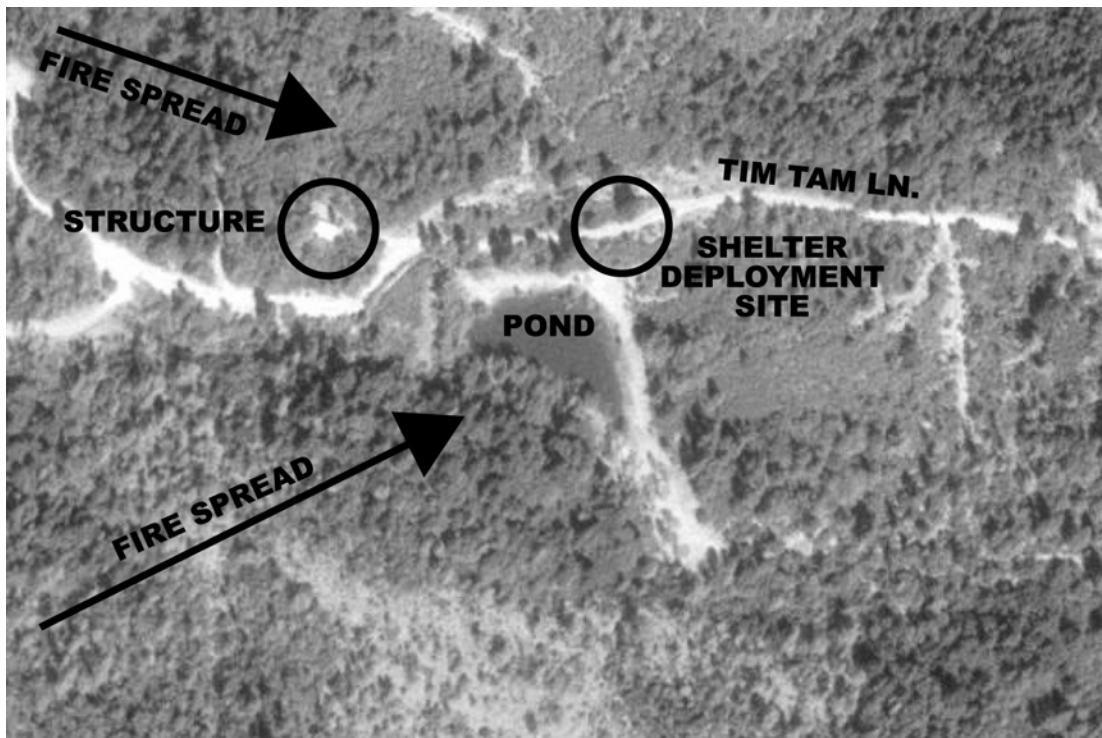
There was no coordination of the firing operation with the Division Supervisor. The officer of Engine A (Engine 64R) took the lead putting down fire, on the south side of the roadway, approximately every twenty (20) feet. The firefighters burned out the vegetation between these spots. The firefighters only had one torch and no other tools were taken along. The extra firefighter was told to watch the progression of the fire, but was not specifically ordered to act as a lookout. Approximately 70 yards into the firing operation, the engine officer noticed two small spot fires to the southwest of their position, and that there was fire on the ridge behind the spot fires. The officer also noticed a small spot fire on a knoll approximately 200 yards

to the southeast of their position. The firing operation was proceeding well, with fire being carried slowly downhill, in the ground litter. Fire did not extend into the Manzanita canopy. After completing the firing to their objective, approximately 470 feet, the crew turned to go back to the engines. At that time, the engine officer realized the main fire had come up behind them and was moving in their direction. The officer ordered the drip torches be put down and the firefighters to start back toward the engines. The fire started to sheet across the roadway from the south cutting off their escape route to the engines. They turned to go in the opposite direction and noticed the fire had extended up the minor drainage, from the pond to their east, and was also sheeting across the roadway. The officer gave the order to deploy fire shelters. One of the firefighters had difficulty getting the shelter out of the carrying case, and then removing it from the plastic cover. The officer pulled the head and torso of the firefighter into the officer's shelter. The head of the firefighter was in the lap of the officer. The officer was in a sitting position. The second firefighter, who was also in his fire shelter, put his shelter over the first firefighter's legs. After the fire crossed the roadway from the south side the officer ordered the first firefighter who had trouble deploying to finish the deployment of his shelter. The crew then experienced an increase of heat from the north side of the roadway. During this time air support was requested, but due to the smoke obscured conditions, the water and retardant drops did not reach the sheltered crew. Two CDF Firefighters were injured. The first firefighter was treated for heat exhaustion, and received intravenous fluid replacement. The second firefighter suffered two, ½ inch diameter, second degree burns to the left forearm. Both were released after treatment at Oroville Medical Center.

Figure 6. Graphically enhanced aerial photo of the Concow Fire, August 19, 1515 hours, where the fire shelter deployment occurred on Tim Tam Lane (MS Terraserver 2001).

1. Post lookouts whenever working away from an established deployment area or safety zone.
2. Coordination between crews, leaders, and division supervisors has to be established prior to firing operations.
3. Crewmembers not actively putting down fire in a firing operation need to have a fire-fighting tool in their possession.

4. Be aware of dynamic fire behavior in the area of operation, and if the main fire is not seen, contact someone who can see the fire, or post a lookout.
5. Be aware of the surrounding topography and the effect of topography on fire behavior.
6. Identify the risk/benefit of firing out the down slope side of a mid slope roadway, while moving in an uphill direction.

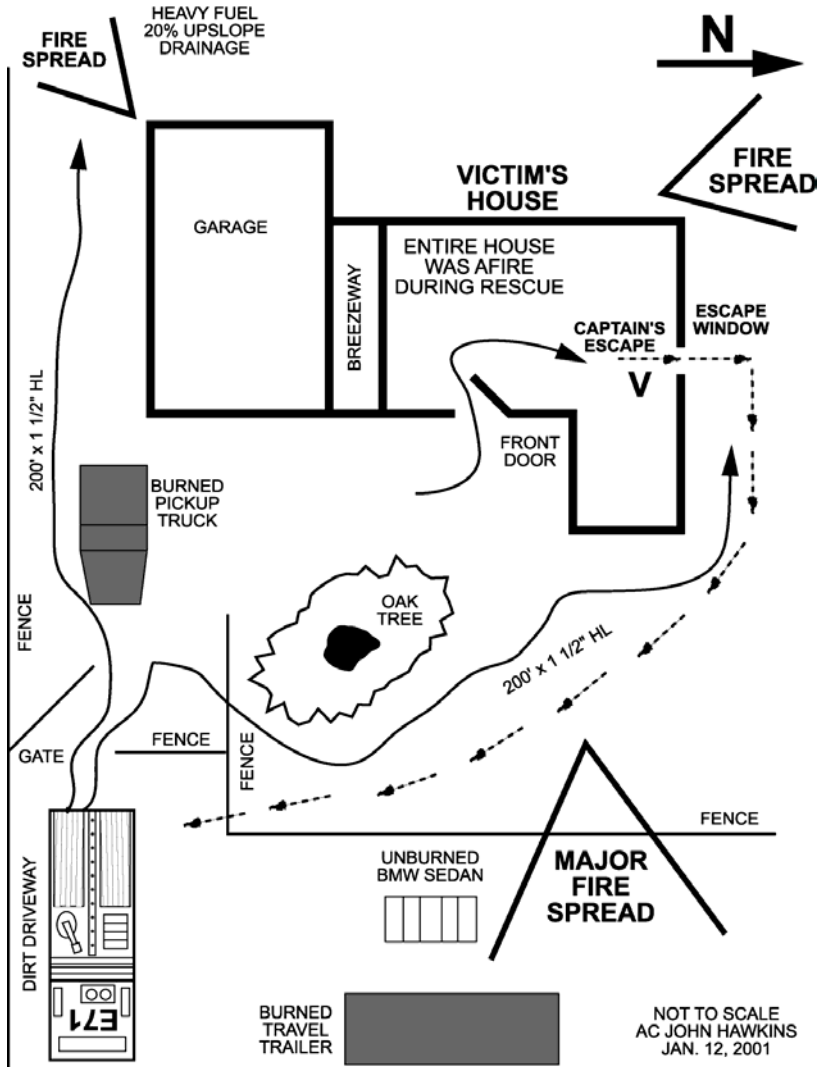
The structure was a single story wood frame, wood sided dwelling with an aluminum roof. A detached garage was connected to the house by a roof, creating a breezeway of about 5 feet. The garage was used for storage and provided a heavy fuel load and excellent fuel bed on the fire-side of the structure. The structure sat on top of a knoll, with gentle slopes on the fire-side with pasture and star thistle. The fire was driven down a hillside of heavy fuel (grey pine, manzanita, probably over 90 tons per acre) until it crossed Stagecoach Lane. At this point the fire was driven by the now heated winds across the field of star thistle and into the structure.

Figure 7. Sketch of the structure protected by Engine 71 where the attempted rescue occurred (John Hawkins 2001).

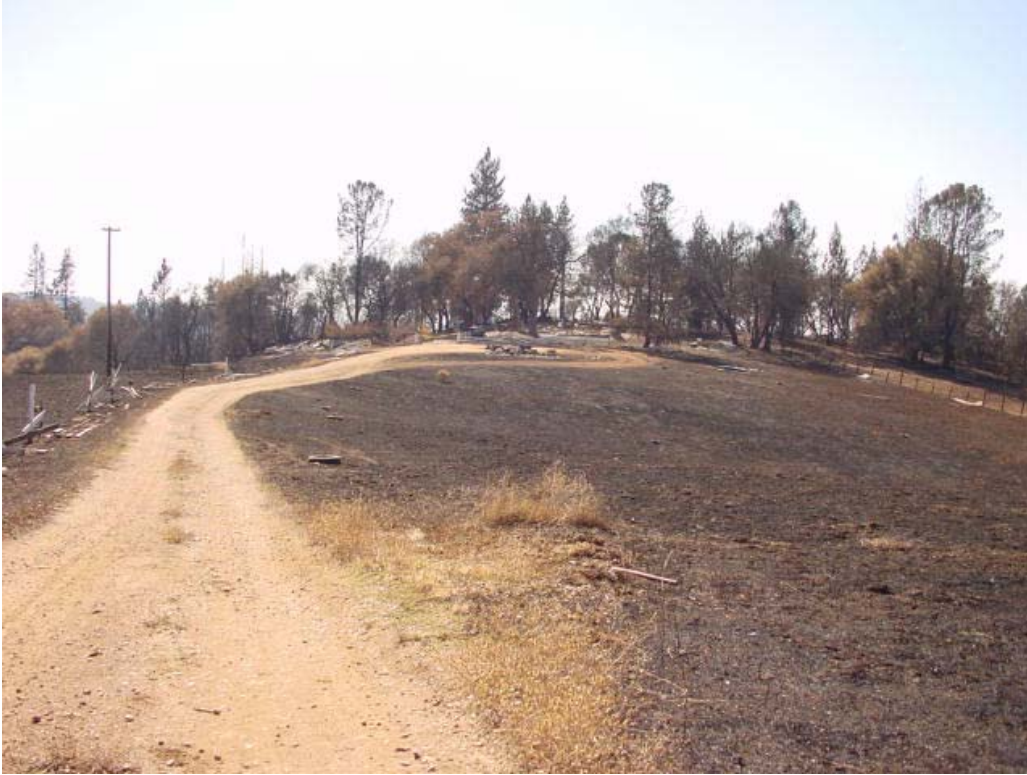
Figure 8. Picture of the driveway leading to the structure protected by Engine 71 where the attempted rescue occurred (John Hawkins 2000).

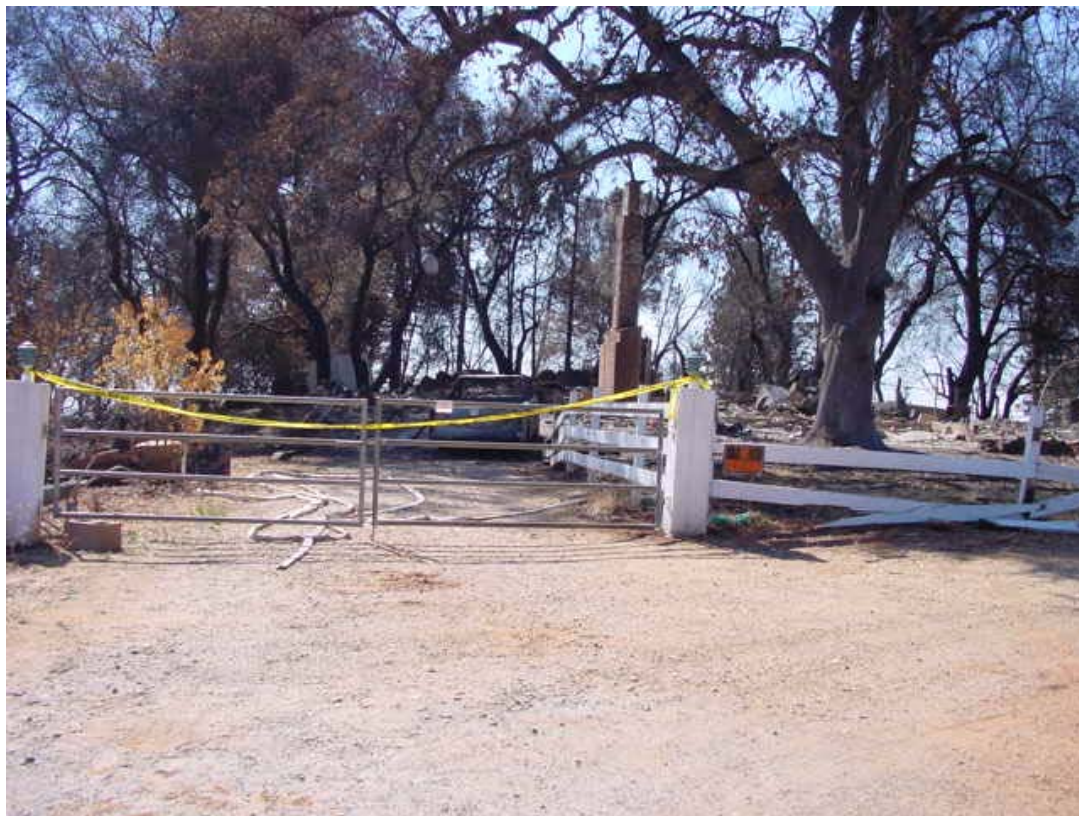
Figure 9. Picture of the structure protected by Engine 71 where the attempted rescue effort occurred. Note the abandoned hose lines near the gate (John Hawkins 2000).

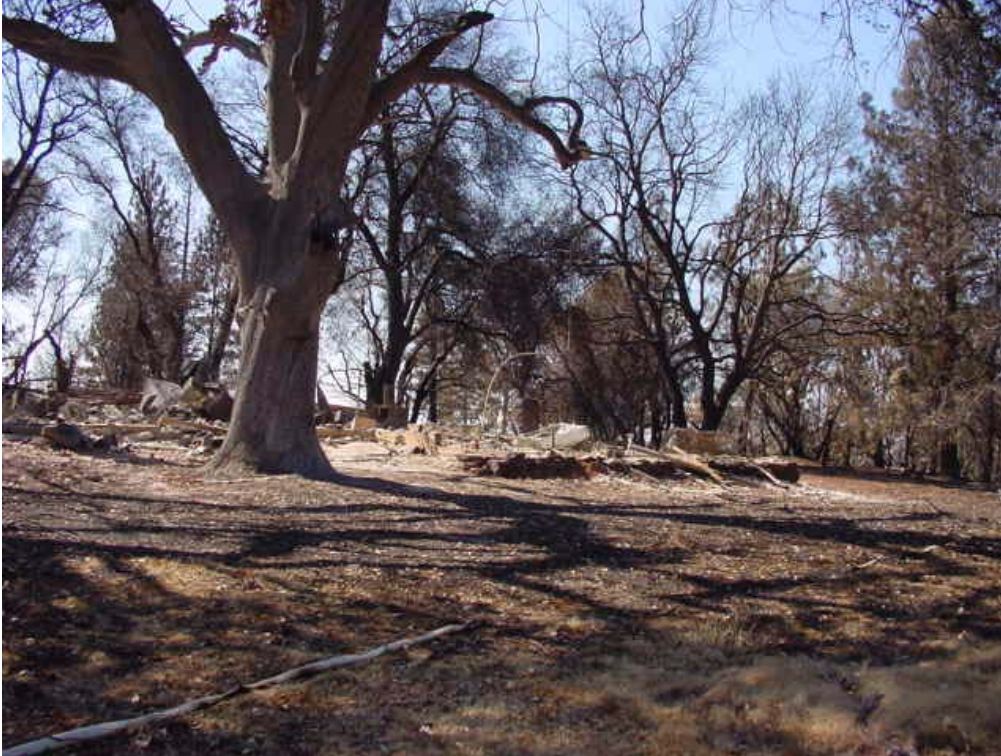
Figure 10. Picture of the structure protected by Engine 71 where the attempted rescue occurred. Note the discarded hose in the foreground. The Captain escaped from the right side of the structure (John Hawkins 2000).

1. The fire engine was properly located with proper deployment of hose lines.
2. The Fire Captain was wearing a non-approved dust mask, which significantly reduced airway injuries.
3. Silk-screened ink on the Fire Captain's t-shirt may have added to burn injury severity.
