ALTAMONT FIRE

ACCIDENT INVESTIGATION REPORT

NOVEMBER 14, 1988

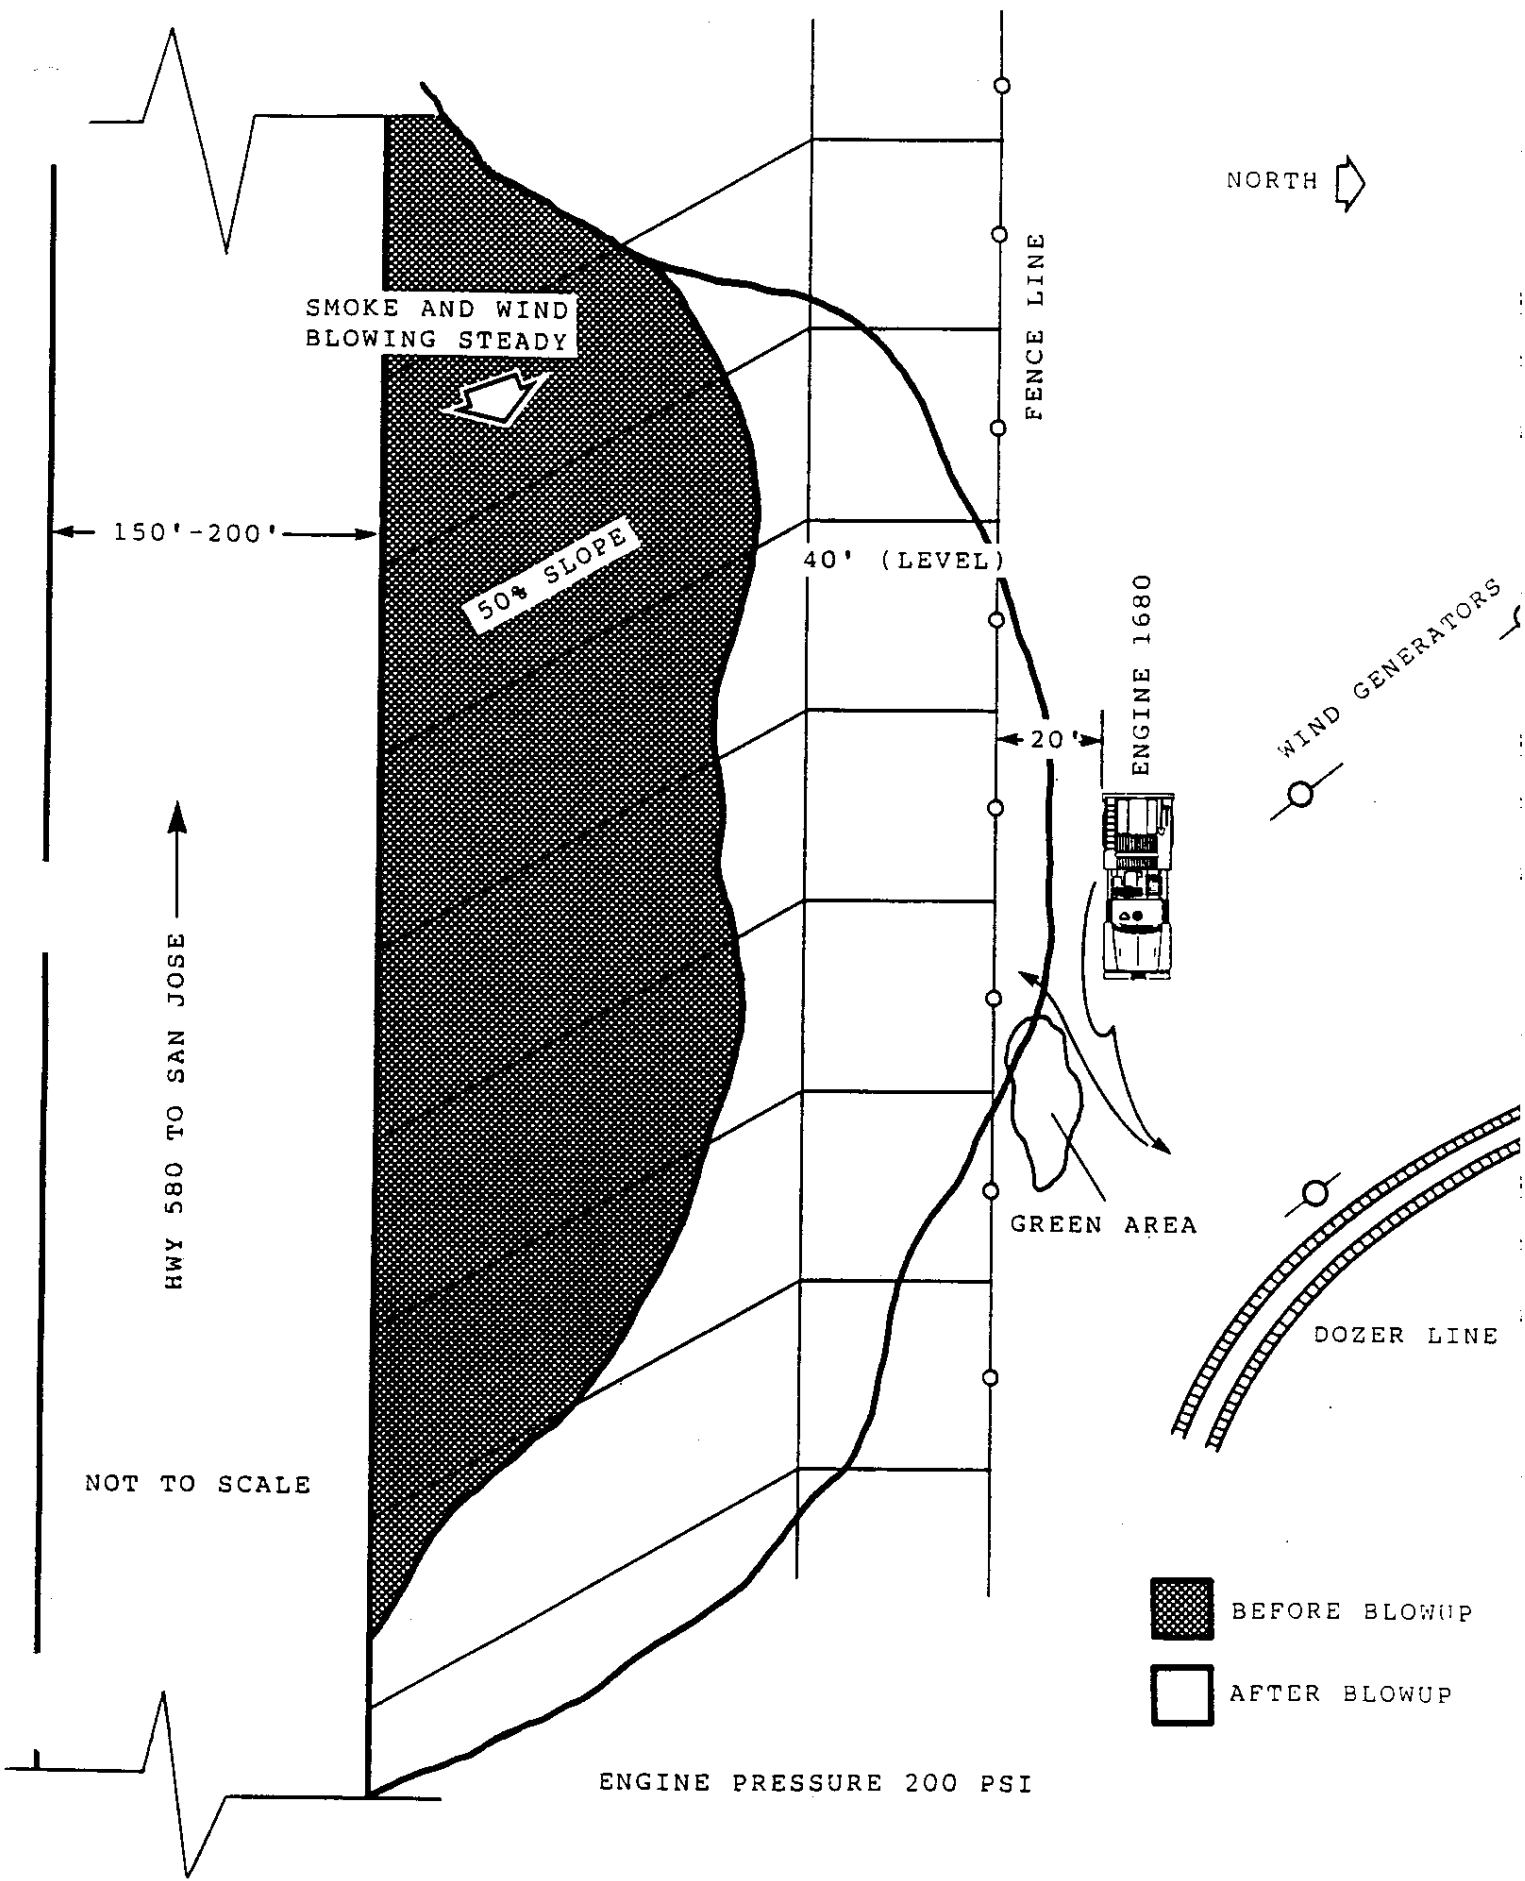
SMOKE AND WIND
BLOWING STEADY

50% SLOPE

ENGINE 1680

ENGINE PRESSURE 200 PSI

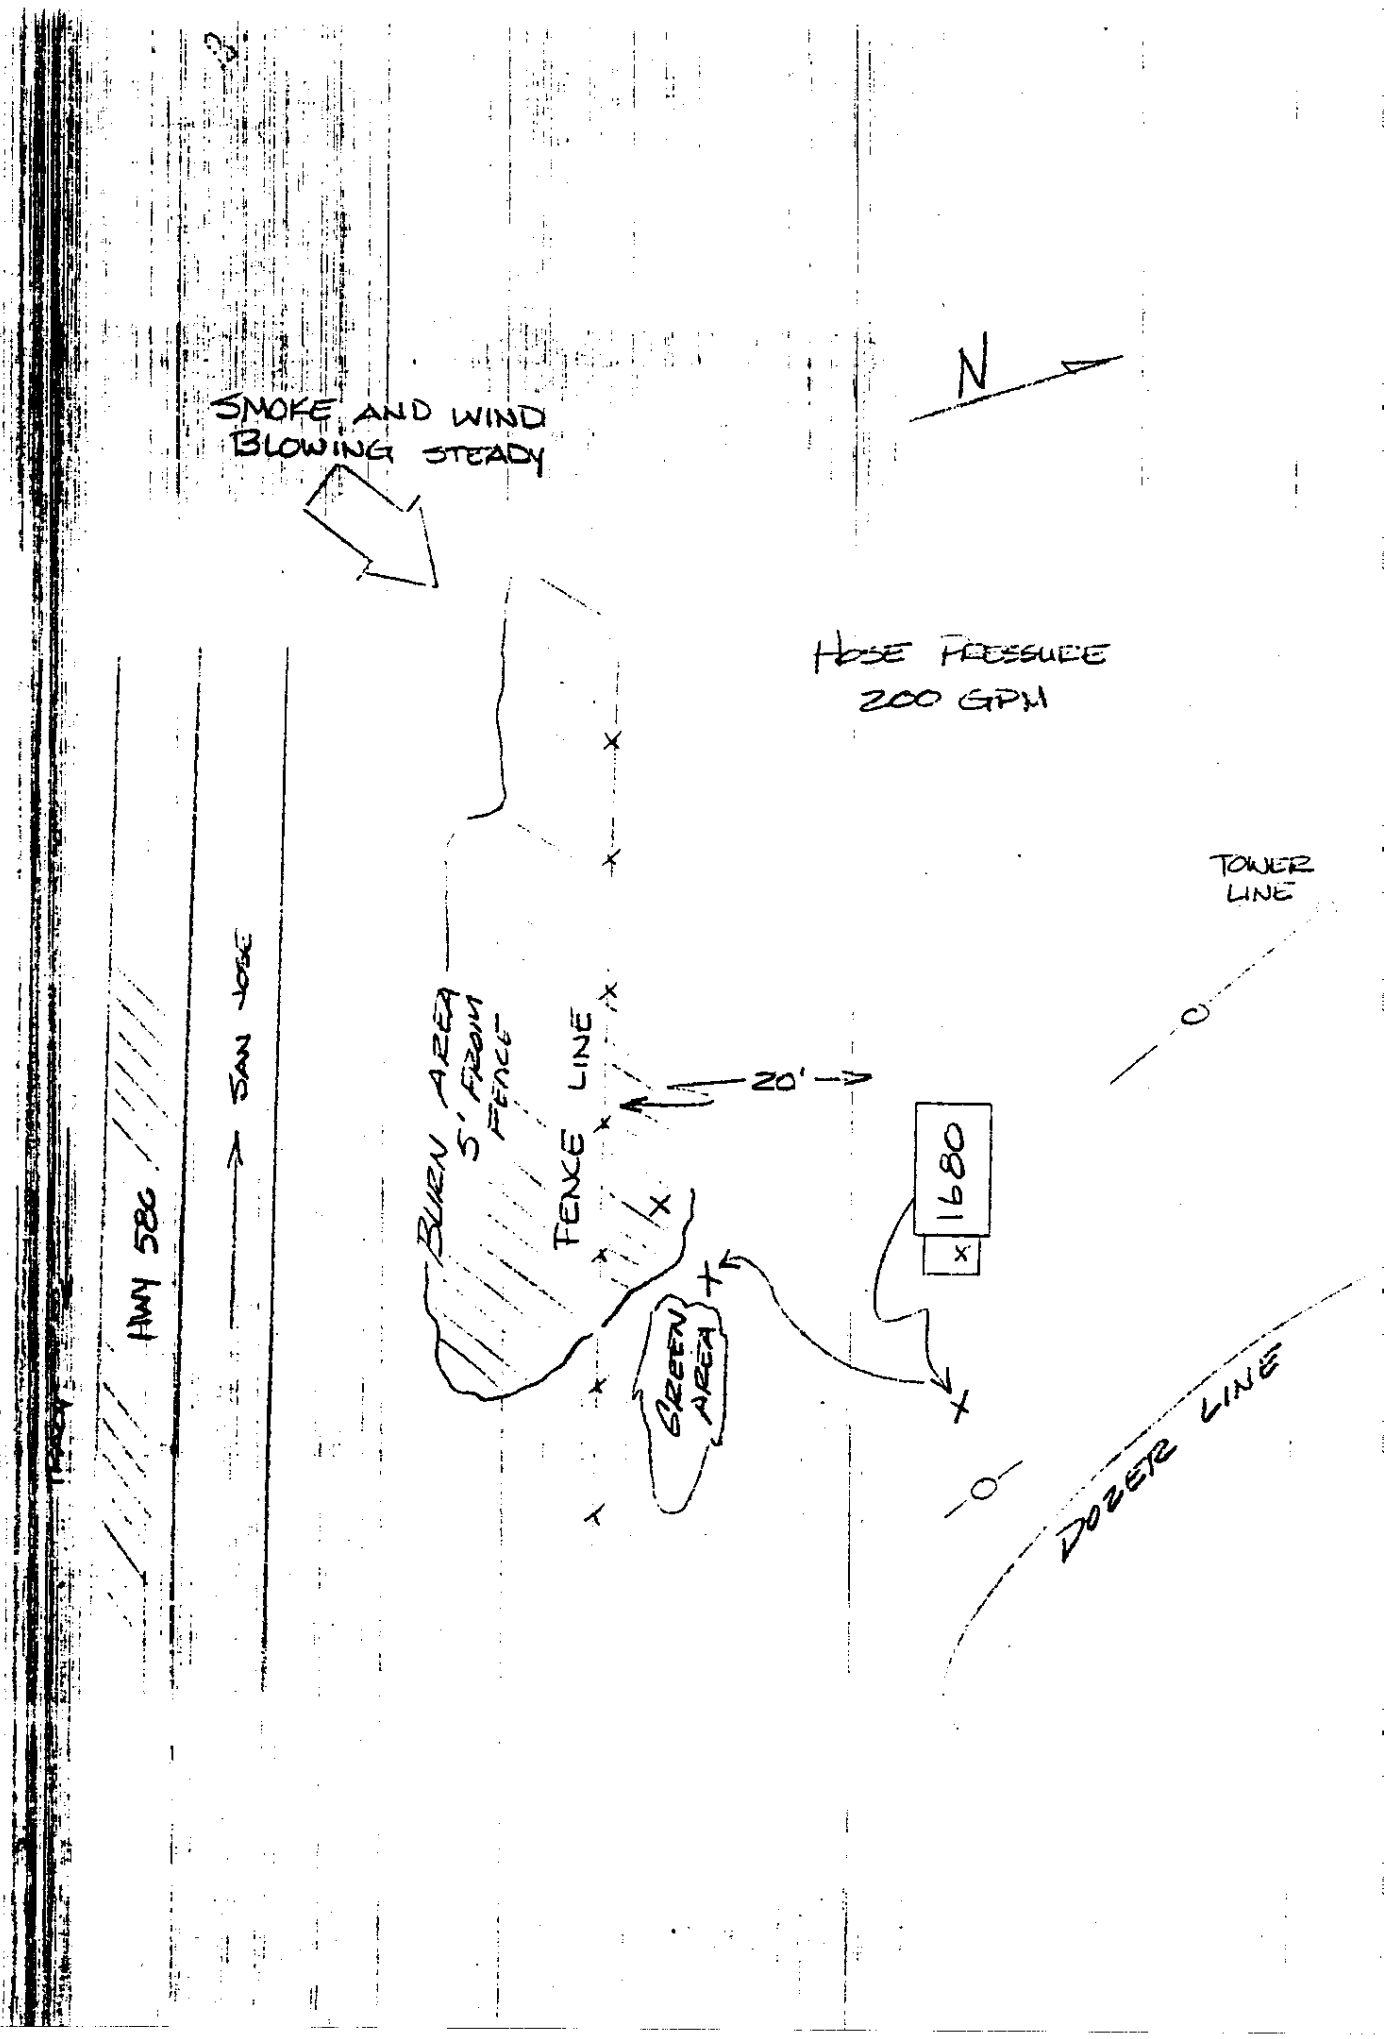
BURN AREA
5' FROM
FENCE

1680
x

NOZZEL PRESSURE
100-120 1/4" TIP

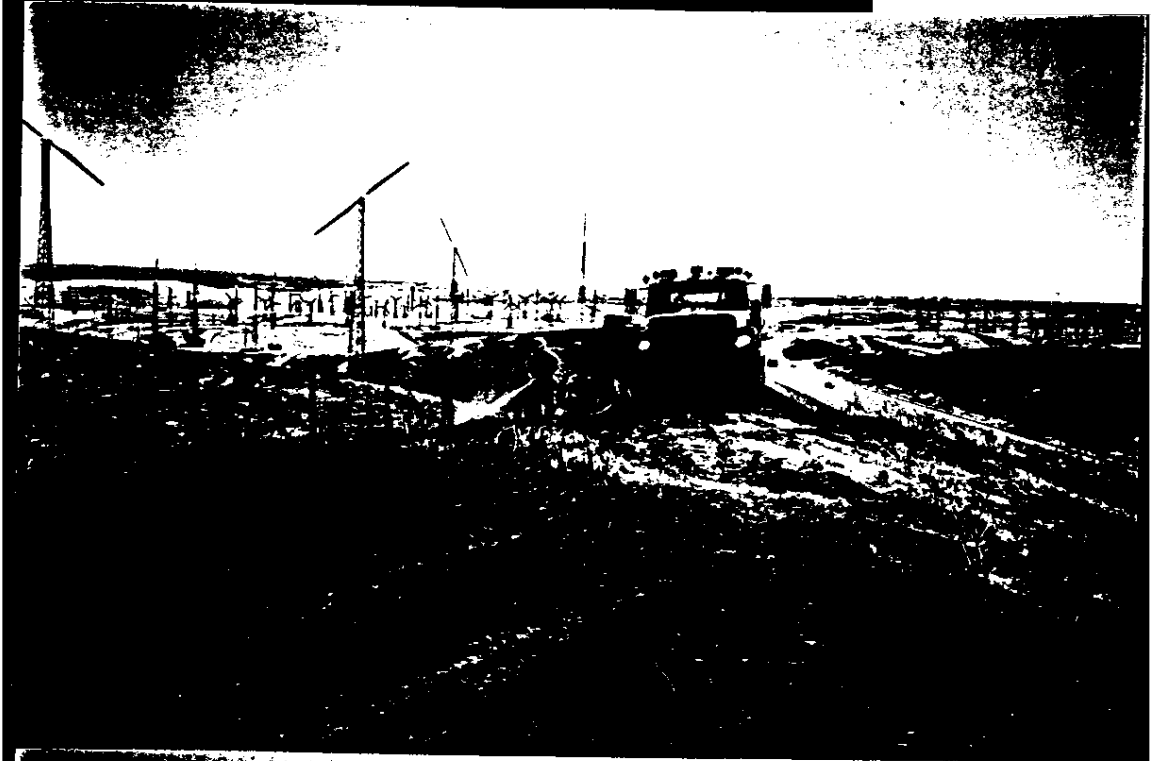
Access to the burn
from the east.

Initial attack #1

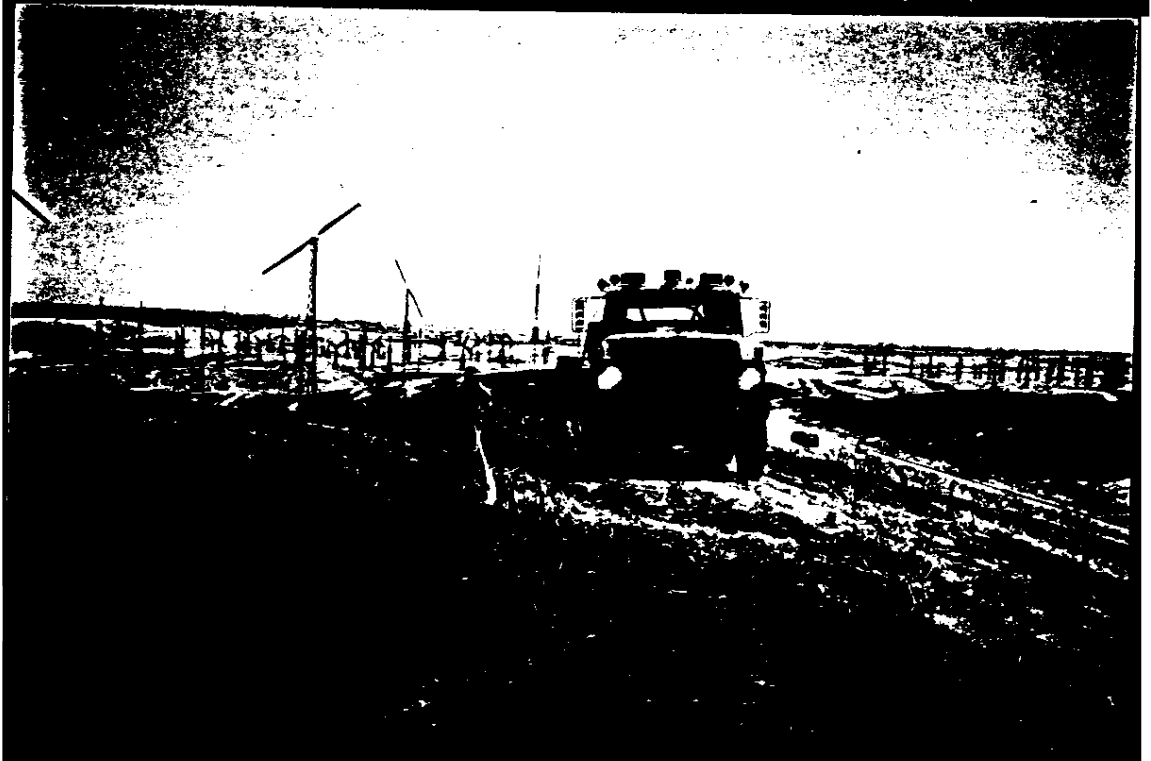
Initial attack continues #2

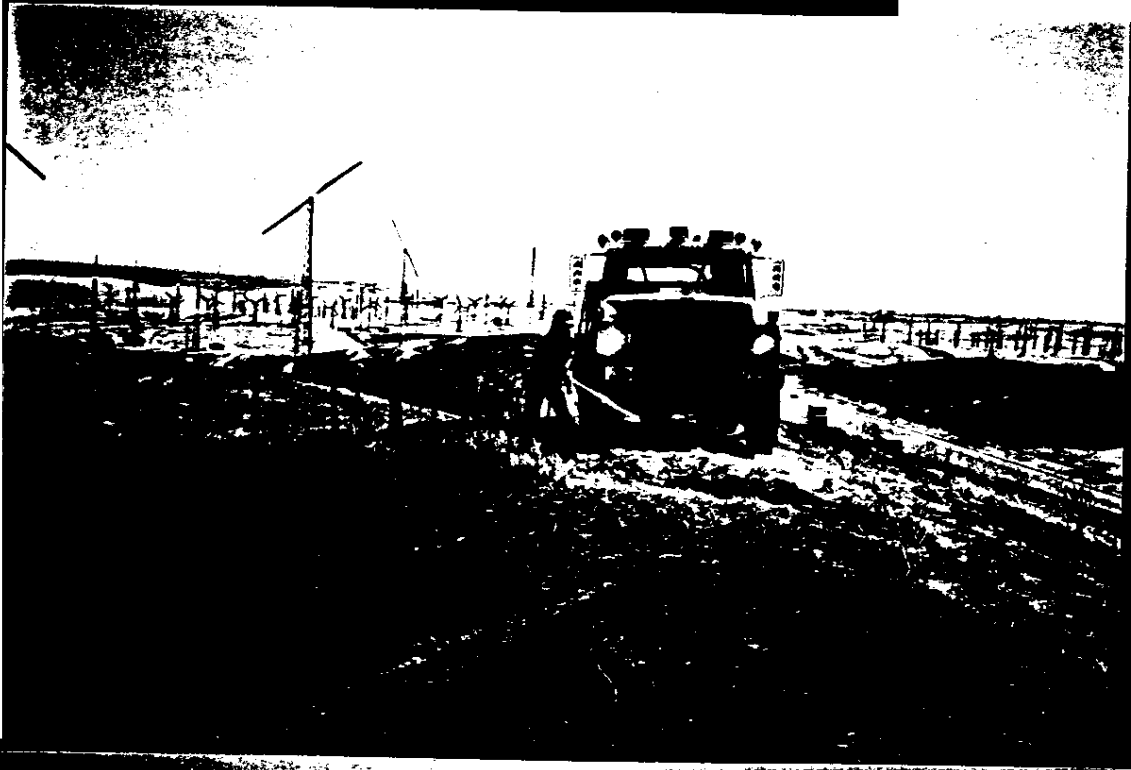
Initial attack continues #3

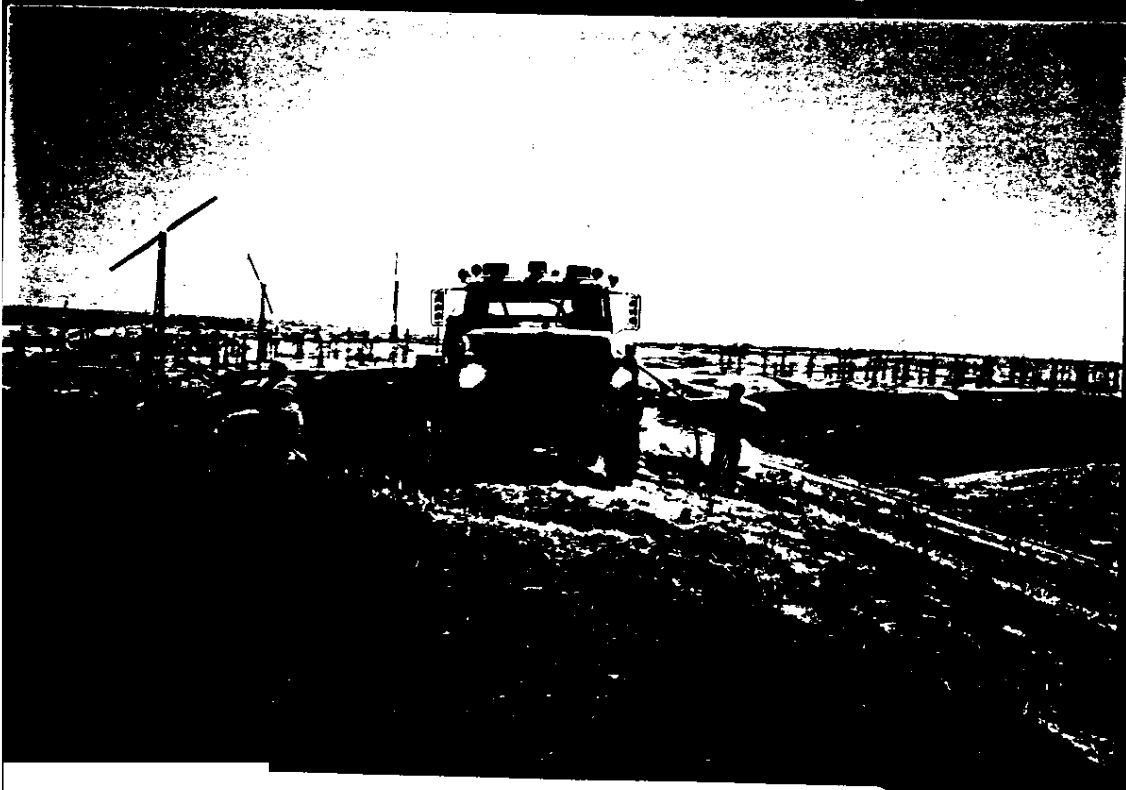
Initial action

Armijo extending 3/4"
hardline.

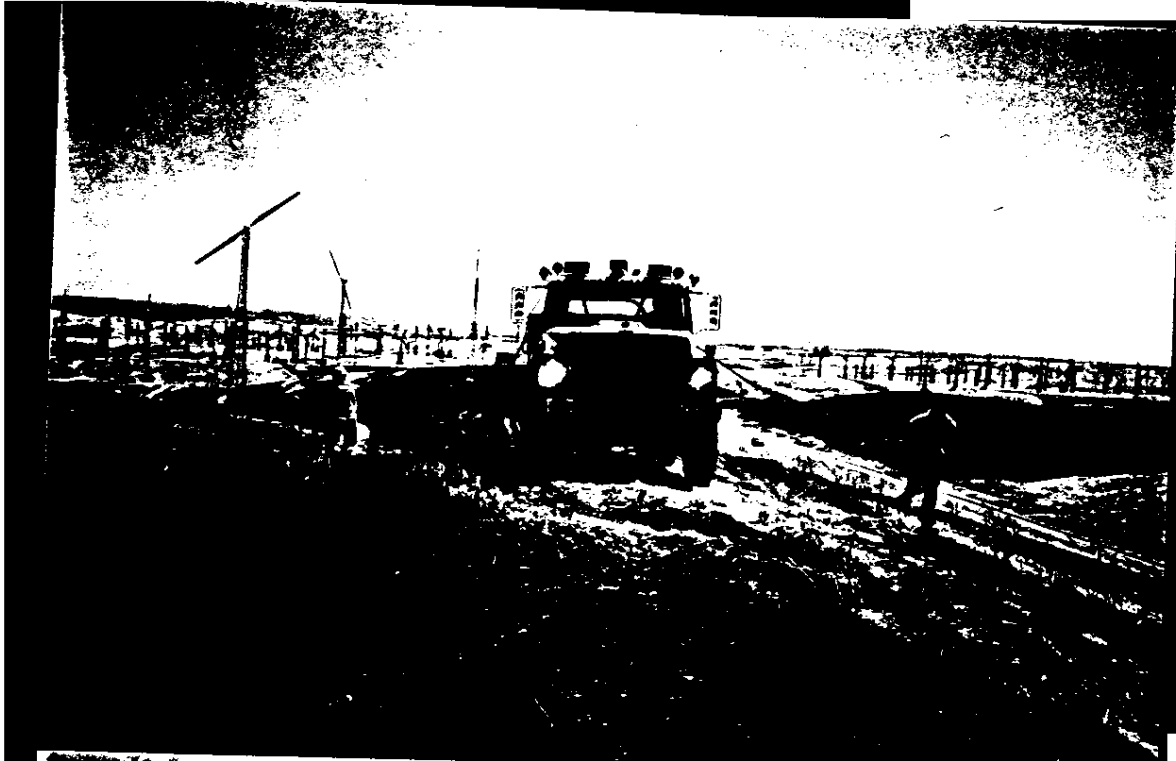
Point at which the flashover
occured.

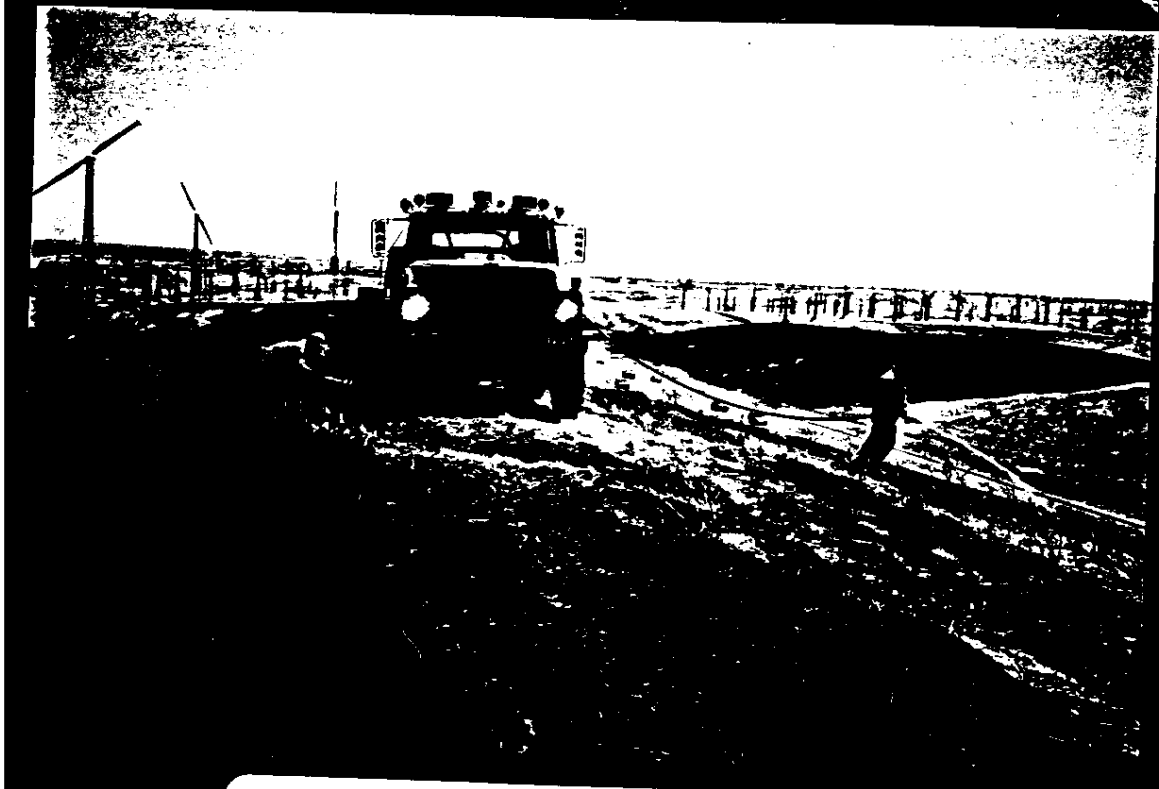
View looking east, Engine 1661
accident occurred at the top
of the farthest burned knoll.

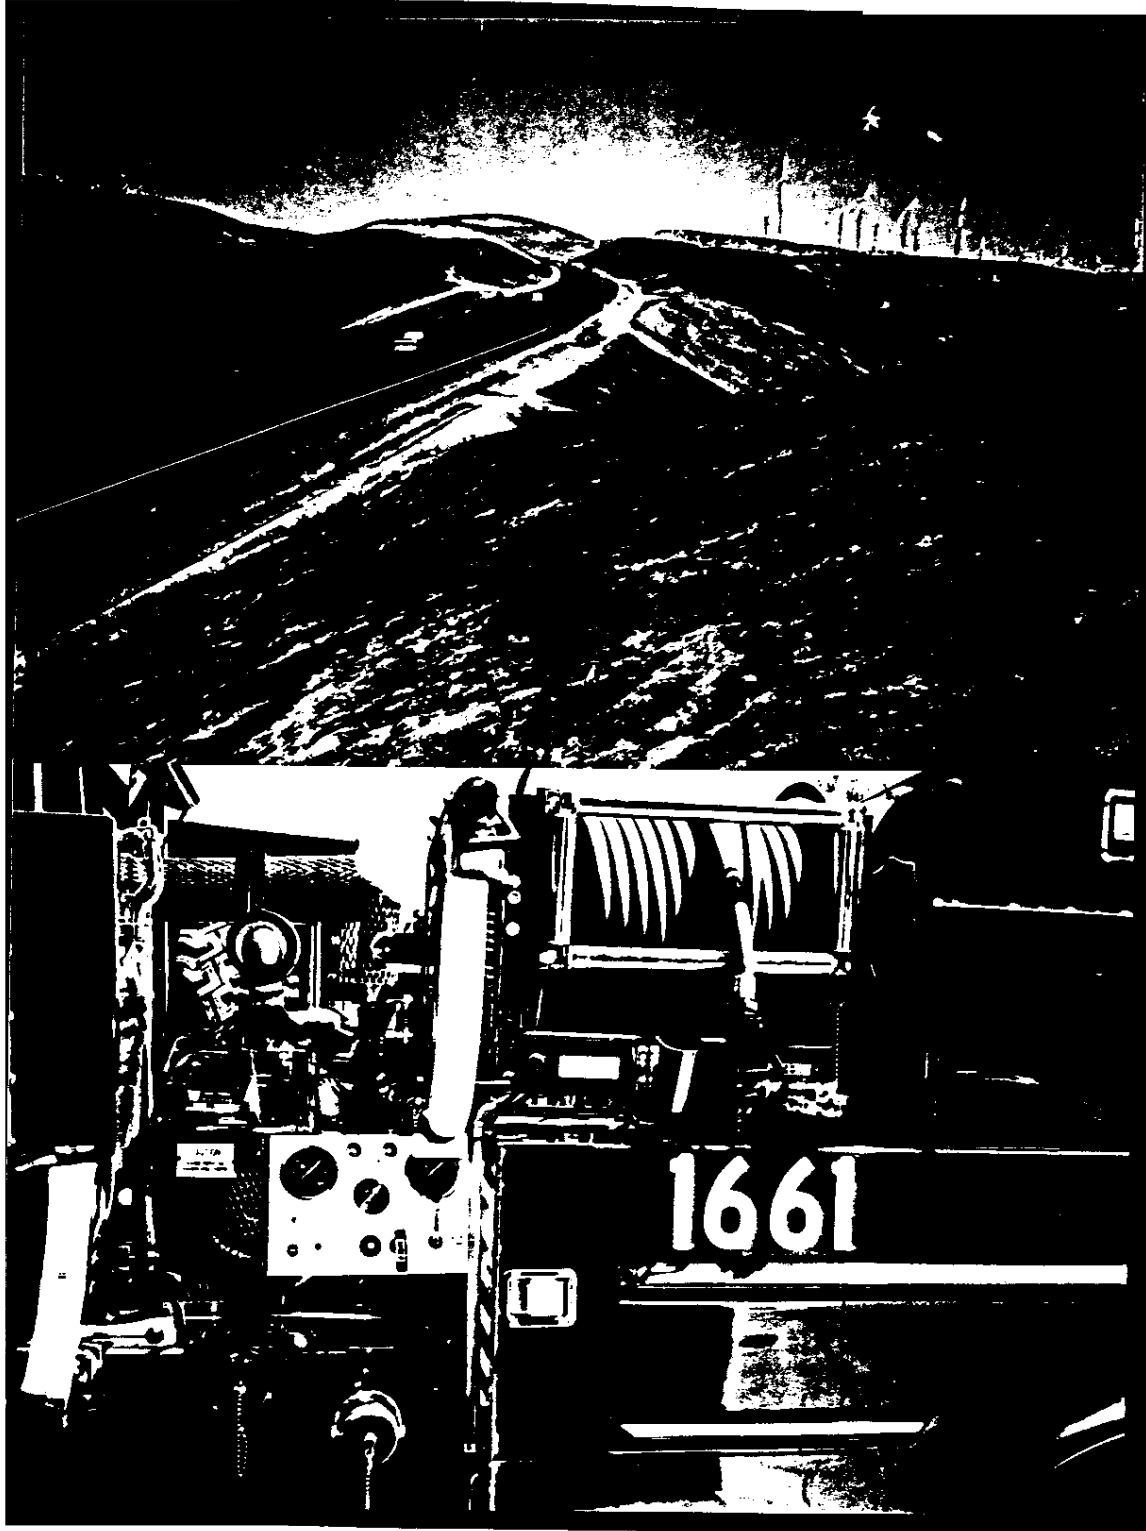
#1

1. Both Armijo and McCallum were using 3/4 inch hardlines equipped with 1/4 inch smooth bore tips. The hardline proved inadequate to suppress the fire.

1/4" smooth bore tip used
during flashover

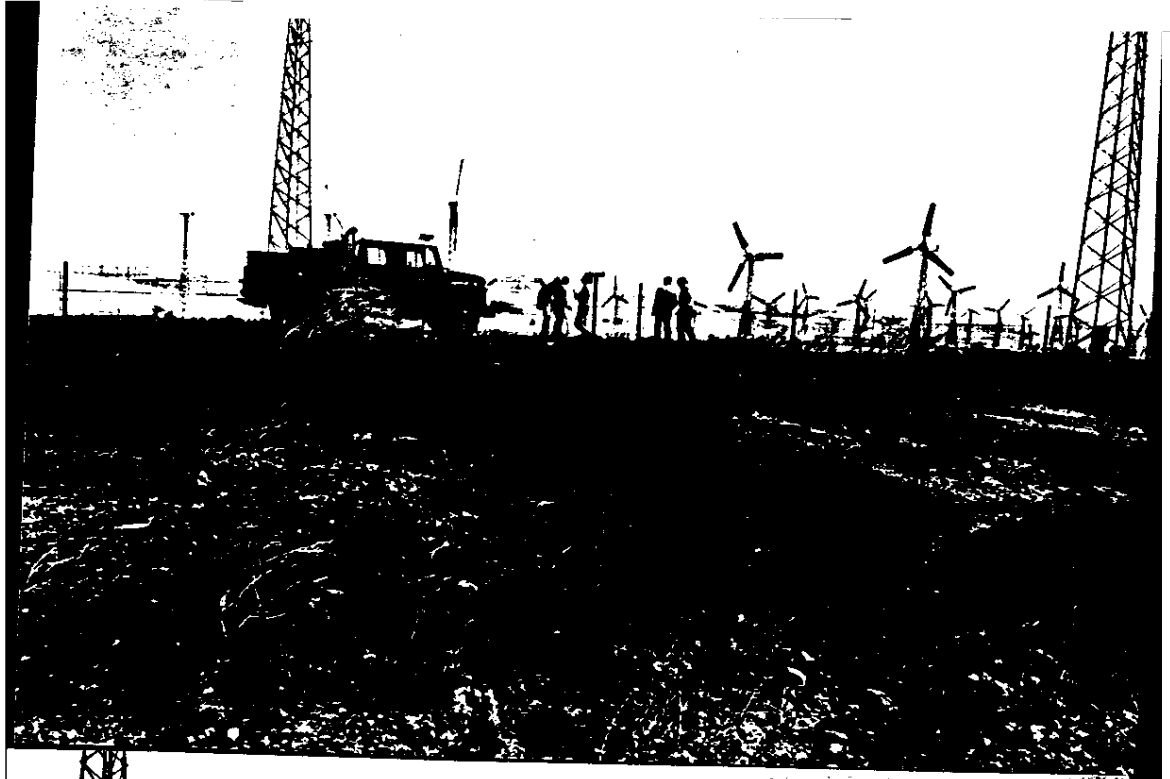
Actual placement of
Engine 1680.
