January-June 2010

FOREST SERVICE AVIATION RISK MANAGEMENT

SAFECOM
Aviation Safety Communique

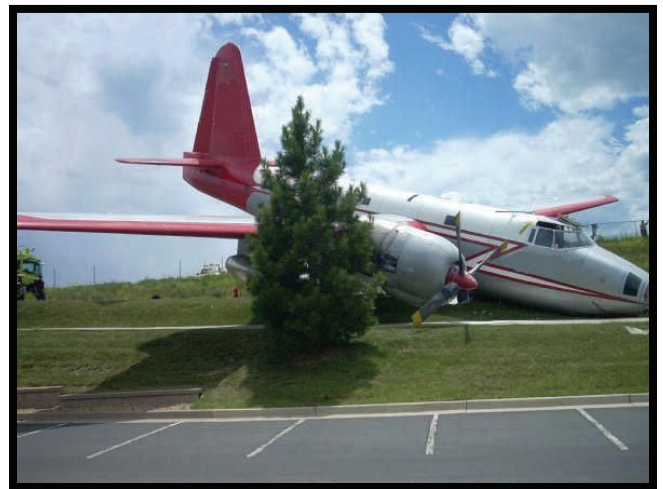
SAFECOM 10-380 A P2V Neptune returning from the Round Mountain Fire on the Arapaho-Roosevelt National Forest had an aviation mishap upon landing at Rocky Mountain Metro Airport. The Tanker declared an emergency on final approach. The aircraft landed safely but was unable to stop and rolled through the airport fence and came to rest on 120th Avenue. There was a small fire in one of the engines after the landing, but was quickly extinguished by airport fire crews. There were no injuries. **CORRECTIVE ACTION:** A Forest Service Aviation Safety Accident Investigation Team has been ordered and will investigate the mishap in coordination with the NTSB. After the incident all tanker operations at the base were temporally suspended. RASM comments: Tanker Base operations returned to operations normal on the 27th. [NTSB Preliminary Report](#)

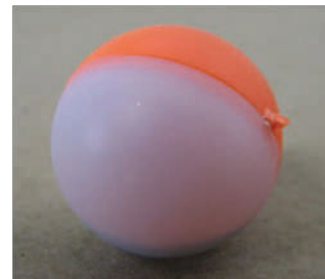
SAFECOM 10-205 We recently purchased two Red Dragon aerial ignition machines and had some issues when we used them for the first time. First, we installed the exit chute incorrectly so that the spheres could not drop out. We bench tested without the chute so was unaware of our mistake until the PSD operator experienced a jam. He attempted to clear it manually and noticed smoke coming from the machine. He immediately extinguished the fire and returned to the helispot, where we discovered our mistake. The machine worked fine for a fuel cycle then on the next fuel cycle, the PSD operator experienced 3 jams in one chute. The first time, he was not able to clear so they returned to the helibase, we were not able to duplicate or solve the jam. We were aware of the jamming issue caused by removing the hopper and then not removing the two spheres, but this was not what had occurred in this case. The aircraft returned to the unit and continued firing until he experienced two more jams. He was able to manually clear both jams. Upon examining a random sample of Dragon Eggs, we discovered several spheres had a sharp, jagged piece of plastic protruding from the seam area. We had noticed a large number of shavings in the hopper and wondered if some of these protrusions broke off while the spheres were agitated in the

hopper. We suspected that these hard plastic protrusions might be causing the eggs to jam in the chute. **CORRECTIVE ACTION:** If we had bench tested with the chute on, we would have discovered our first mistake. We contacted SEI, the manufacturer of the Red Dragon. They requested pictures of the affected spheres and the ship date {August 2009}. They have agreed to replace the stock of spheres we have.

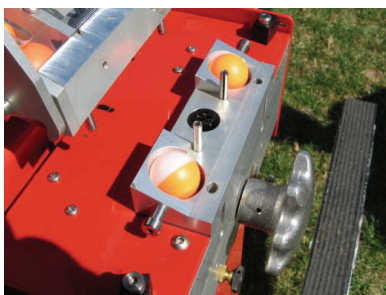
SAFECOM 10-153 Two issues using the Red Dragon aerial ignition device. 1st - Upon filling the hopper one Regular PSD sphere was discovered in the hopper along with the Red Dragon spheres. 2nd - the Red Dragon the machine jammed without releasing any spheres. Helicopter returned to helibase. **CORRECTIVE ACTION:** 1st corrective action was to empty the hopper and visually inspect to insure no other regular PSD balls were present. The regular PSD sphere must have been stuck in the bottom of the bag, all bags were removed and inspected, no regular PSD spheres found. Double check bags to ensure unwanted spheres are not inside. 2nd issue was related to taking the hopper off to inspect the spheres. When the hopper was removed it was full of spheres. When the hopper is filled while on the RED DRAGON it automatically preloads 2 spheres onto the top of each slipper blocks into a cylinder. When the hopper was removed and then replaced, it is possible for 2 preloaded spheres in the cylinder to be pushed down. The bottom of the two spheres will then jam in the cylinder between the cylinder wall and the sphere stopper. When the machine turns on, the system recognizes the resistance from the jam and fails. We cleared the jam on the ground, tested the machine and resumed the mission. Upon landing and shut down we easily duplicated the jam again and again with success. Lesson learned: If you remove a hopper containing spheres after it has deposited 2 spheres into the cylinders of each slipper blocks, remove the top sphere of the two preloaded spheres so they won't be pushed down and jam. Sent manufacturer a message identifying the problem and they responded immediately saying the issue was identified in the manual ([see 1st attached pdf document](#)). They have been discussing the concern and are looking at a short term prevention of possibly a warning sticker to put on the machine and in the long term a remedy. SEI issued a Tech Bulletin 4/22/10 ([see 2nd pdf attachment](#)). In the mean time

take a look at the you tube videos. Pass on far and wide.....thanks. National Helicopter Operations Specialist You Tube Red Dragon Jam Videos can be viewed by entering the following in the YOU TUBE search: red dragon jam 3
