FILE: FATALITY - 8/11/73 DO 12
MARK ARROLLADO, IFF
SAN DIEGO CA

REPORT OF INVESTIGATION
Fatality
Steve Mark Arrollado
Firefighter

CONFIDENTIAL
REPORT OF INVESTIGATION

Accident
Steve Mark Arrollado
Firefighter
Fatality

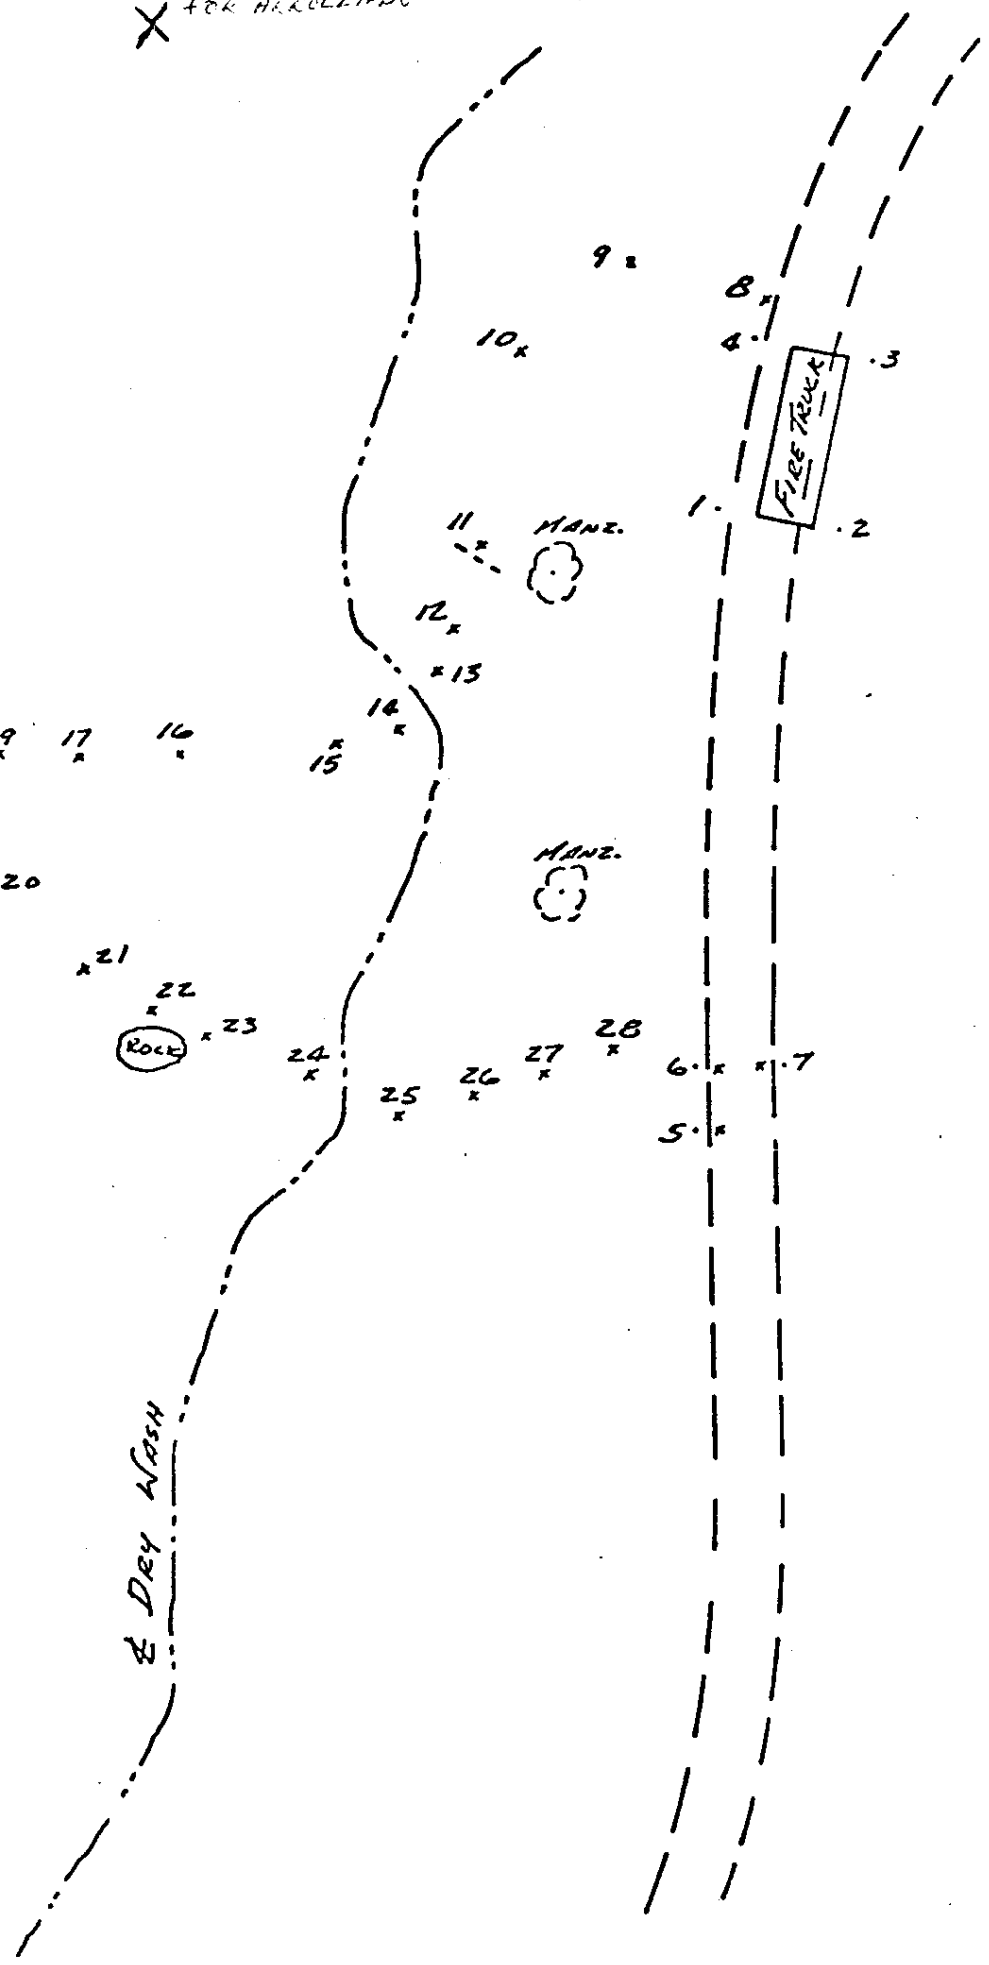
Following the reassignment of Eberhardt, the situation was then as is shown on exhibit 4a with the fire truck commanded by Linton spotted as shown and a single length of 1-1/2 inch hose laid from the fire truck to a point between figures 5 and 6 on exhibit 4. Photograph 1 is the hose lay as seen shortly after the accident. Photograph 2 is a reenactment of the hose lay as it looked to Engineer Linton at the time of the accident. Photograph 3 is a reenactment showing where Arrollado stood as he sprayed the unburned fuel. The hose line was charged with 125 pounds of pressure supplied by the mid-ship pump on the fire truck. The nozzle was equipped with a 3/8's inch tip.

Meanwhile, it is presumed that Arrollado continued to travel from point 22 on exhibit 4 to point 19. Upon his arrival at point 19 Arrollado leaned on a large rock at point 19. (See photograph 9.) An imprint of one knee and one large piece of cloth and three small pieces were found in this immediate vicinity after the accident. Photograph 10 shows the large piece of cloth. Photograph 11 and 12 show the three smaller pieces of cloth found in the same vicinity. Point
