CDF GREEN SHEETS

Investigation Summaries of Serious CDF Injuries, Illnesses, Accidents and Near-miss Incidents

**CONCOW FIRE
CA-BTU-10476
BUTTE RANGER UNIT
COAST-CASCADE REGION
SEPTEMBER 20, 2000
RESCUE BURN INCIDENT**

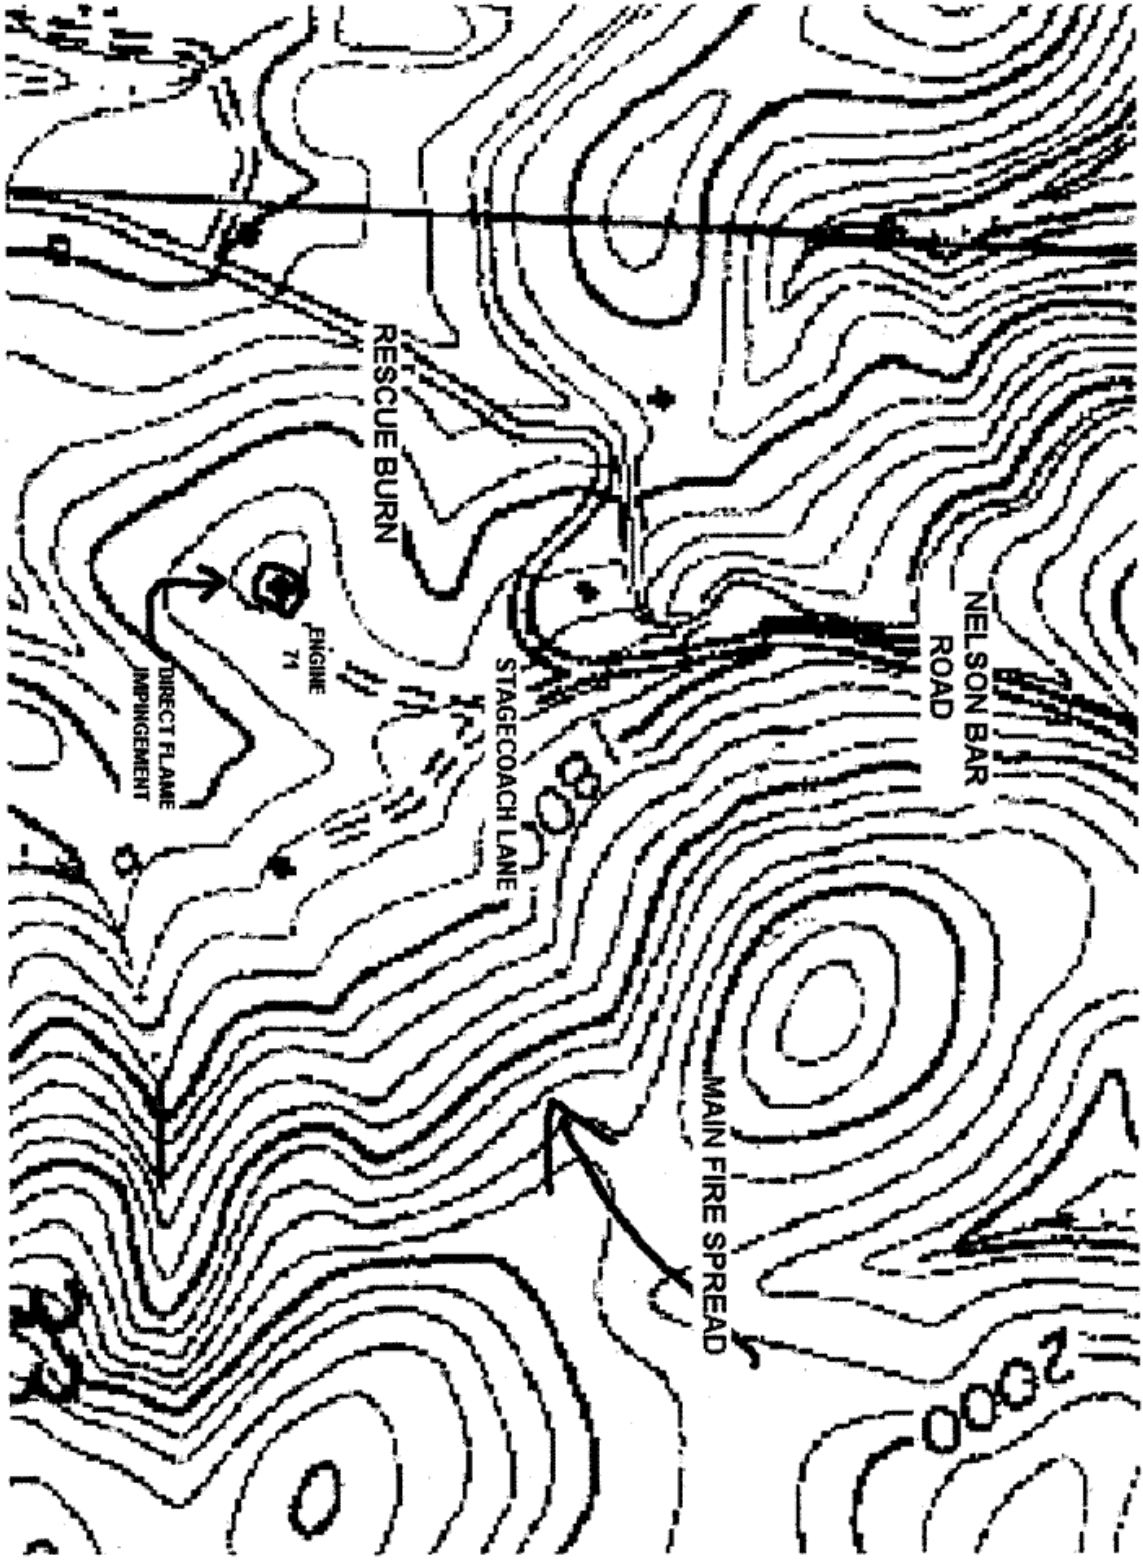
RESCUE BURN

DIRECT FLAME IMPINGEMENT

MAIN FIRE SPREAD
