**Accident Investigation  
Factual Report**

**Loss of Fire Engine 3662  
During High Water Crossing of  
Gila River**

**Arizona  
Bureau of Land Management  
Colorado River District**

**September 6, 2009**

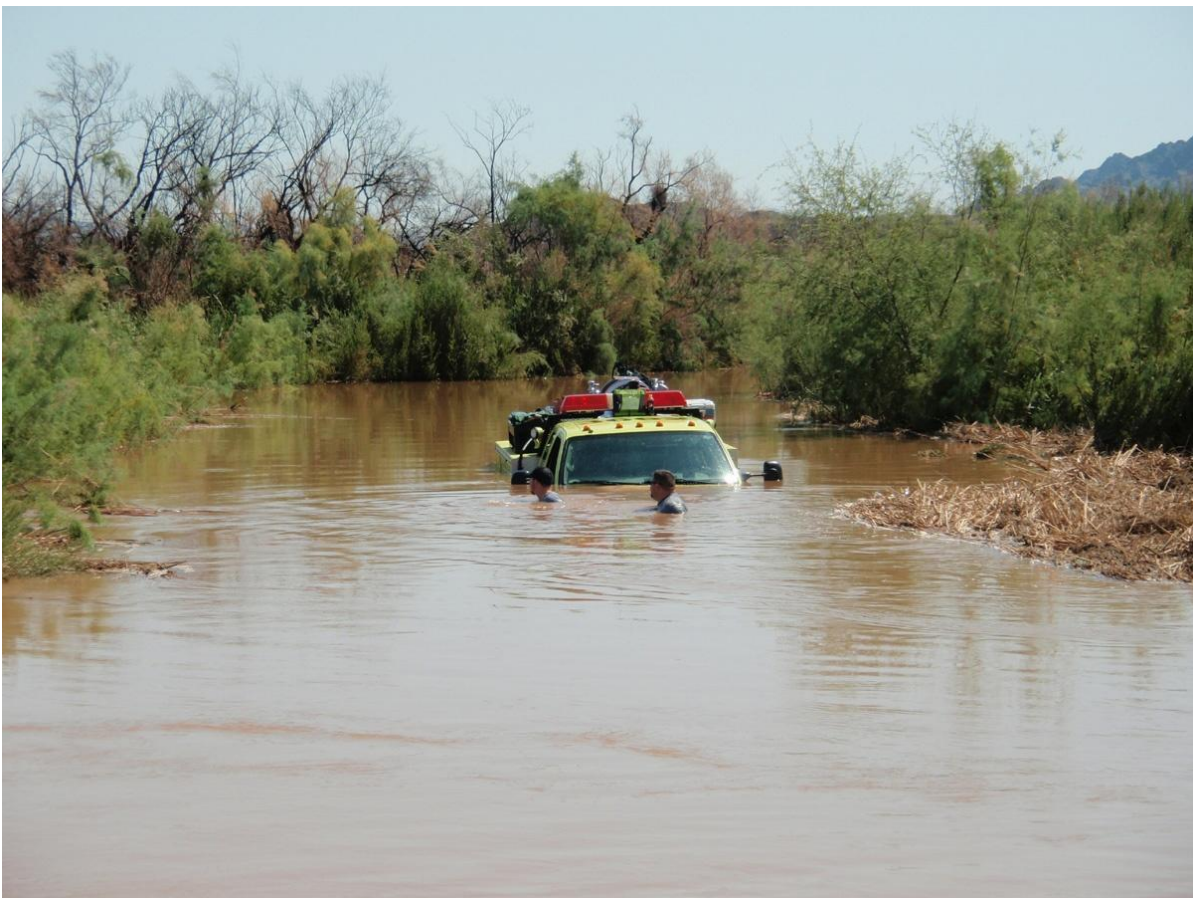
COVER PICTURE IS POST SUBMERGING OF ENGINE 3662 IN GILA RIVER.

On Sunday September 6, 2009, Engine 3662 (3662) a type 6 engine from the Colorado River District stationed in the Yuma Field Office was involved in an accident while attempting to cross a flooded portion of the Gila River North of Yuma. As a result a large portion of 3662 was submerged in four to five feet of water for approximately one hour. The accident was caused as 3662 attempted to make a high water crossing of a normally passable river ford. Heavy rains from the day before had left the river well above its normal levels and the engine was submerged in the Gila River to the bottom of the windshield. There were no injuries to the crew. Damage to the engine is still being ascertained. **(See Cover Picture)**

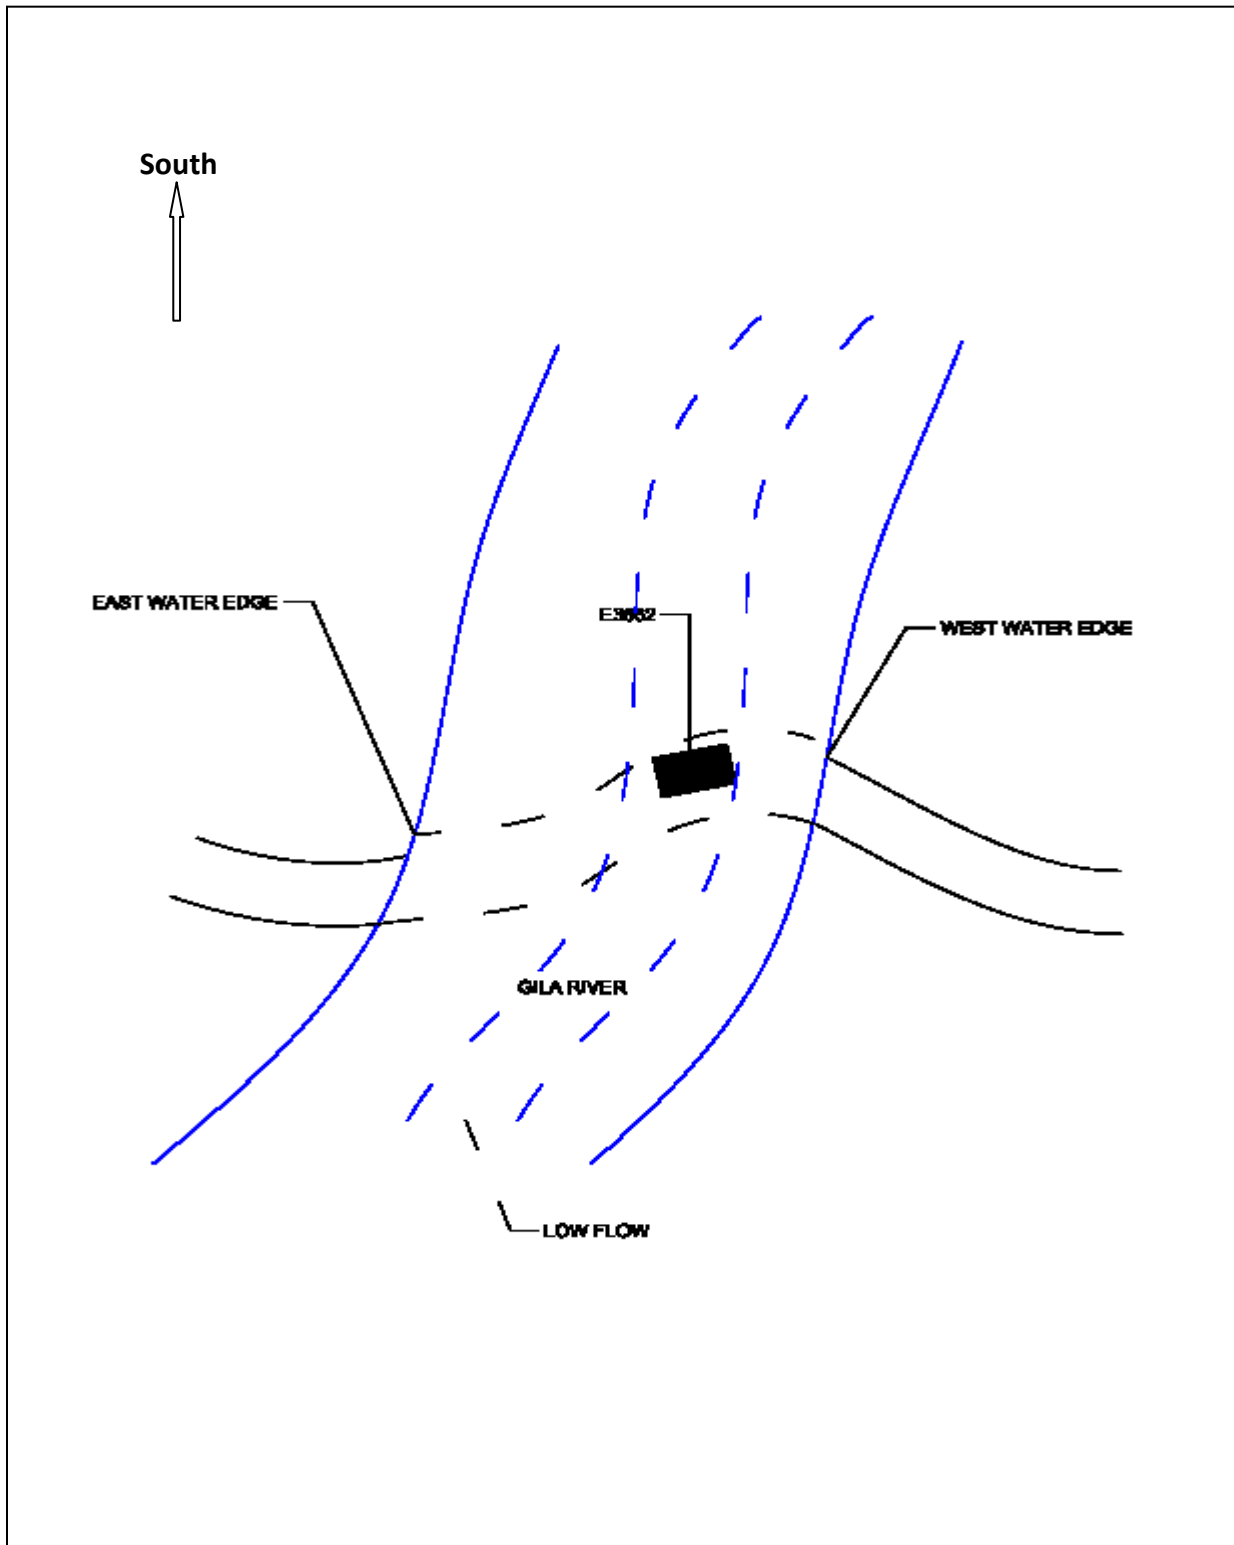
# Diagram No. 1

River crossing terrain in plan view

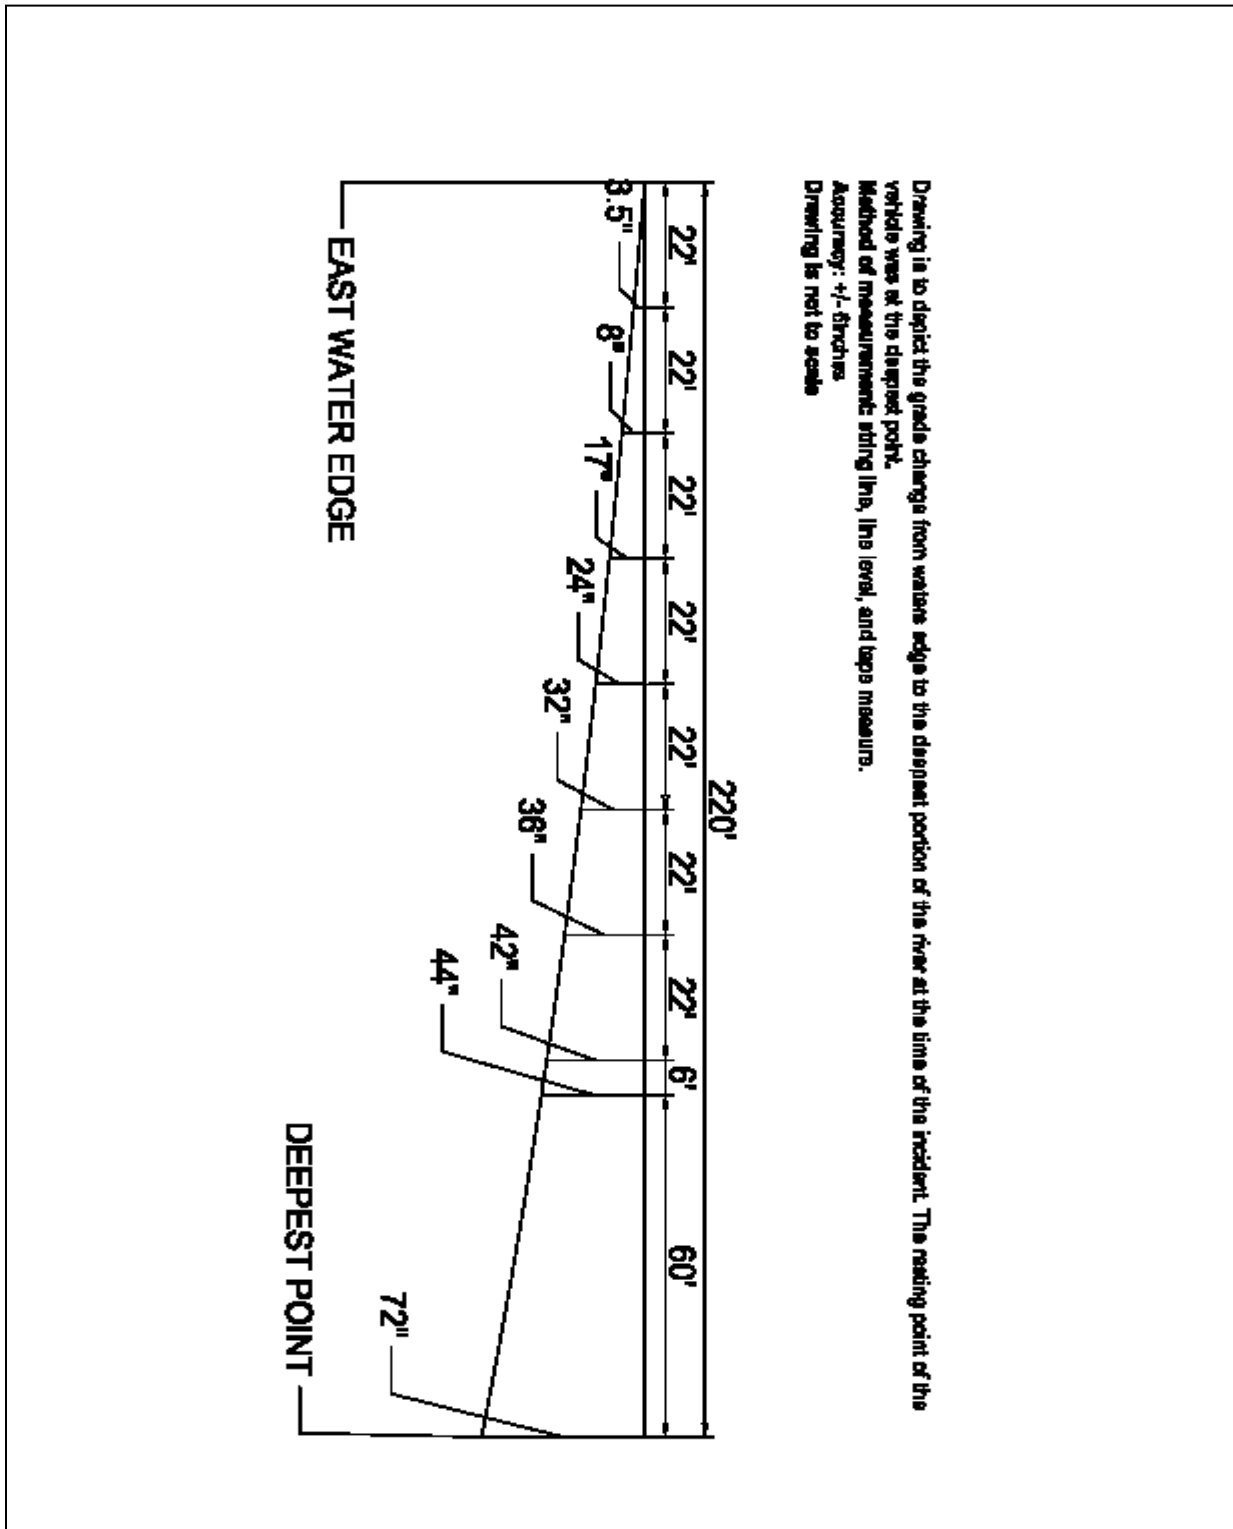
Diagram No. 2

Road slope from high water edge to center of Gila River Channel
