REVIEW REPORT

Subject: Fire Shelter Deployment

Date: September 9, 1988

Location: Table Mountain, Canyon Creek Fire, Rocky Mountain Ranger District,
Lewis and Clark National Forest

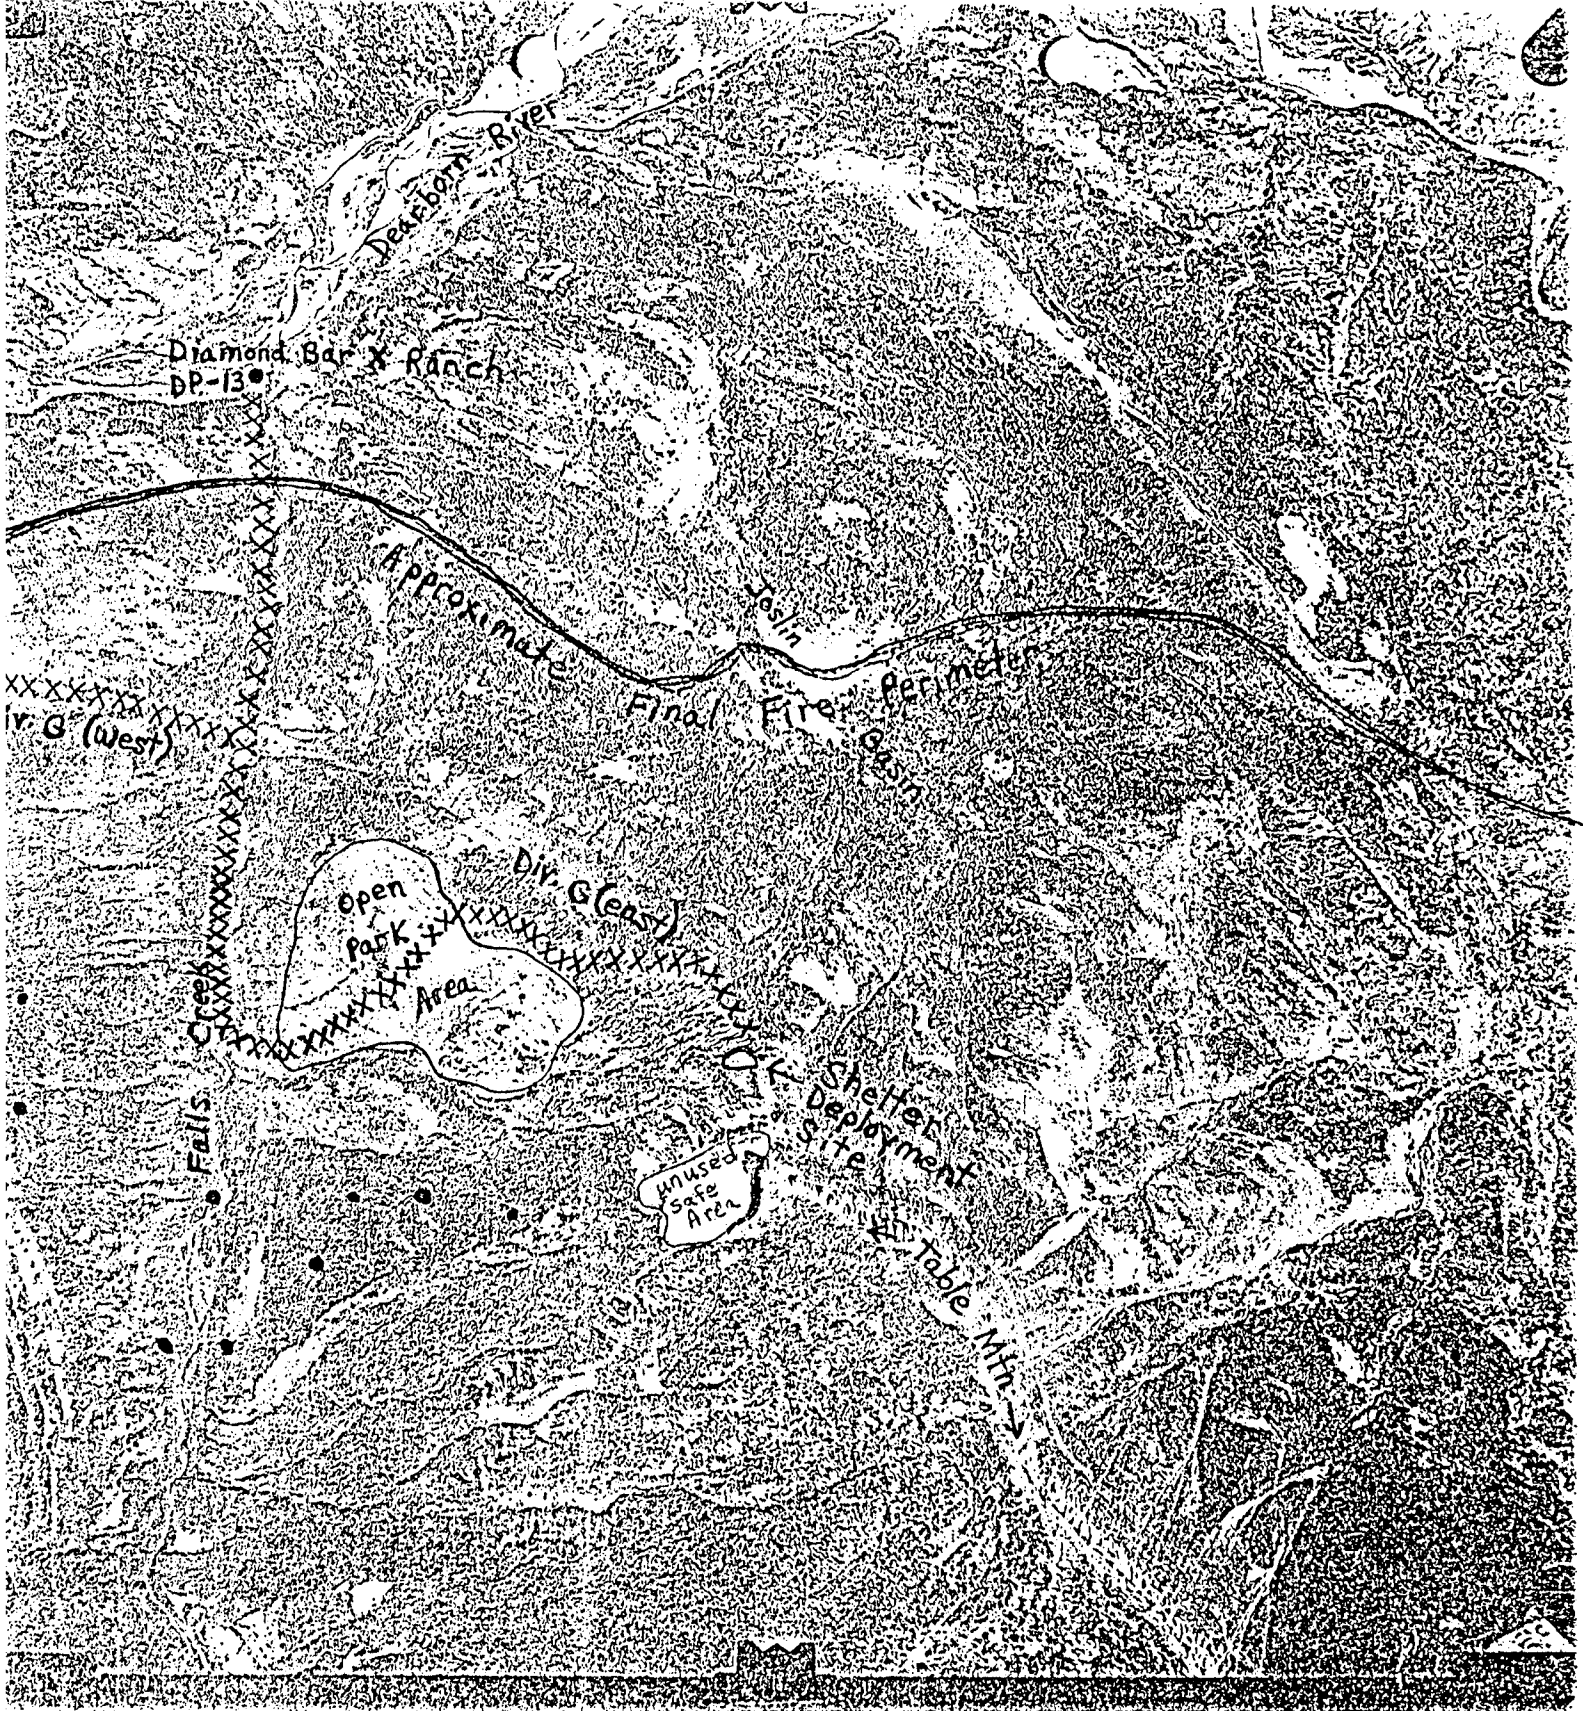
EXHIBIT Y

Discussion - Given the actual line location (see exhibits X and Y) it is difficult to project a reasonable probability of being able to construct, burnout and hold the same under the time frames allowed. The Division Supervisor stated that he and the OSC had viewed the area from the air the day before but had not visited the east side of Falls Creek on the ground. Based on the review teams on site visit and photos (see Pictures #12 and #13) taken by the crew a successful burnout of the sparse grasses in the park would have required a 20+ mph wind from the NE. Under the predicted winds and with its location down from the top of the ridge on the windward side it is probable that there would have been difficulty in holding the fire line during burnout operations. Given buildings in the NW 1/4 of the SE 1/4 of Section 34 and throughout the Joslin Basin the line location on the east side of Falls Creek was the last opportunity to control the fire short of direct structure protection. Again, the probability of success combined with the attendant risks did not warrant the tactics used.
