Chalk Fire – Engine 56 Rollover Accident Prevention Analysis Report

Chalk Fire

Los Padres National Forest

October 3, 2008

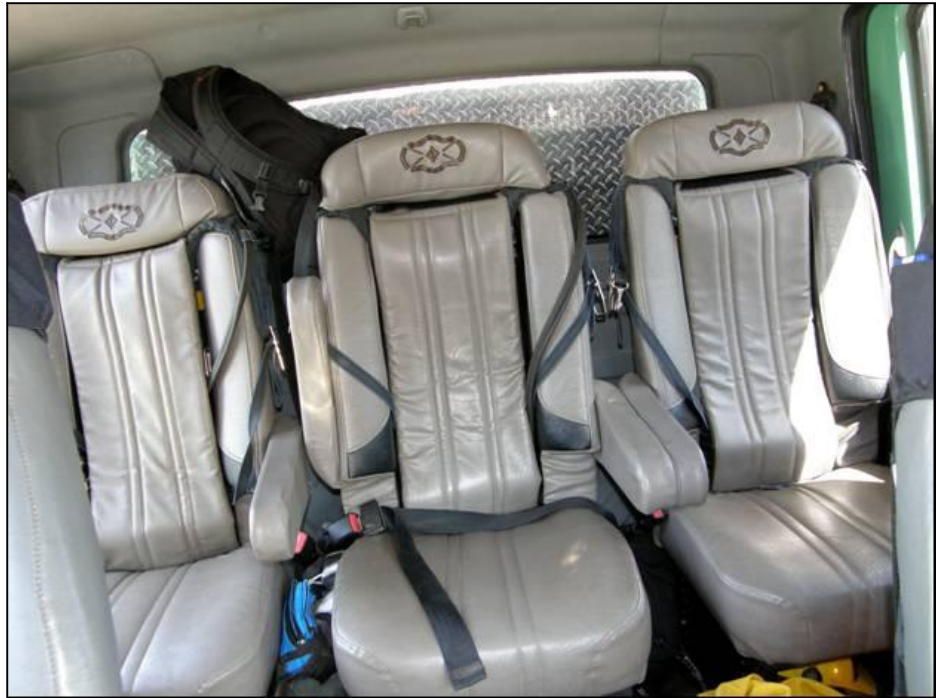
Fig1 – Position of firefighters, from right to left: Firefighter #1, Firefighter #2, and Firefighter #3.

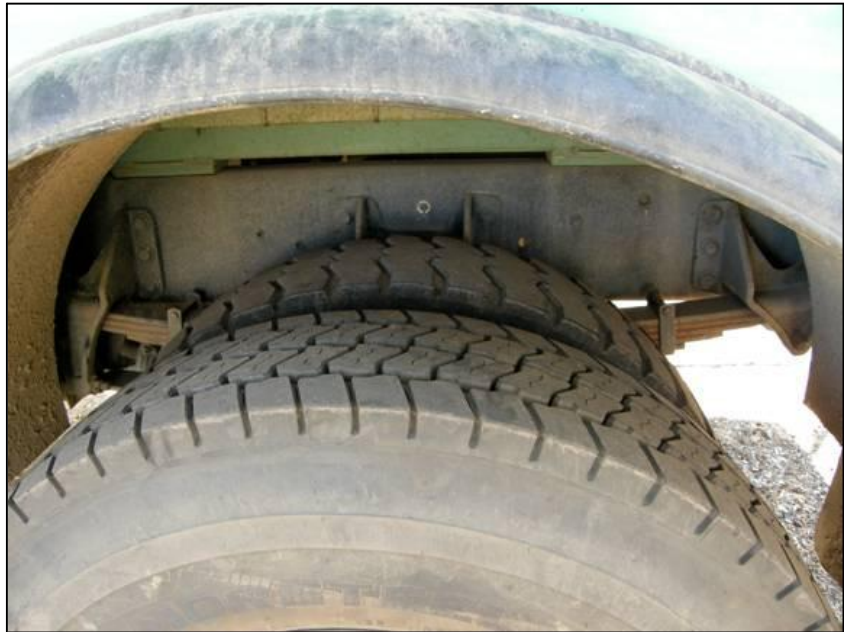
Fig 2 – The replaced outside rear dual on Engine 56. Findings revealed a difference greater than one-inch diameter between the two tires.

On Thursday, Oct. 2, while preparing for their shift, the driver of Engine 56 drives over the wheel chock block causing a blow-out on the outside left-rear dual. They take the engine to the Ground Support Unit to have the tire changed. It is replaced with a mismatched tread-pattern and circumference size tire because the vendor states that they do not have any tires of the same style/size. The Engine 56 Acting Captain questions the Ground Support Unit Leader about whether or not the engine would later be able to pass the Demob inspection with this new, mismatched, tire. A Ground Support Equipment Inspector checks tread depth on the left front tire and assures the Acting Captain that the vehicle will pass Demob inspection, even though there is a difference. After driving with this replacement, the driver does not notice any vehicle handling differences.

- Due to the left rear dual tire damage, the tire was replaced at the Incident Command Post by Ground Support. However, during the post-accident demobilization inspection, all six tires were at—or near—tread wear bar limits. In addition, a difference in diameter in the rear dual tire was noted. The difference of one inch in diameter between the two left rear dual tires as revealed in the post-accident findings may have been a contributing factor in the handling of the apparatus during the accident. The November 2002 International Operator's Manual states: *"Dual tires should be matched using tires of equivalent size. Tires that differ more than ¼ inches in diameter or ¾ inch in circumference should not be mounted on the same dual wheel assembly."*

Acting Engine Captain and driver questioned the mismatched size and tread of the tire, they were told that there would be no issue during demobilization from Ground Support. There was no concern or question that the mismatched tires may affect safe handling of the engine. The goal by Ground Support, the Driver and Acting Engine Captain was to repair the engine, become serviceable, and return to the fireline.

2. After inspection of all six (6) tires on Engine 56 it has been determined by the Equipment Specialist and numerous tire management personnel from Goodyear commercial tire systems that were consulted that Engine 56 could have had much better handling capabilities and control of the vehicle if it would have had its six tires replaced and properly matched before the accident occurred.

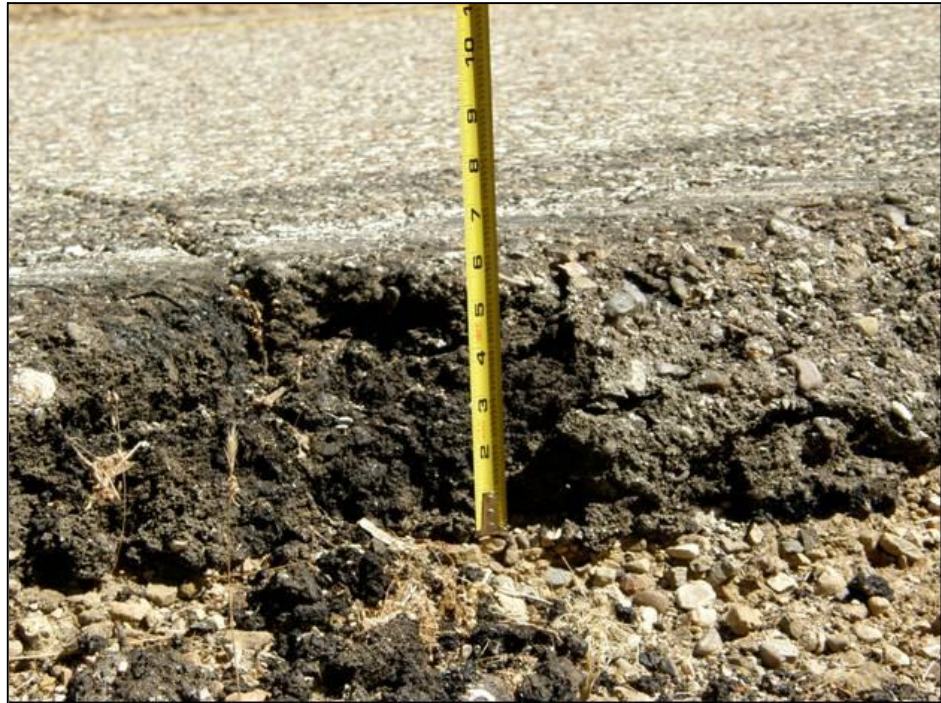
Fig 3 – Asphalt thickness and road edge where Engine 56's rear dual tires went off Vasquez Road.

As Engine 56 continues through a slight left bend in Vasquez Road, traveling between 30 to 56 mph³, the driver feels the passenger side rear dual tires of the apparatus slip off the edge between the asphalt and shoulder. (This height was measured post-incident to be between 4 and 8

inches, averaging approximately 6 inches through the distance traveled by Engine 56. This is the height between the top of asphalt and final grade road base material measured post-incident.)

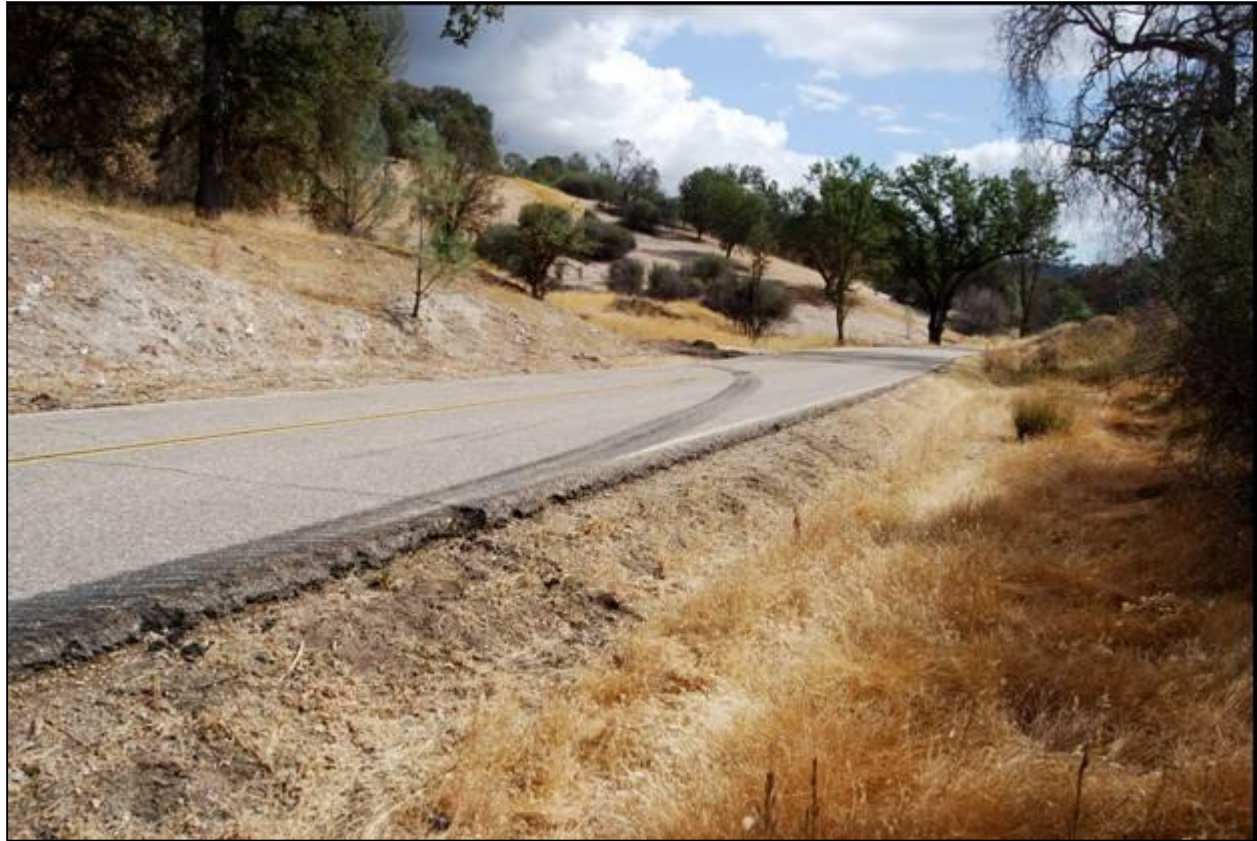
Figure 4 – The skid line where Engine 56 returned to the pavement and headed toward the embankment.
