Informational Summary Report of Serious CAL FIRE Injuries, Illnesses, Accidents and Near-Miss Incidents

**VMP Live Burn
Near Miss**

January 3, 2012

Corte Madera Ranch VMP

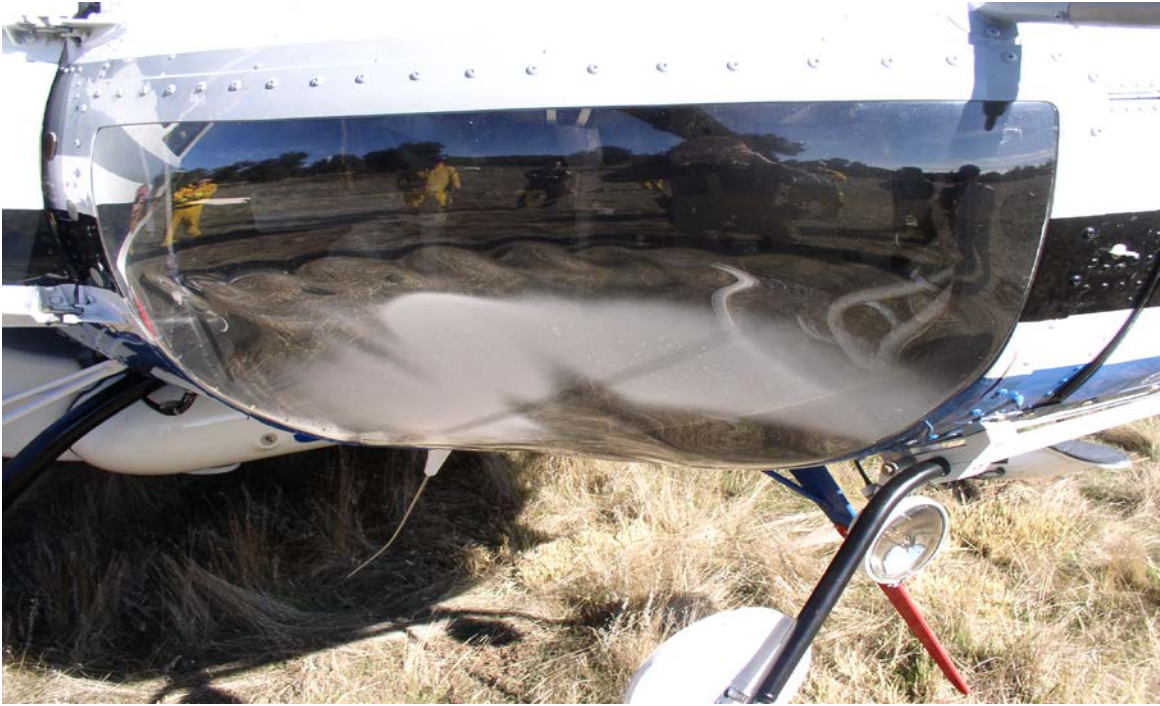
As the helicopter continued in a northerly direction, the pilot noticed frosting and deformation to the plastic chin bubble below his feet and the smell of melted plastic. The pilot immediately

Upon inspection of the aircraft, it was determined that the pilot's side (right seat) chin bubble was distorted and had a frosted / opaque look across the middle of the bubble. The Fire Captain's side (left seat) chin bubble was distorted but had no change in color. The nose of the aircraft on what is described as the battery compartment door which is painted with a 10 was distorted at the bottom side center line and the paint appeared to have been damaged from heat exposure. See photos. After a thorough inspection by the aviation mechanic on site, it was determined that Copter 10 was airworthy and it was flown back to Gillespie Helibase by the pilot. The CAL FIRE Helitack Crew was flown back in a separate helicopter along with the aviation mechanic. There were no injuries as a result of this incident.

Right Seat Chin Bubble Damage

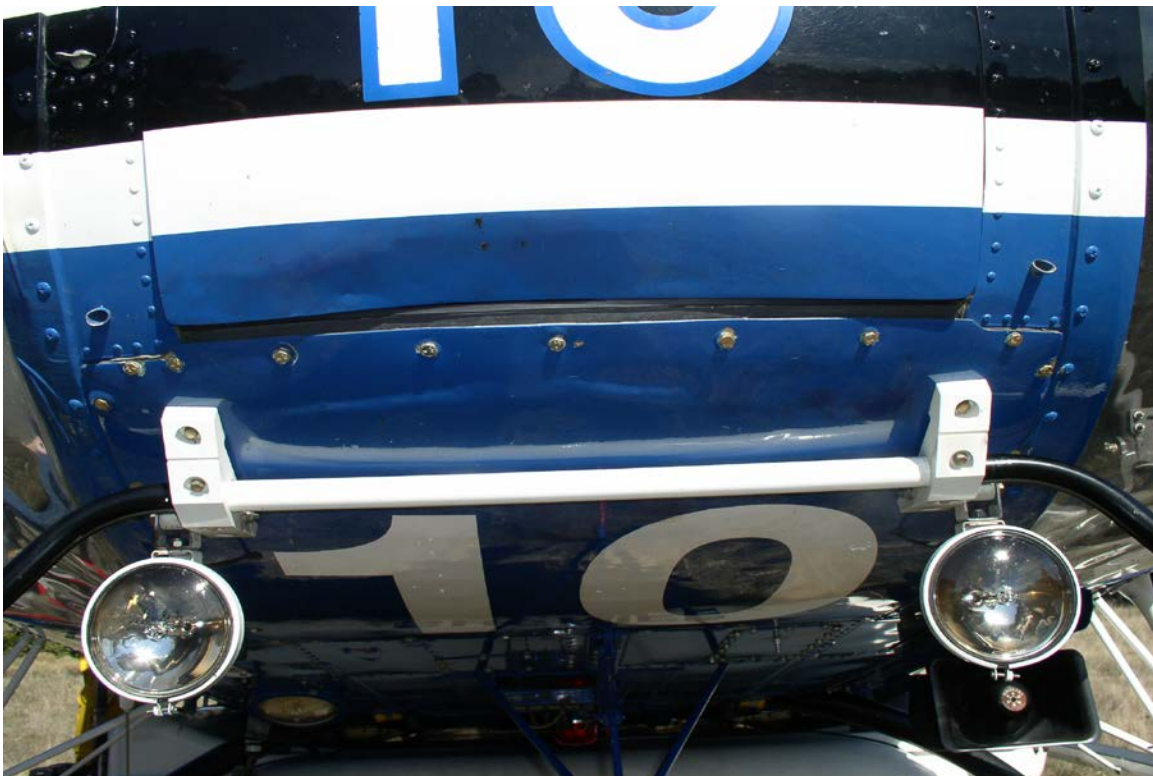
Nose and Battery Door Damage
