Appendix D—Equipment Found at H-2 and the Fatalities Site

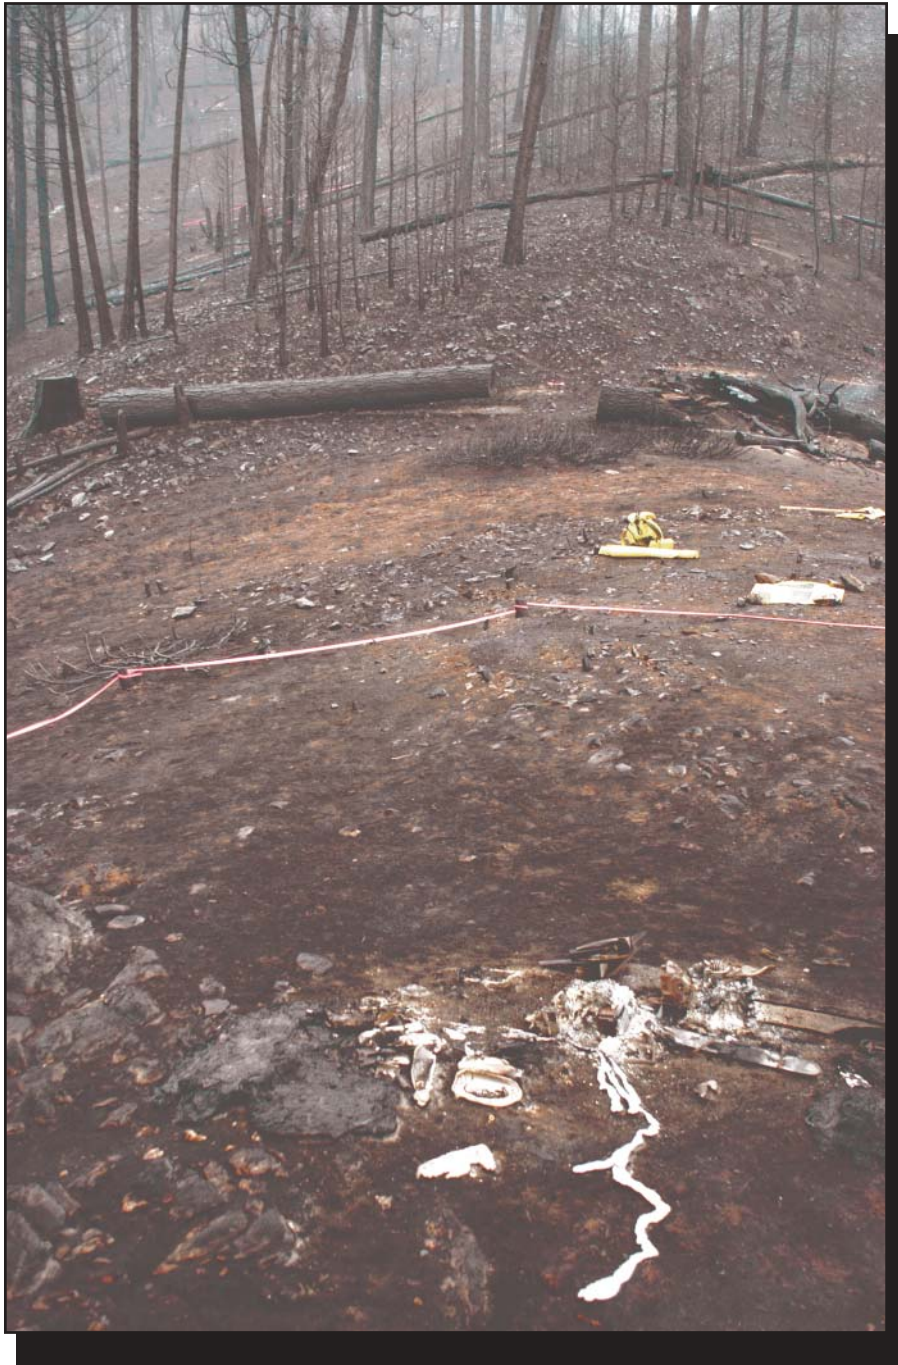
Equipment used by Jeff Allen and Shane Heath for rappelling from H-193 to the ground and for construction of the helispot was found at H-2. The equipment had been readied for transport. One of the saws had been wrapped with chain saw chaps, the hand tools had been wrapped in fiberglass tape, and all of the equipment was stacked in a single pile. Though severely damaged by fire, the stack appears to have contained helicopter rappel equipment, a radio, three hand tools, and two chain saws with associated maintenance tools. Only steel, glass, brass, and some aluminum were still intact. The rest of the material was either consumed or melted by the fire. Some pieces of cast aluminum melted, indicating material temperatures of at least 1,000 °F (photos 1 and 2).

Photo 1—H-2, chain saws, and rappel equipment.

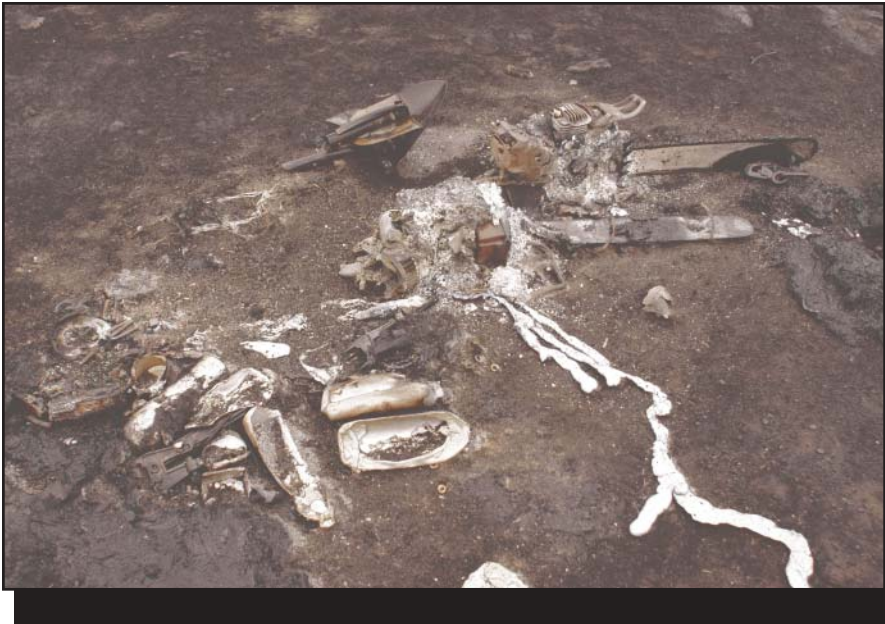
Photo 2—H-2, chain saws, rappel equipment, and melted aluminum.

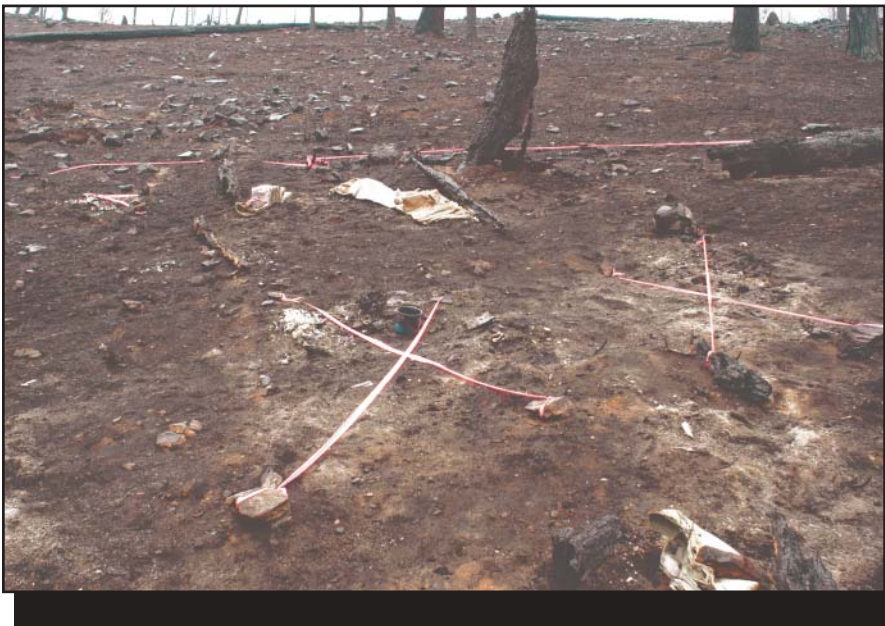
The remains of two fire shelters, personal items such as watches, cameras, keys, and belt buckles, and work-related items, including a radio, carabiners, and batteries were found at the fatalities site. Only steel, glass, and brass items were intact. The glass watch face was distorted as if it had softened. Glass begins to soften when it reaches about 1,100 °F. Two flight helmets on the site were charred, easily compressed, and brittle (photo 3).

Photo 3—Fatalities site, fire shelters, and flight helmets.

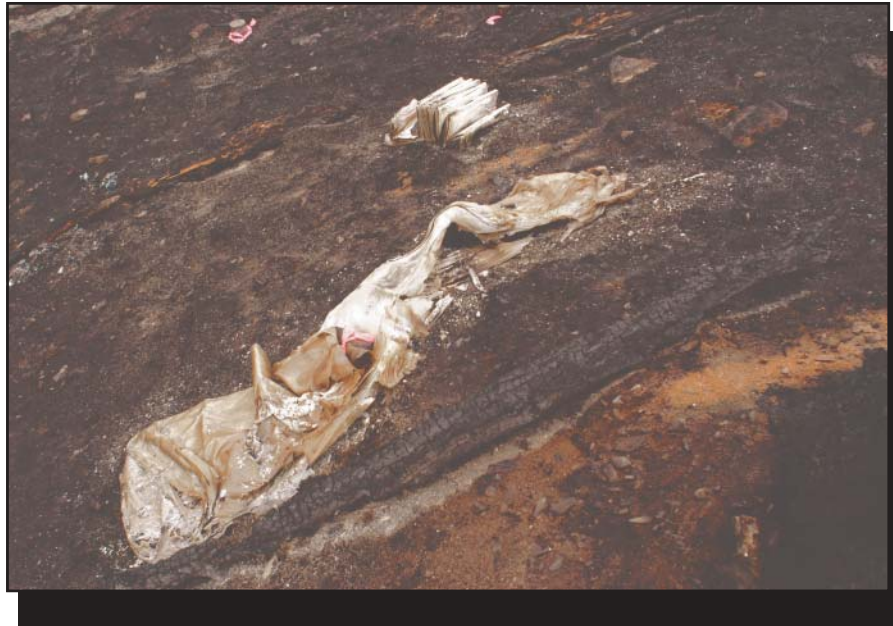
The fire shelters were the older style (NSN# 4240-01-121-8698, NFES# 0169), which meet agency requirements (photo 4). The shelters were separate from other materials, which indicates they had been removed from their packs. One of the shelters was accordion folded in the same shape in which it was packaged, indicating that it had not been unfolded prior to the burnover. The exposed top layers of the folded shelter had no remaining foil and the fiberglass layer was white and

very fragile. Where foil was present on the more protected layers, it was completely delaminated from the fiberglass cloth. Aluminum used in the shelters melts at about 1,200 °F. The fiberglass used in the shelters softens between 1,350 and 1,611 °F. The condition of the exposed fiberglass indicates that material temperatures were within this range.

The second fire shelter was unfolded lengthwise but almost completely folded width-wise. This indicates that the shelter was removed from its plastic bag and partially unfolded prior to the burnover. The foil had melted from 10 of the 12 layers of the shelter and was present on the two layers that lay closest to the ground. Foil that remained had completely delaminated from the fiberglass layer. The fiberglass cloth was white and extremely brittle, indicating that it had reached a softening temperature between 1,350 and 1,611 °F.

Crown fires studied with instruments by MTDC have reached temperatures over 2,000 °F. Temperatures from approximately 1,300 °F have damaged fire shelters, melting aluminum, and fracturing and disintegrating fiberglass cloth. Conditions inside fire shelters tested in these conditions were not survivable. The condition of the partially unfolded fire shelter found at the fatalities site resembled fire shelters tested under these severe conditions. This indicates that the shelter was subjected to temperatures from 1,300 °F to potentially over 2,000 °F.

Photo 4—Fatalities site where fire shelters were not deployed.
