## ***After Incident Report Lessons Learned Center***

**Incident Name and Type: East Lake**

**Unit or Jurisdiction(s): Hiawatha National Forest Geographic Area: Upper Peninsula of Michigan**

**Report Submitted by: Don Mikel Type 4 IC**

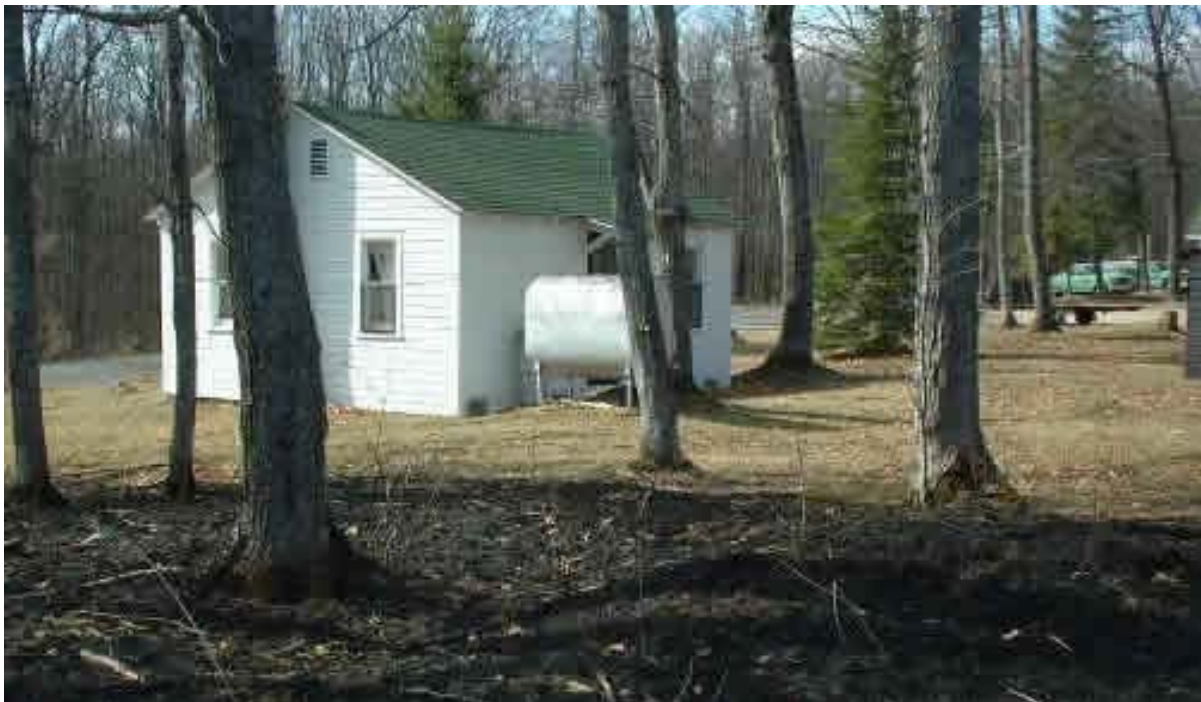
***Fire prone property protection*** – most of the local private property owners had worked last fall, cleaning up their property – mowing the lawn, raking leaves, etc. One individual lost a cabin, trailer, two sheds, and a garage because brush, long grass and leaves were allowed to remain rather than being removed. A little pre-work is worth the effort.

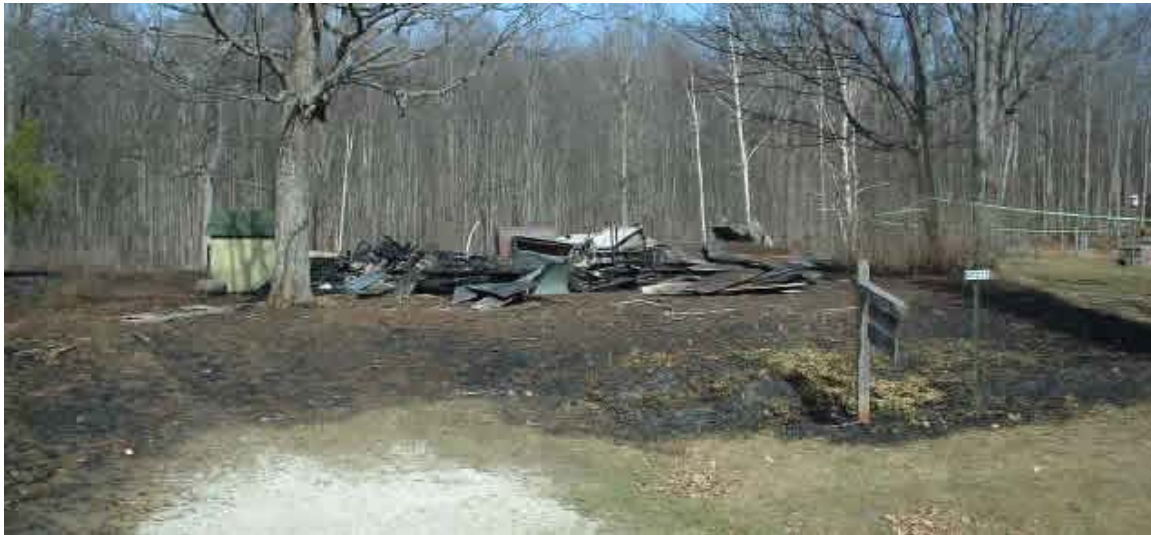
Any loss of private structures is unpleasant. The ***efforts to increase private property owner’s knowledge*** of fire prone property protection methods are a continuous process. However, some will never get the word until too late.

Remains

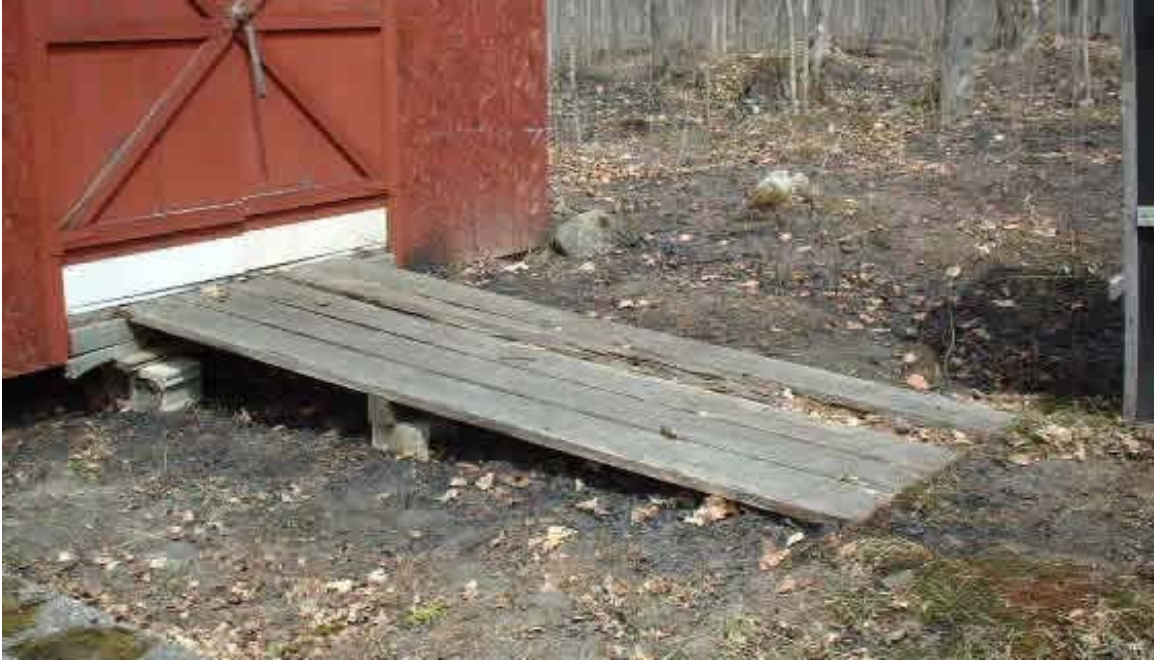
It is very important to do a ***thorough check of all buildings*** in the area of the fire. The accompanying photograph below entitled “Close Call Wet Wood” was not immediately recognized as threatened. It was found when the rest of the fire was being attended after the readily visible structures had been checked.

Close Call Wet Wood

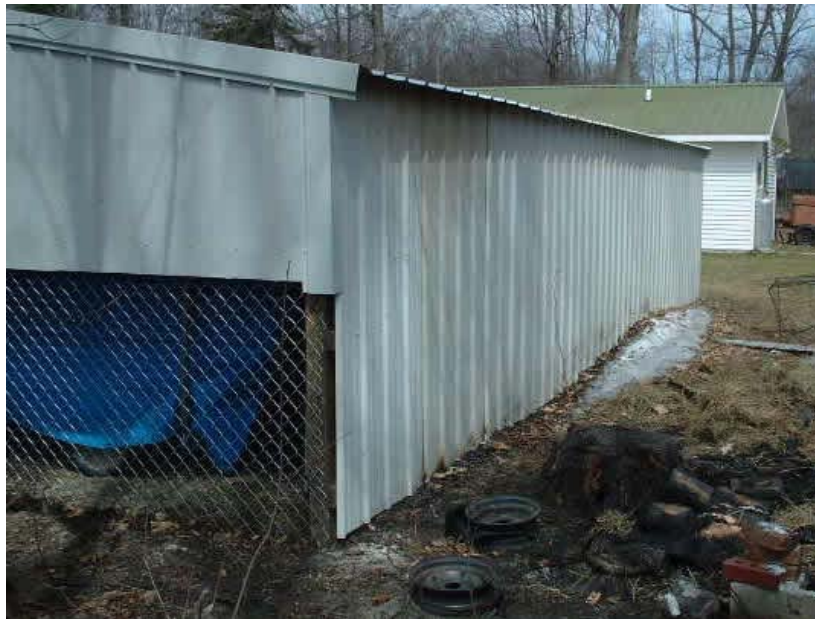
Metal Siding Works

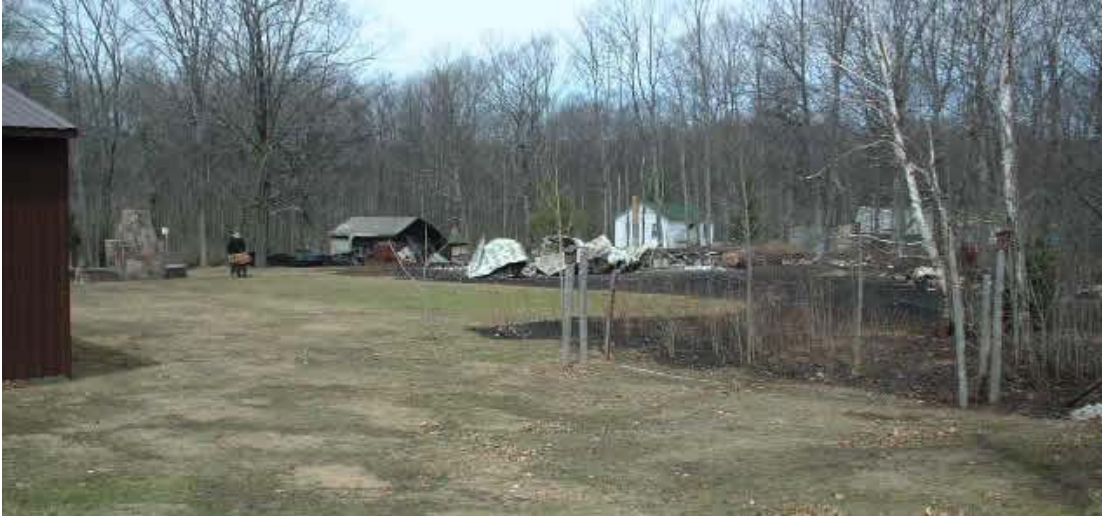
Saved By A Yard

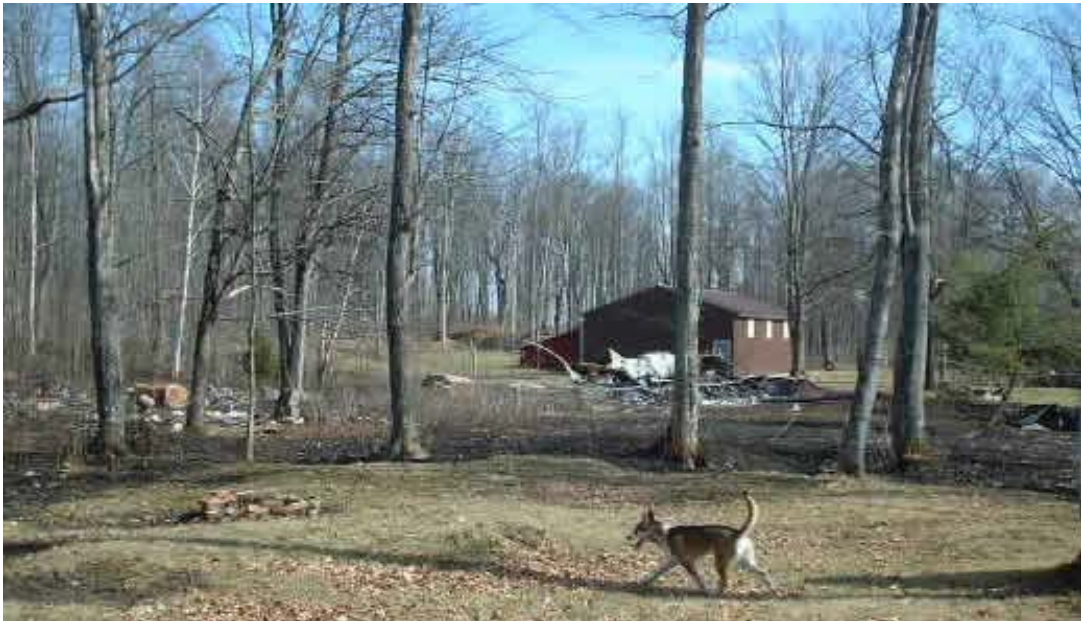
Yard Rubble
