Facilitated Learning Analysis

EXCAVATORS AND INTERSTATE OVERPASSES DON'T MIX

Incident Date: January 12, 2011

Type of Event: Motor vehicle accident with excavator/bridge strike and no personal injury.

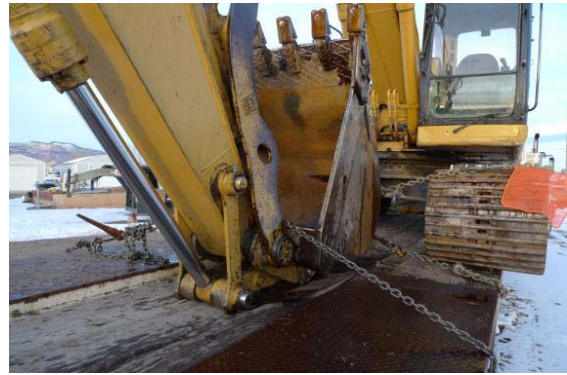
- Employees loaded excavator on flatbed trailer in the same manner as accustomed. There were no discussions about the specifics of this equipment during transfer. This included ensuring the deck was clear, and leveling the load. The excavator was then secured by chaining both the front and back in a criss-cross fashion from the outboard side of the tracks to the opposite sides of the deck. Finally, the bucket was pulled up against the front-end tie-down chains and secured with another chain. After leaving the equipment yard enroute to their home Forest, the chase vehicle operator noticed the excavator boom barely clearing a phone cable across the road. The employee attempted to contact the transport operator by radio; without success. "I've not felt like the radio system is reliable enough to feel comfortable with it." Employee made no attempt to further communicate this issue.

- If it looks like you can get it lower, get it lower. Bring the bucket in tight as possible and then chain it the way you must to secure the load.
- Sometimes we dwell on one thing too much, i.e., securing the equipment with crossed chains and don't pay attention to other details, like the height of the boom.

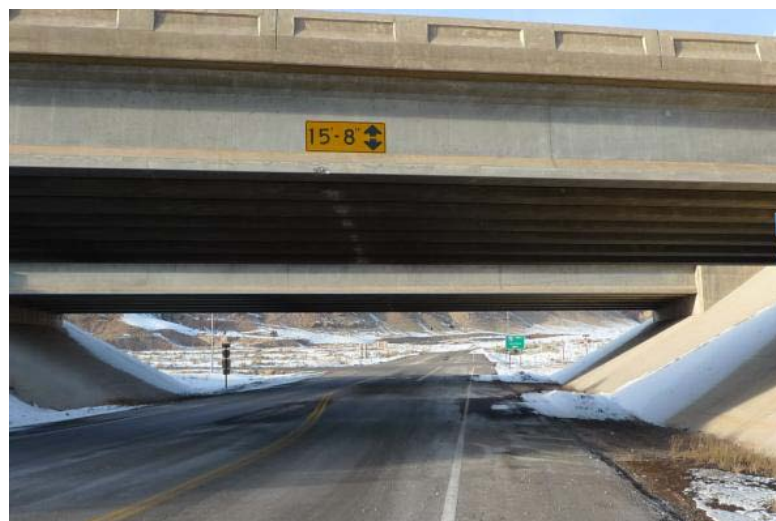
- As the transport vehicle approached the interstate overpasses, the chase vehicle operator noticed that the excavator boom appeared to be too high for the 15 foot 8 inch height of the overpass. Before he could warn his fellow employee the excavator reach boom hit the overpass.

- Before coming to a complete stop the transport with excavator passed under and collided with both overpasses.

- Have a grade rod to measure boom height available in all transports.
- There needs to be communication of the different sizes and quirks of equipment particularly at transfer. Maybe put a "sticker" inside the cab and in an obvious place for operator to see; with anomalies for the particular equipment. For example: "Reach boom" installed with 14 ft. stick vice 9 ft. stick (which would affect the height of the boom).
