SAFETY ALERT

Year of Vehicle: 2001
Make of Vehicle: Ford F550
Mileage on Vehicle: 150,000 miles plus.

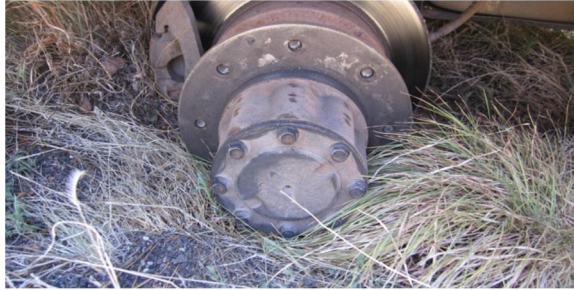
On the 1st of July, the Idaho City Hotshots were in route to a fire in New Mexico when the driver side rear dual tires came off the vehicle. The wheels crossed the median and struck another vehicle in the oncoming lane, no injuries were reported but both vehicles received damage. The superintendant of the hotshots called local law enforcement to investigate the accident, filed a report and complete agency accident reports. The vehicle was towed to a local community and repaired. The Idaho City Hotshots continued on to their fire assignment on the 2nd of July.

Picture 1: Sheered Lug Bolts

The vehicle was inspected on several previous assignments this spring. The daily preventative maintenance inspections were current. Be sure to conduct preventative maintenance inspections on your vehicles. Look under the vehicle to see if there are any fractures or things that look out of the ordinary with the undercarriage or frame.

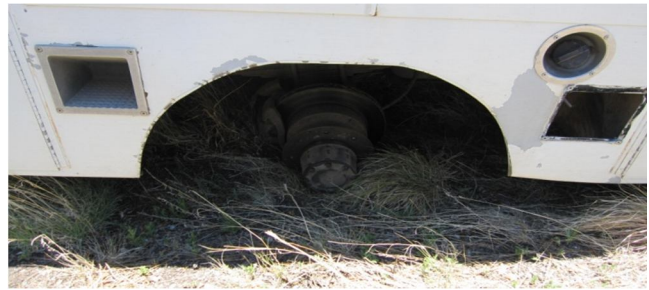
Picture 2: Vehicle resting on frame and utility box

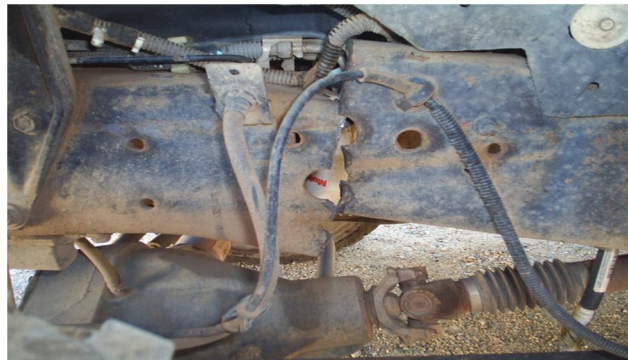
On the 5th of July, the crew was demobed from their incident. Prior to leaving, the Superintendant checked the lug nuts on the repaired wheel. He found they were loose and some were missing. He took the vehicle to Ground Support and they found the vehicle had a broken frame on the driver side of the vehicle, in front of the U-joint. It has not been determined what caused the broken frame or how long it had been damaged.

Picture 3: Broken Frame on Drivers Side
