**NIOSH**  
Fire Fighter Fatality Investigation  
and Prevention Program

# Death in the line of duty...

## Forest Ranger/Fire Fighter Drowned After Catastrophic Blow-out of Right Front Tire - Florida

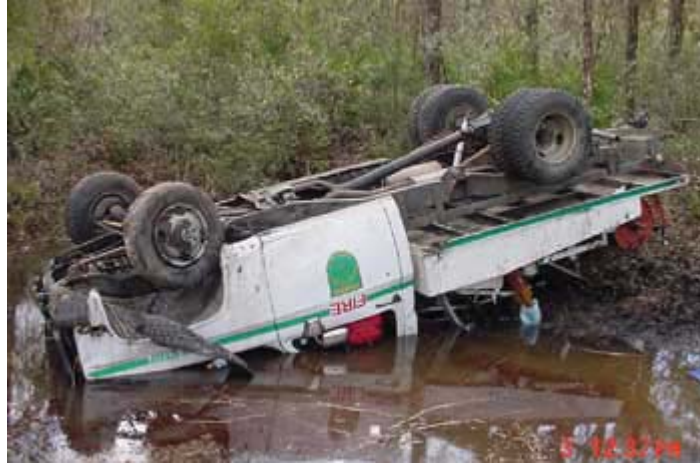
On March 3, 2004, a 40-year-old male forest ranger (the victim) died after he lost control of the brush truck he was driving to a controlled burn. The truck experienced a catastrophic blow-out of the right front tire, left the road, struck a culvert and overturned. It came to rest on its roof in a ditch filled with approximately 2 feet of water. The victim was pronounced dead at the scene.

**Overtured truck**

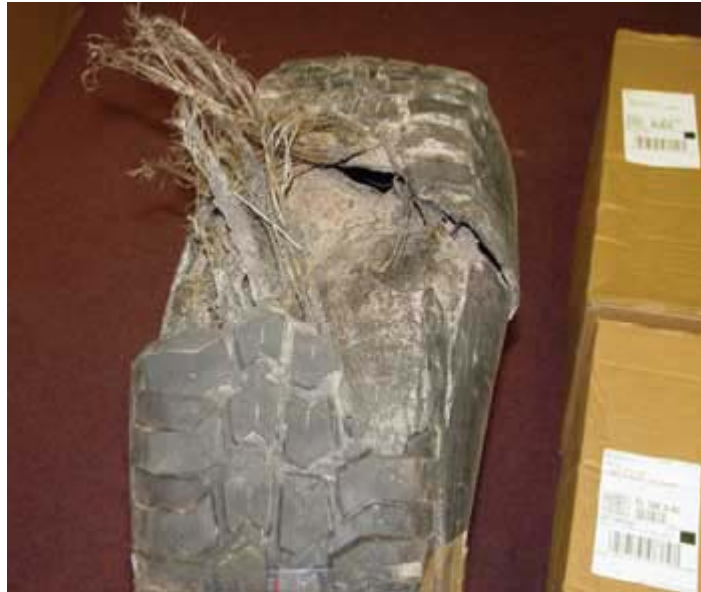
A post-crash examination by the crash reconstructionist determined the tire had undergone a catastrophic, burst type blow-out that compromised the casing integrity (radial casing cords), inner radial ply and liner. Tread depth of this tire was 9/32. According to the reconstructionist, the tire damage resembled similar damage documentation patterns resulting from a previous impact that may have compromised the inner tire radial ply and liner. The reconstructionist stated in his report that this type of damage is *nearly impossible to detect* because tires may still hold air and show no outward signs of deformation. He also noted that, post crash, there was *considerable tread deformation and separation along with complete cord disruption at the blow-out epicenter* ([Photo](#)).

Discussion: Tires should be checked for signs of wear, for drying or cracking, for cuts, proper pressure inflation, adequate tread depth, and condition of the valve stems. As with any rubber product; however, degradation of tires occurs with age, regardless of tread depth and use.<sup>5,6</sup> States with high average ambient temperatures have higher tire failure rates.<sup>6</sup> Thus, imposing time restrictions is important. The tires in this incident were six years old and, according to the reconstructionist, showed no signs of degradation or excessive tread wear. However, neither the division nor the fire department from which the division bought the donor vehicle could document the age of the tires.

**Photo. Right front tire after blow-out.**

***Recommendation #2: Fire management agencies and fire departments should, as part of the apparatus maintenance program, ascertain the age of tires and impose time restrictions for usage according to manufacturers’ specifications and guidelines.***

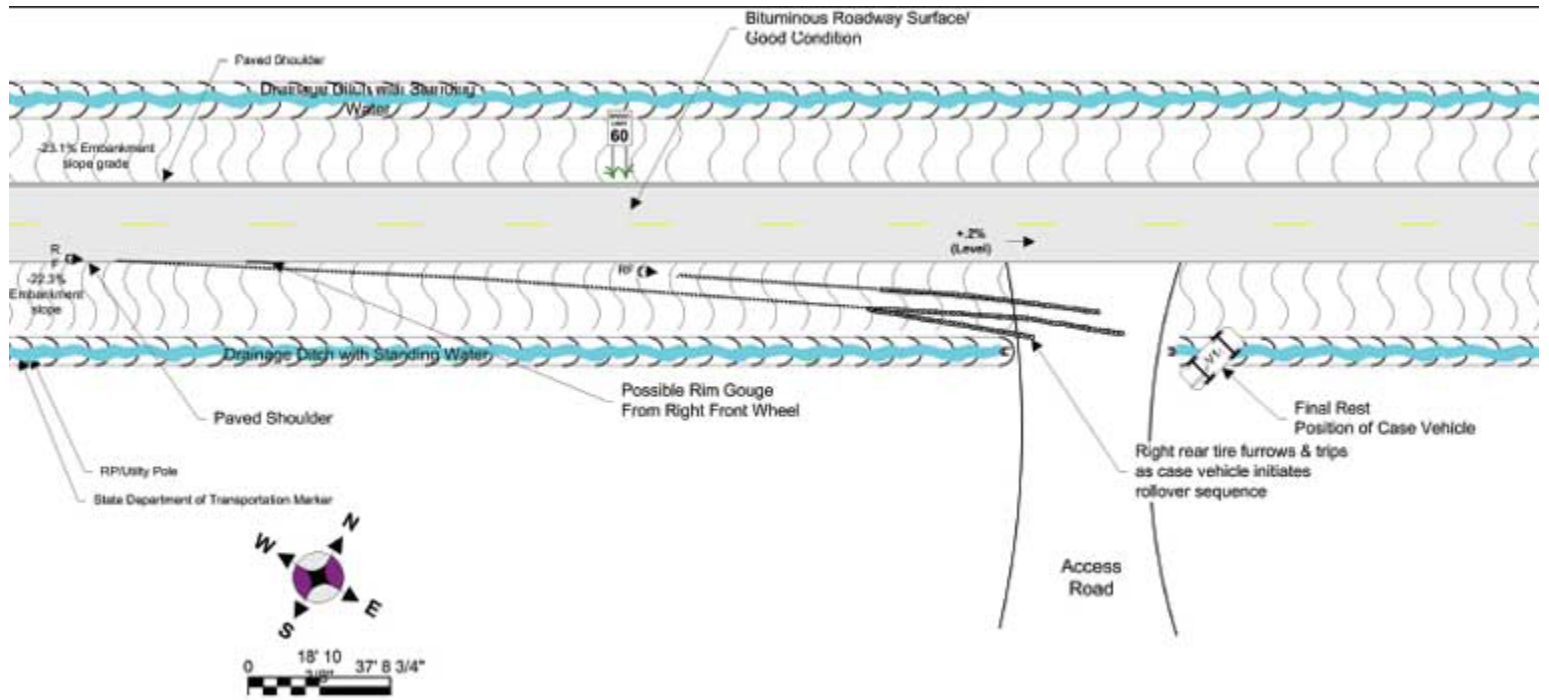
On March 3, 2004, at approximately 0900 hours, the victim was traveling northeast on a two-lane road to conduct a controlled burn when his right front tire experienced a catastrophic burst-type blow-out causing him to lose control. The incident occurred on a long, straight section of level road. The victim was familiar with the vehicle, the road and the area. His estimated speed at the time of the incident was 55 mph based on the reported speed of a witness traveling behind the victim. The truck left the roadway, rotated counterclockwise, hit a culvert, and overturned ½ turn coming to rest on its roof in a ditch ([Diagram](#)). The drainage ditch contained approximately 2 feet of water at the time of the incident. The victim, who was wearing his seatbelt, was suspended upside

Diagram. Aerial view of incident scene.
