## **Appendix A. Felling Operations Subject Matter Expert Report**

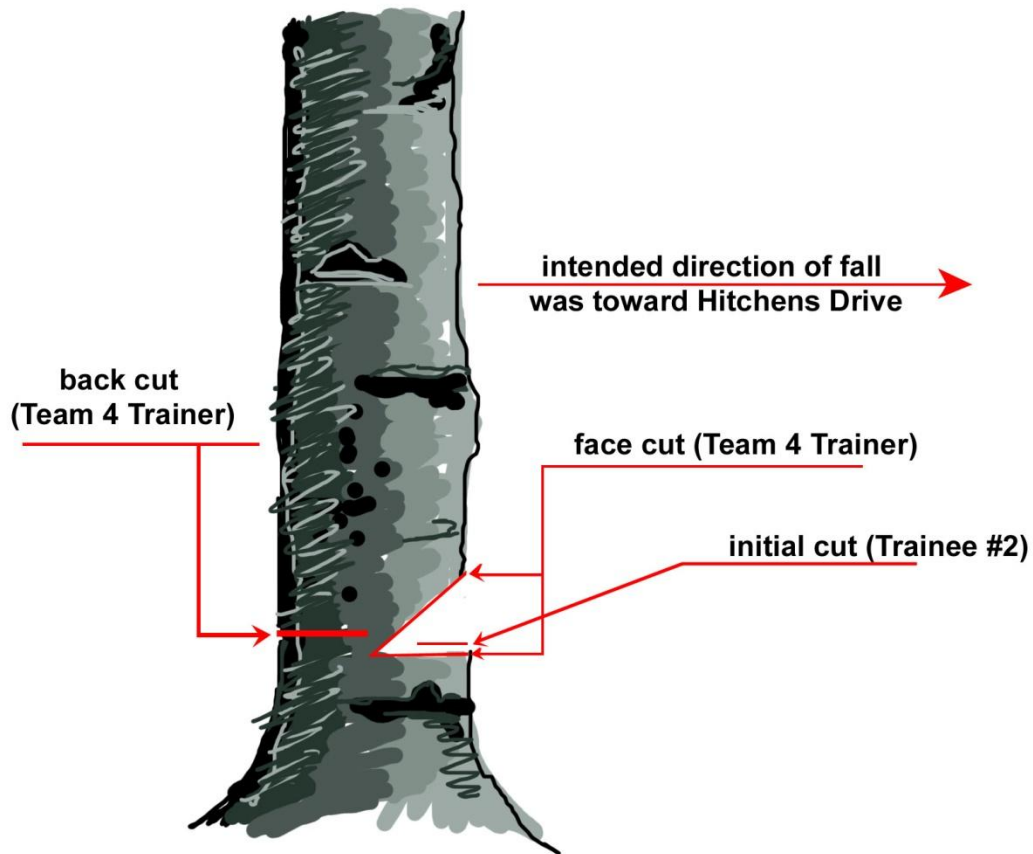
The dead tree was the first tree of the day that Team 4 Trainer cut. Team 4 Trainer started the saw and cut the horizontal portion of the pie cut approximately ½ inch below the horizontal cut that Team 4 Trainee #2 had started (see Figure 1).

**Figure 1: Initial cut made by Team 4 Trainee #2 and subsequent face cut and back cut made by Team 4 Trainer.**

The SAIT was unable to determine why Team 4 Trainer dropped ½ inch below the initial horizontal cut. Team 4 Trainer finished the face cut which was well-aligned and had good matching points. Team 4 Trainer removed the cut out and realized that the 23-inch diameter tree was rotted inside and only had approximately 3 inches of solid wood around the outside of the tree (see Figure 2).

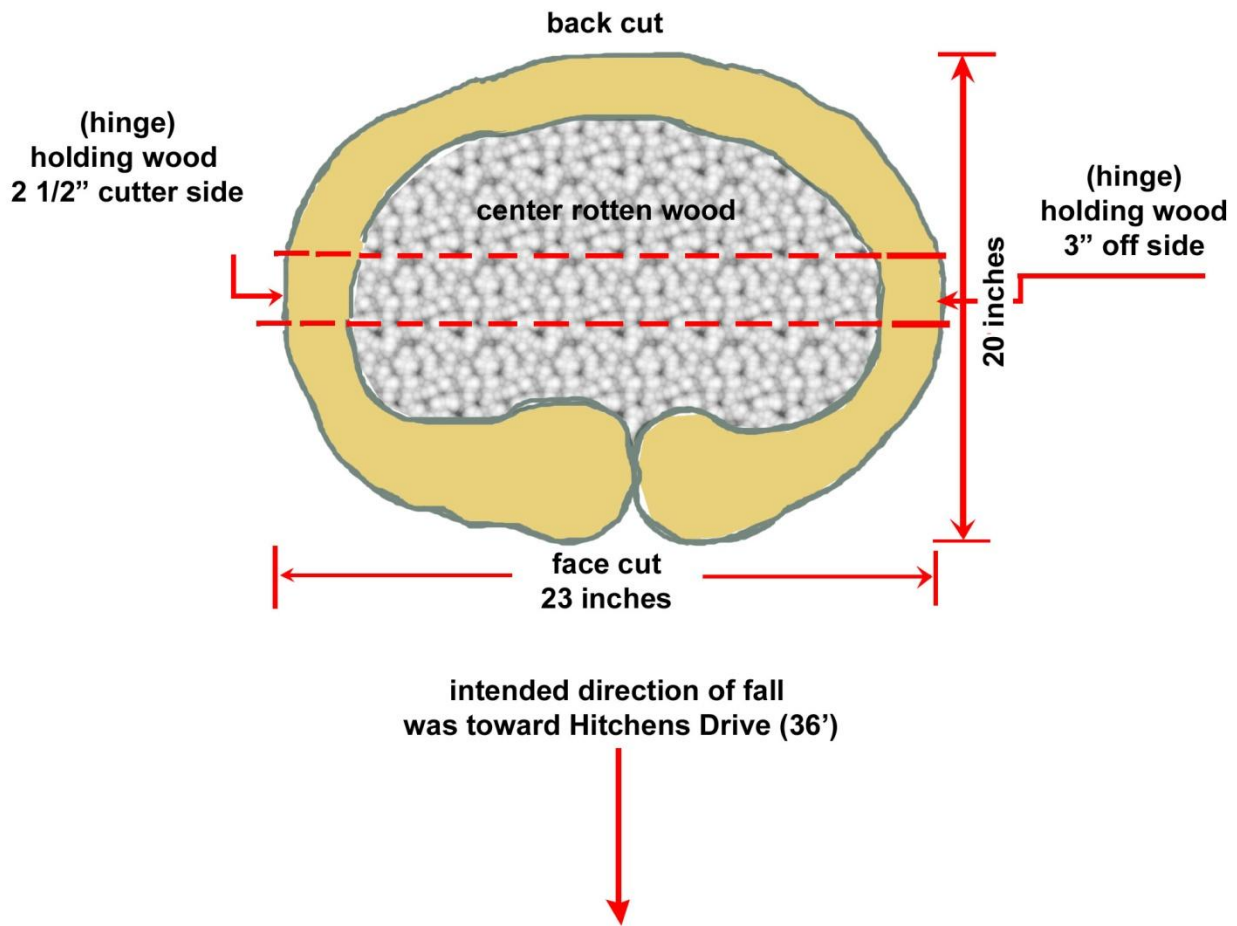
**Figure 2: Stump analysis (downward view)**

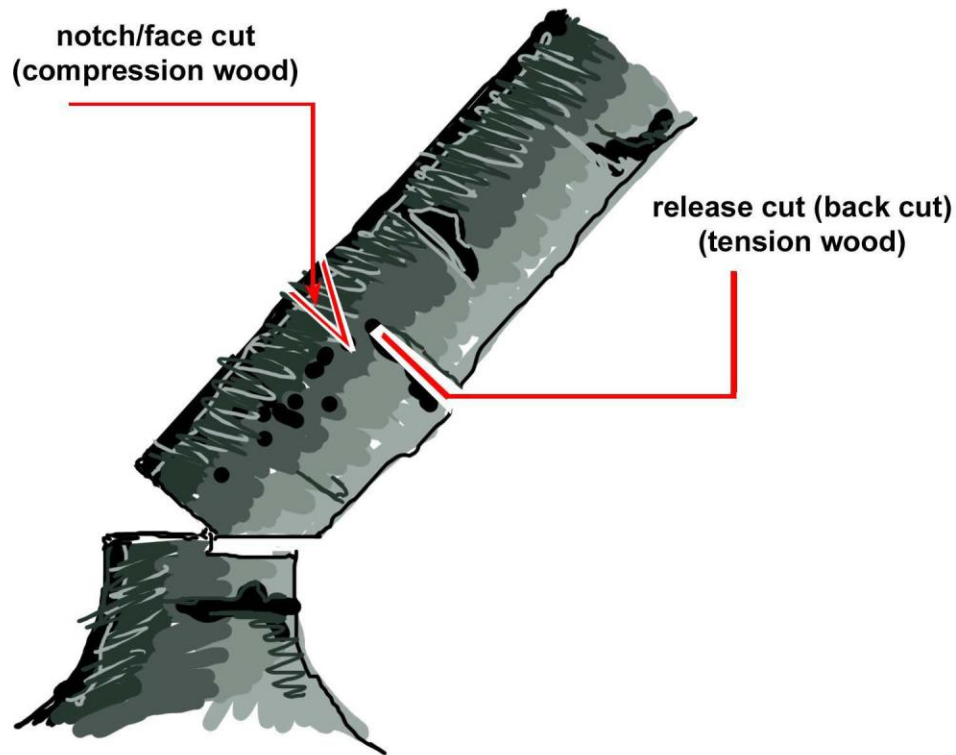
along the tree trunk toward Hitchens Drive and initiated a second cut to free the tree from the stump and put the tree on the ground. Team 4 Trainer cut a pie-shaped notch approximately 18 inches above the original back cut to make space for the compression wood on the top side of the tree (see Figure 3).

**Figure 3: Close-up of Team 4 Trainer’s second set of cuts after the tree got hung-up**

After the notch face cut was completed, Team 4 Trainer initiated a tension release cut by utilizing the top of the saw bar and coming up from the bottom towards the previous cut. The tension release cut was approximately 3 inches above the flat cut on the notch face cut (see Figure 3). This action caused the tree to fall off the stump and simultaneously caused the portion between the original cut and the tension release cuts to split in two and be pushed out to the cutter side. When the tree fell off the stump and came into contact with the ground, the force was great enough to cause the tree trunk to break into two pieces approximately 20 feet up from the second cut (see Figure 4).

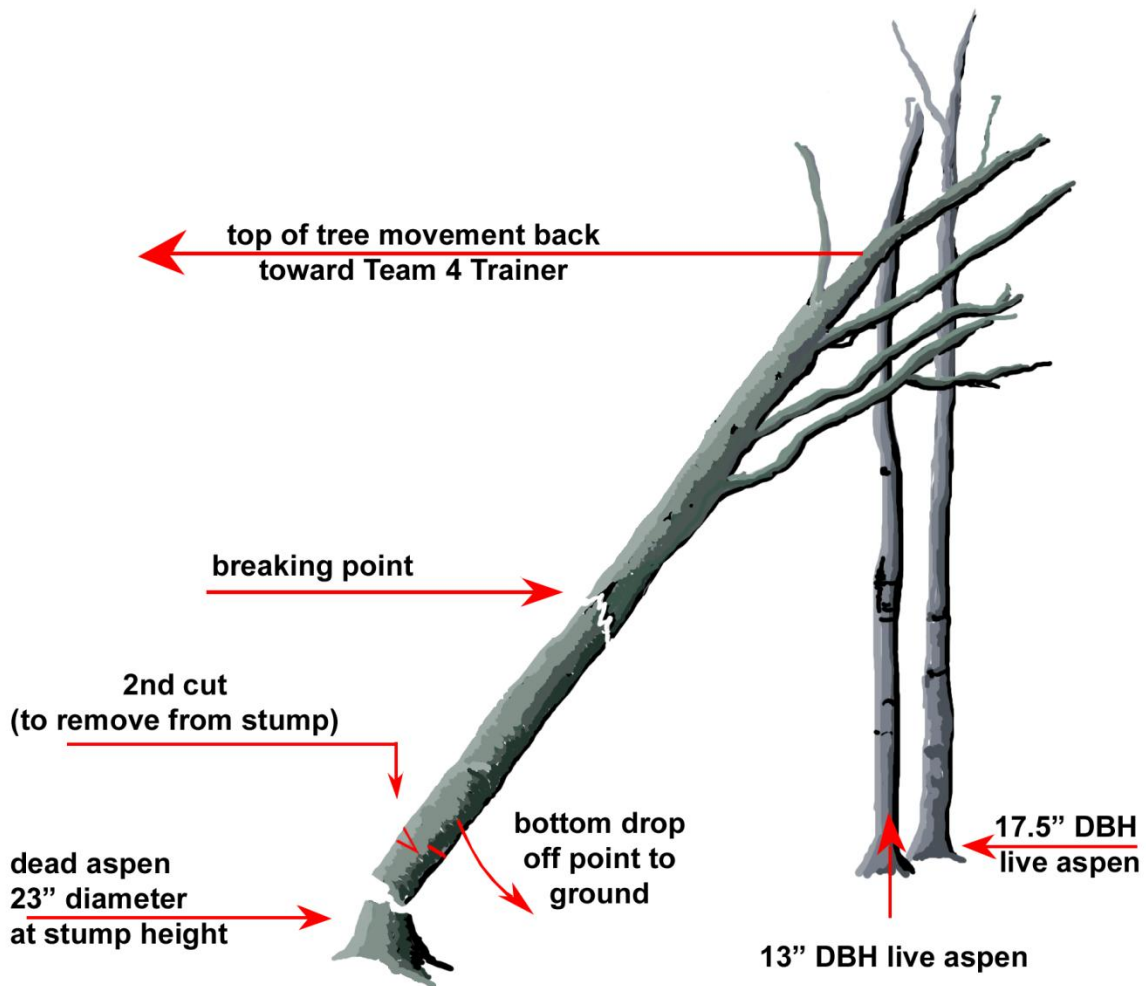
**Figure 4: Profile of cutting area showing action of broken top during second cut by Team 4 Trainer**

The lower portion of the dead aspen measured 20 feet, 4 inches long; and the upper portion measured 37 feet, 8 inches long. The remaining length of the tree consisted of broken limbs and the stump.

As the tree broke, the pressure on the live aspen that the tree was hung up in was released. Acting like a catapult, the live aspen threw the crown of the dead aspen tree back toward the direction of the stump and Team 4 Trainer's position. As the upper portion came back towards the stump and the Team 4 Trainer, the bottom end of the upper portion was driven into the ground at an angle towards the cutter. When the tree fell off the stump and broke, the spotter Team 4 Trainee #1 yelled at Team 4 Trainer to get out of the way. Team 4 Trainer turned and began retreating in the general direction of the escape routes.

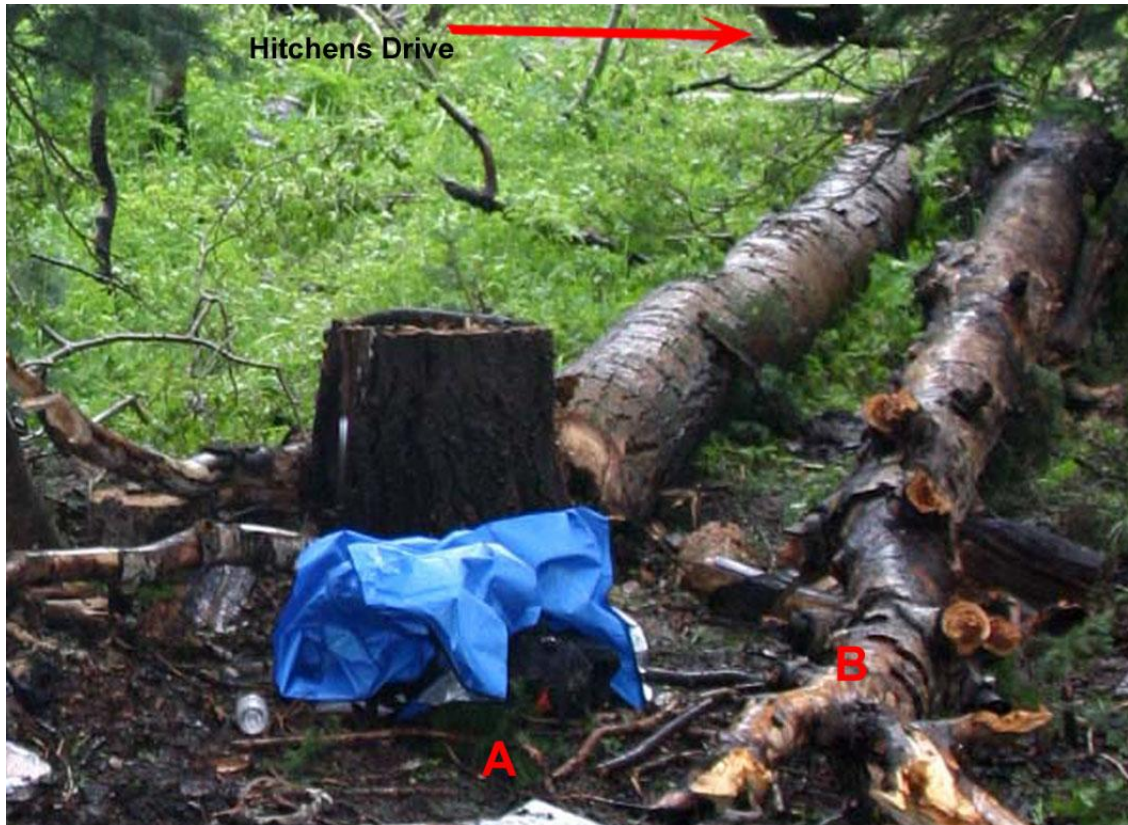
Team 4 Trainer took approximately three steps in the general direction of his escape route. Neither his movement nor his retreat was inhibited by environmental conditions. While retreating in an upright position, with chainsaw in hand, the tree struck the back of his head and body, crushing him to the ground. The impact immediately rendered Team 4 Trainer unconscious and unresponsive (reference Photo 1 below).

**Photo A1:** This photo shows the location of Team 4 Trainer and the top portion of the tree.

**Point A indicates the location of Team 4 Trainer when he was struck. Point B indicates top portion of the tree (7 ½ - 8 inches diameter) that struck Team 4 Trainer. The tree was moved to this location in order to provide medical assistance to the victim.**
