## Appendix B. Illustrations and Photographs

## **Appendix C. Hard Hat Inspection Report**

Submitted by John R. Smith  
Equipment Specialist  
Missoula Technology & Development Center

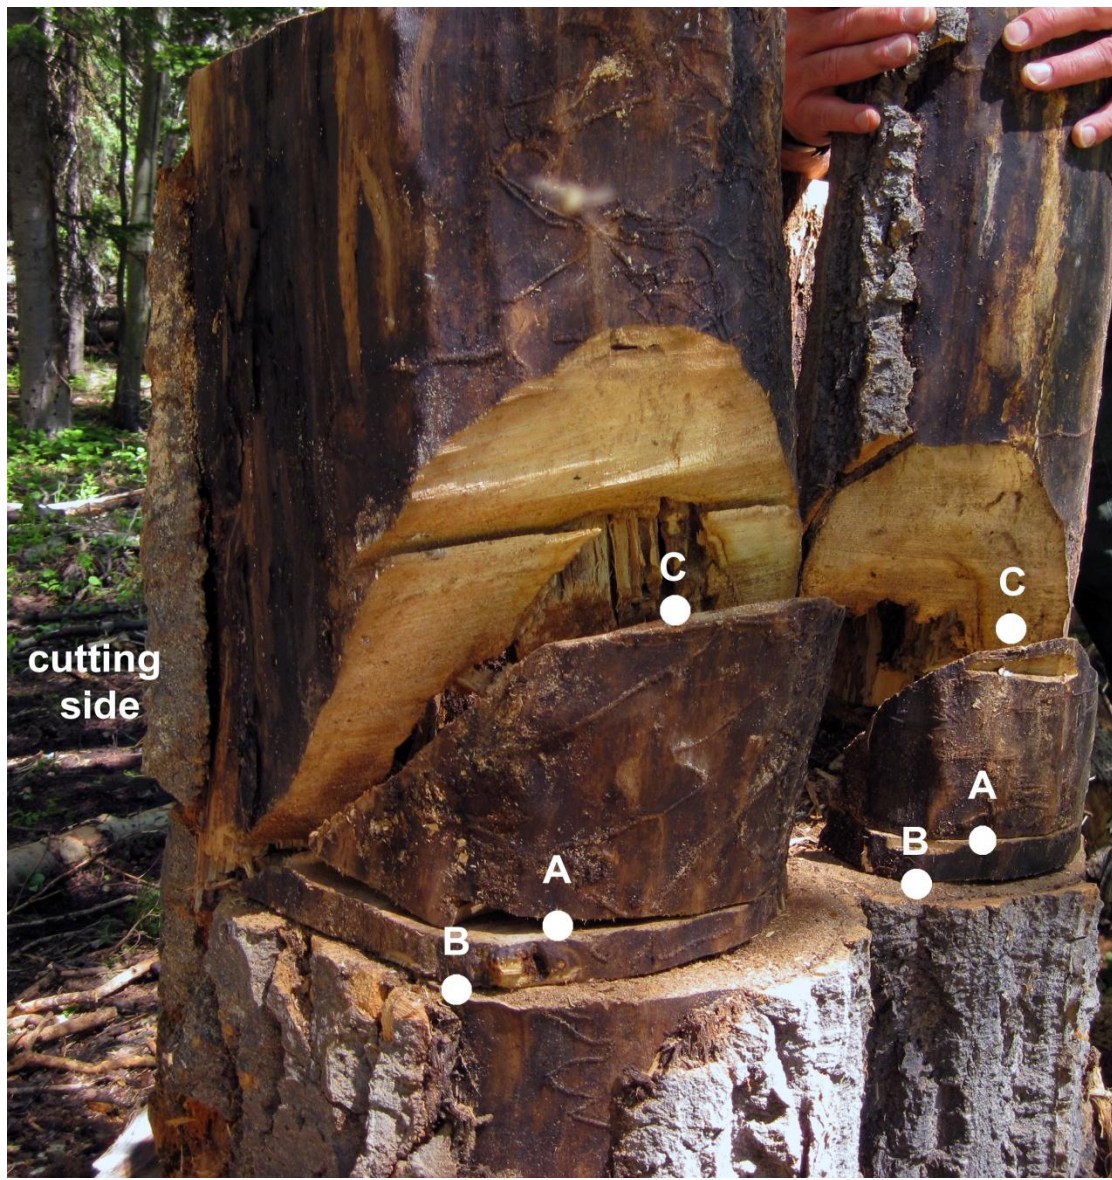
**Photo B1:** This photo is a reconstruction of cuts performed in the felling operation.

**Point A** shows the original horizontal cut made by Team 4 Trainee #2.

**Point B** shows the horizontal cut made by Team 4 Trainer.

**Point C** shows the downward diagonal cut made by Team 4 Trainer.

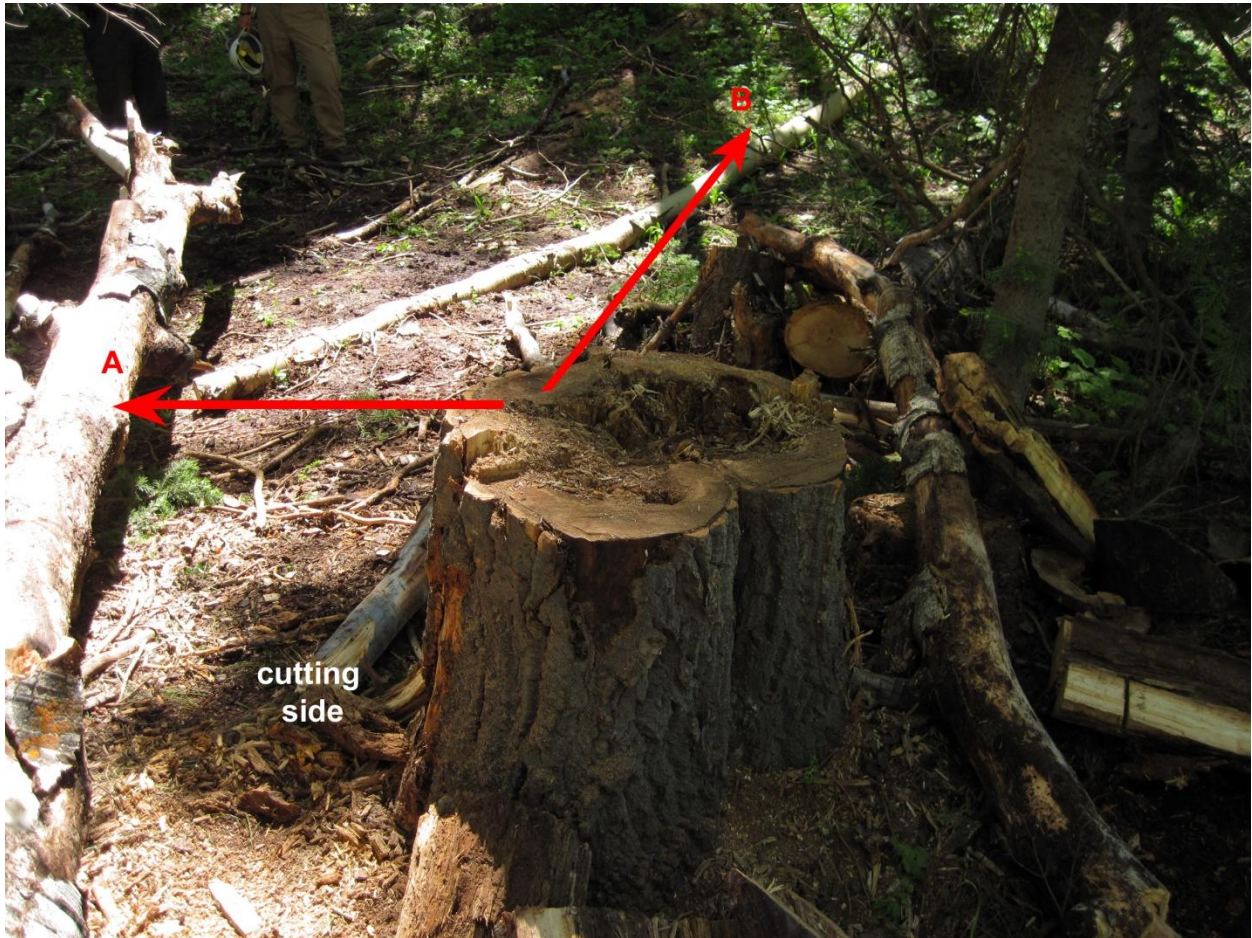
**Photo B2:** This photo illustrates the designated escape routes established at the start of the felling operations. Point A shows route on the cutter's side and B shows the route established on the offside.

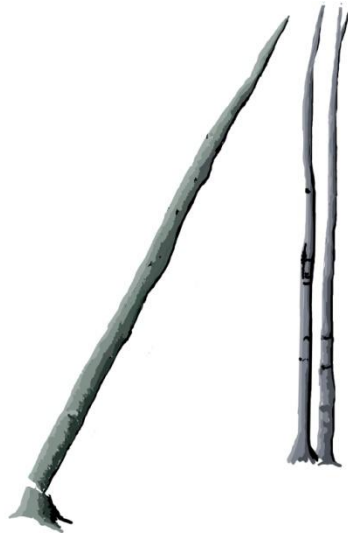
### Part One:

Team 4 Trainer finished the back cut and the tree began to fall in the intended direction.

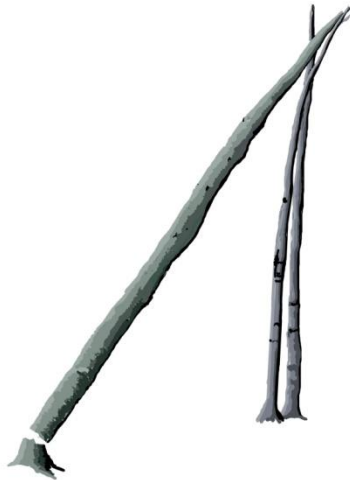
### Part Two:

While falling, the tree hung up in a live aspen. The live aspen was pushed and bent approximately 5 to 6 feet by the weight and pressure until it came into contact with another live

tree of the same approximate size. Team 4 Trainer cut through the remaining holding wood on the off side in an attempt to free the tree. The attempt was unsuccessful.

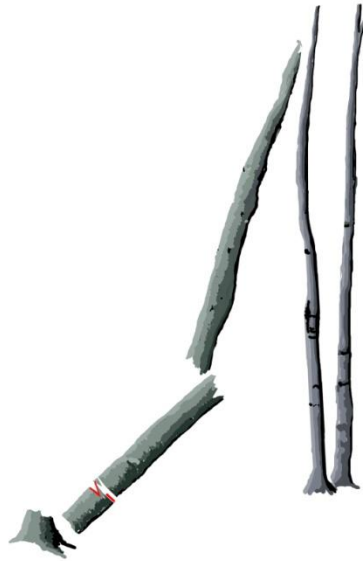
**Part Three:**

Team 4 Trainer moved 2 to 3 feet forward of the stump and began a second cut with the intent to relieve the pressure on the leaning tree and bring it to the ground. As he completed the second cut, the tree came off the stump and the trunk broke into two separate pieces in addition to the butt piece.

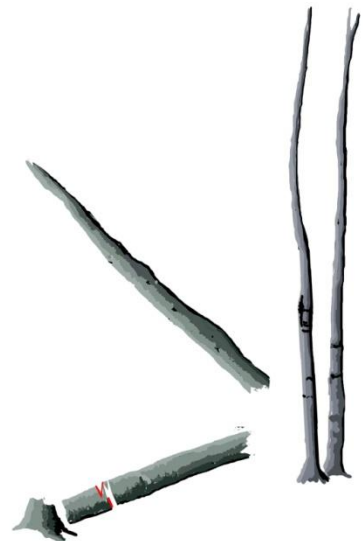
**Part Four:**

The butt section broke and was forced out the cutter side. The lower or bottom part of the tree fell to the ground in the expected direction. The upper piece, however, was catapulted by the pressure of the bent live aspen, back toward where Team 4 Trainer was located.

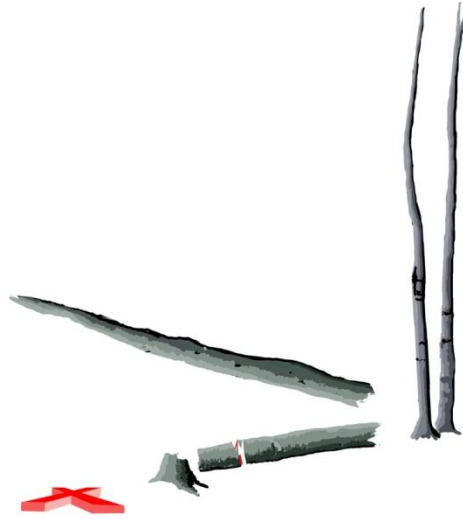
**Part Five:**

The top section of the tree fell at an angle towards the cutter. The bottom of this piece hit the ground and impaled itself with the upper part continuing to fall toward the Team 4 Trainer's location.

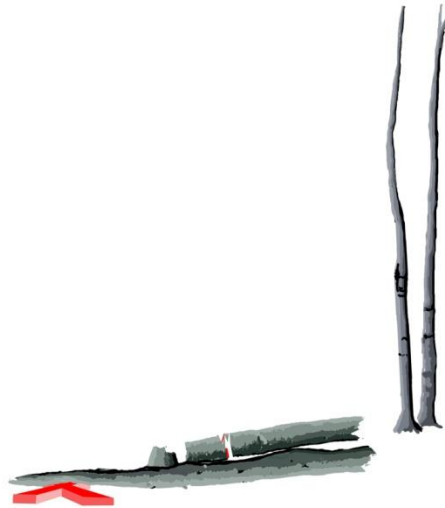
**Part Six:**

The upper portion of the tree strikes Team 4 Trainer in the back of the head and back, driving him to the ground, and coming to rest on top of him.

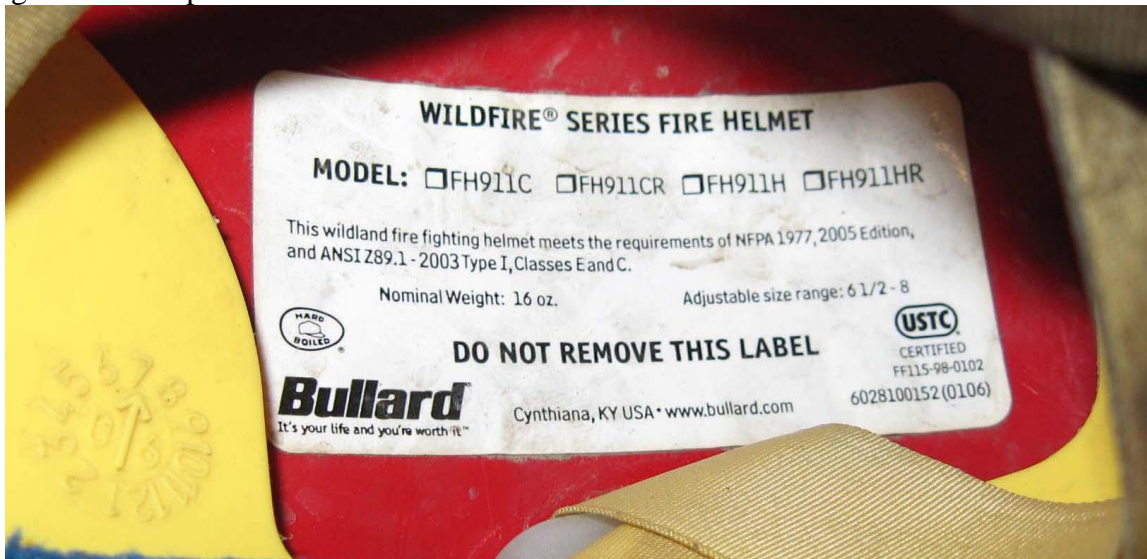
Figure 1 – Compliance Label

Manufacturer: Bullard, Model FH911C with Bullard Sure Lock® Suspension  
Date of Manufacture: Hardhat - May, 2006; Suspension – July, 2006  
Compliance: USTC certified to NFPA 1977-2005 and ANSI Z89.1-2003 Type I, Classes E & C (Figure 1)

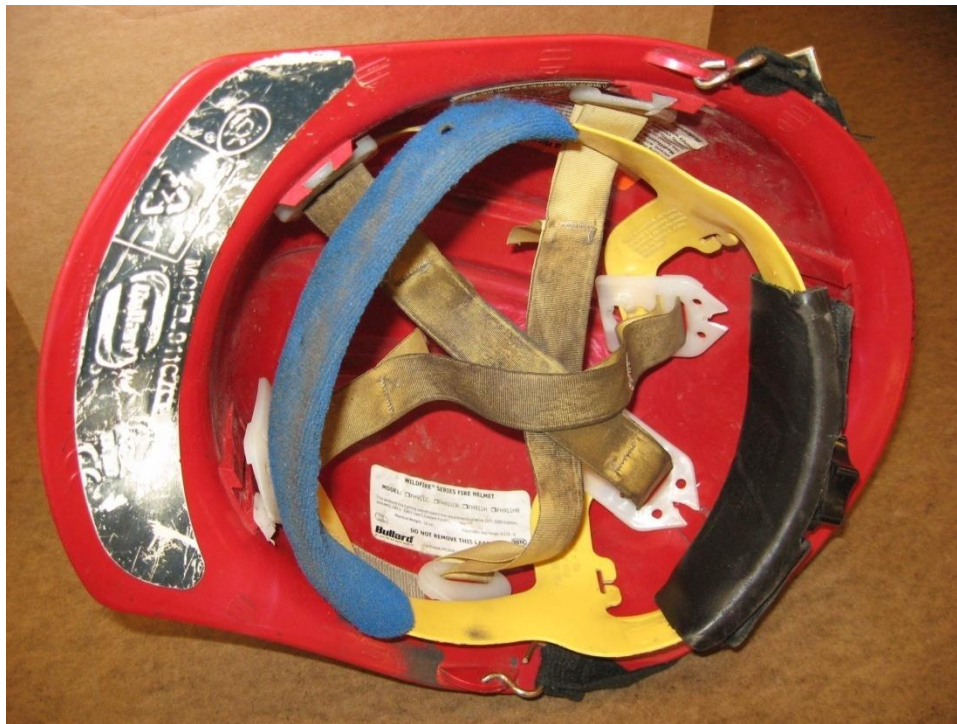
When it arrived at MTDC the hardhat suspension was clipped into the shell by 4 of the 6 attachment points (key and key slot system). Prior to arriving at MTDC, the suspension had been removed and then replaced in the hardhat, but it was reported that immediately post-accident the two side attachment keys had popped out of their respective key slots.

The only observed damage to the suspension system was to both of the rear attachment keys which were broken off of the suspension (Figure 2). The four remaining attachment keys appeared undamaged and functioned properly to attach the suspension to the shell.

Figure 2 – Condition of inside of hardhat

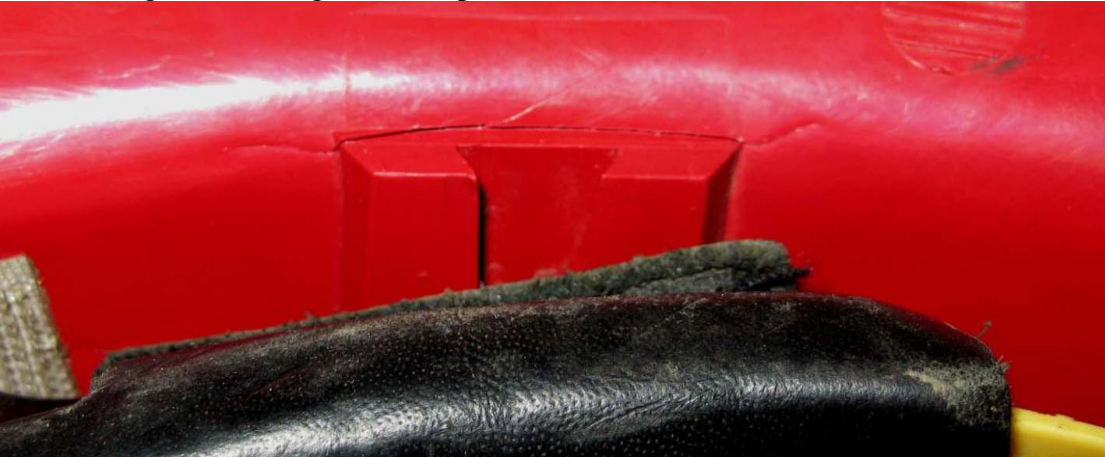
A visual inspection of the hardhat shell revealed only one area of damage. There was a 1-1/2 inch long crack in the shell in the area of the right rear suspension key slot (Figure 3). This crack went through the full thickness of the shell material. Aside from this crack, the shell showed no visual effect of the impact sustained. In overall appearance the hardhat was in good condition with a normal amount of light scuffing and scratching as expected with use. There were no obvious misshapen or deformed areas.

The hardhat meets the head protection requirements of the 2009 Interagency Standards for Fire and Fire Aviation Operations (Redbook), Chapter 7. The hardhat appears to have performed as designed. This hardhat was certified as meeting the test requirements of ANSI Z89.1, Type I, which includes a test for protection from top impact. According to the investigation report, the impact received was to the back of the hardhat more than directly to the top. Therefore it would be inappropriate to make any comparison between the impact force received and the impact force specified in the ANSI Z89.1 test procedures. Discussion with the hardhat manufacturer indicated that the type of damage seen to this hardhat was unlike any their lab had seen in the course of

testing to meet the top impact standards as specified in ANSI Z89.1. Lacking additional information concerning the weight of the tree, falling height and strike angle, it is impossible to make any estimate of the impact force in this incident.

Figure 3 – Damage to shell, right rear suspension attachment area
