Safety Summary Report

Oak Glen Crews #2 & #6

Gilman Fire

CA- RRU-071943

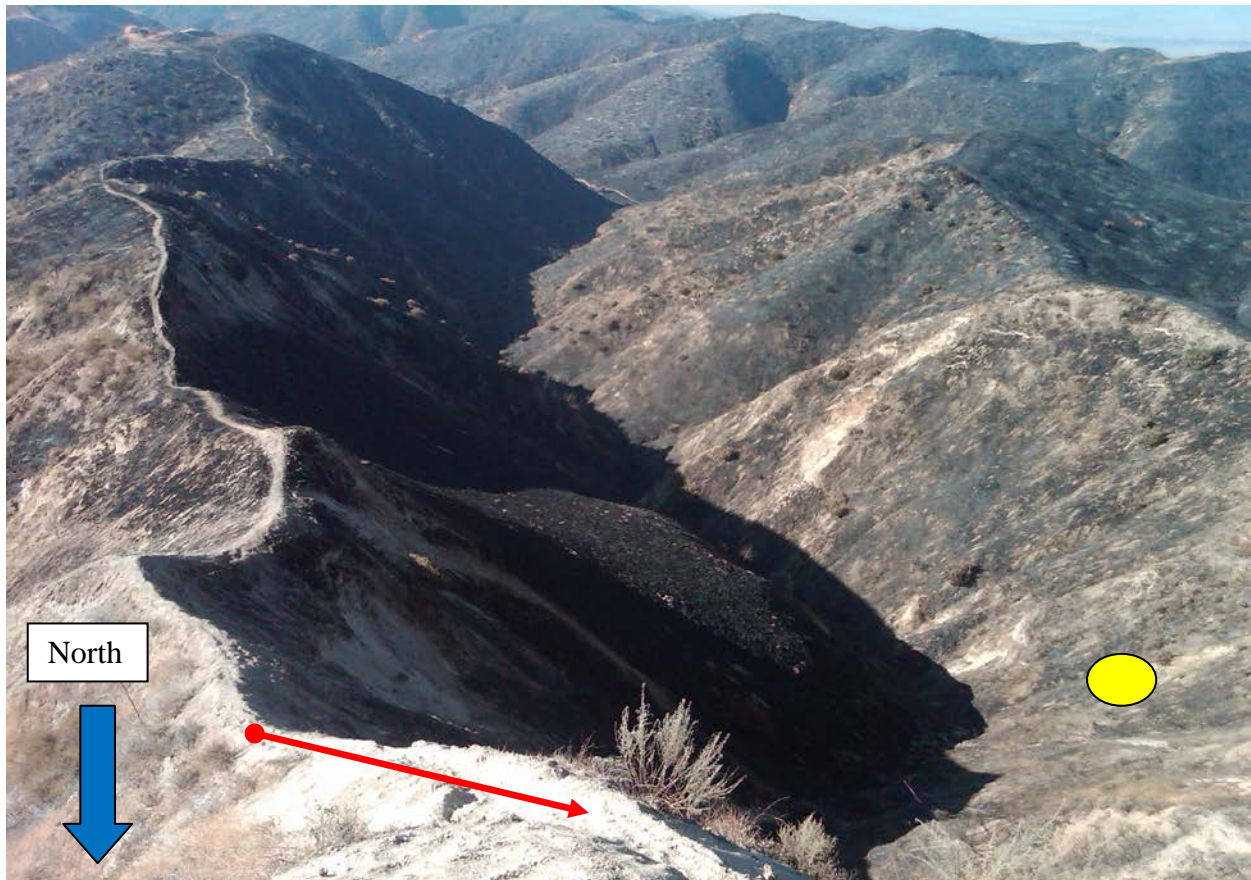
Red arrow signifies the escape route that Crew #6 used.

Yellow area signifies safety zone in the previously burned area that Crew #2 used.
