Informational Summary Report of Serious CDF Injuries, Illnesses, Accidents and Near-Miss Incidents

2008 Shasta-Trinity Lightning Complex

Water Tender Rollover with Minor Injuries

August 2, 2008

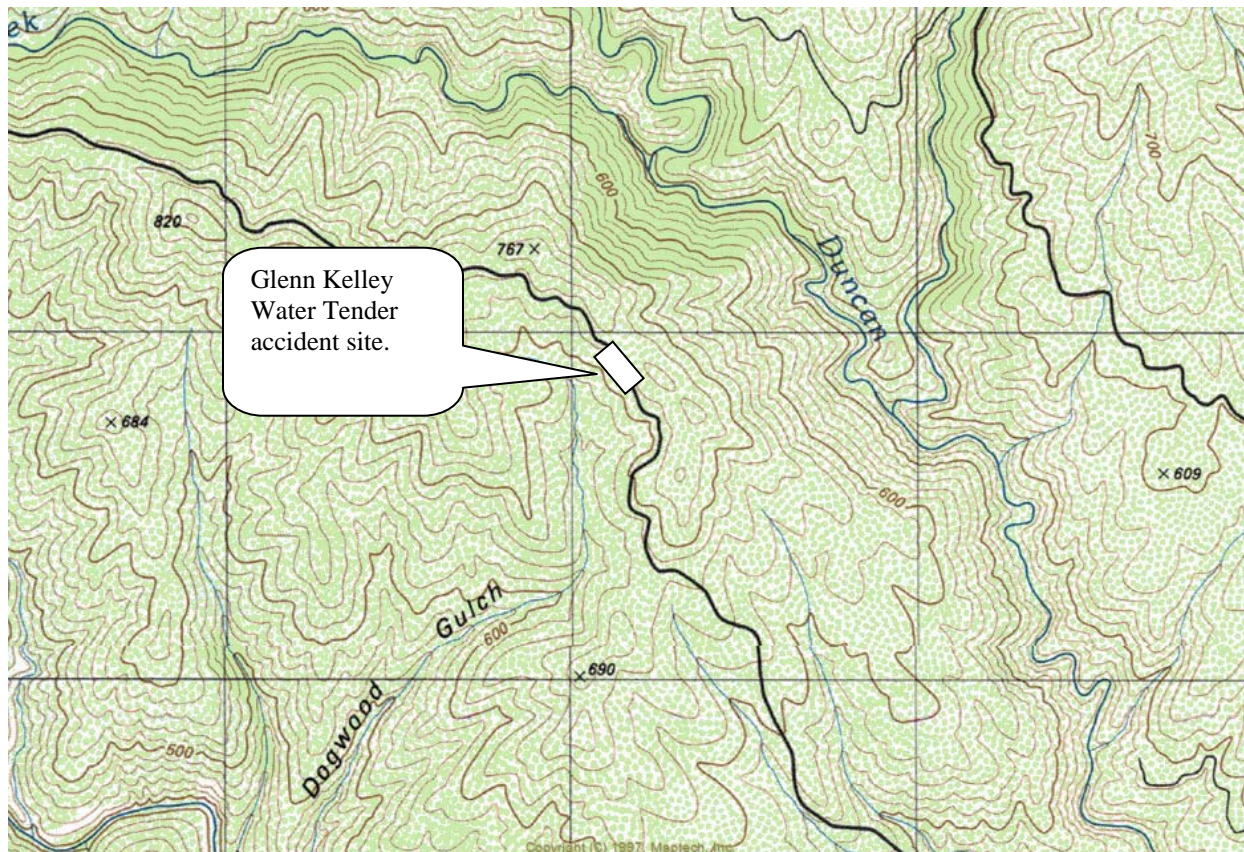
The vehicle traveled approximately 150' down the road with the passenger wheels into the cut bank before hitting some vegetation. As the front passenger wheel made contact with the vegetation, the vehicle rolled over onto the road. The rear bumper dug into the ground and the vehicle came to rest approximately 10' from point of roll over pointing downhill.

**Topography view of accident site. Road surface is Graves Ranch Road at accident site.
Water tender came to rest facing downhill in the center of the roadway.**

1. Vehicle operators must maintain situational awareness when considering or observing changing road conditions, steep slopes and variances in road compaction.
2. Operators must consider gear selection and brake limitations when traveling down steep grades. Operators should never descend down a grade in a gear higher than it would take to climb up the grade.
3. When operating a vehicle with a heavy load on steep grades, it is advisable to stop periodically and check brake temperatures.
4. If there is another occupant in your vehicle, it is advisable to have the passenger get out and scout steep grades prior to taking the vehicle down them.
5. Remember to always use the vehicle's safety restraint systems and secure all loose items in the cab prior to driving.
