Reference: Incident No: 36400

**HYDE FIRE**  
**OCTOBER 9, 1988**

On October 9, 1988 at 1904 on the Hyde Fire, Dozer 3141 was overrun by fire. This accident resulted in 50 percent burns to HFEO Dave Howard and minor damage to the bulldozer.

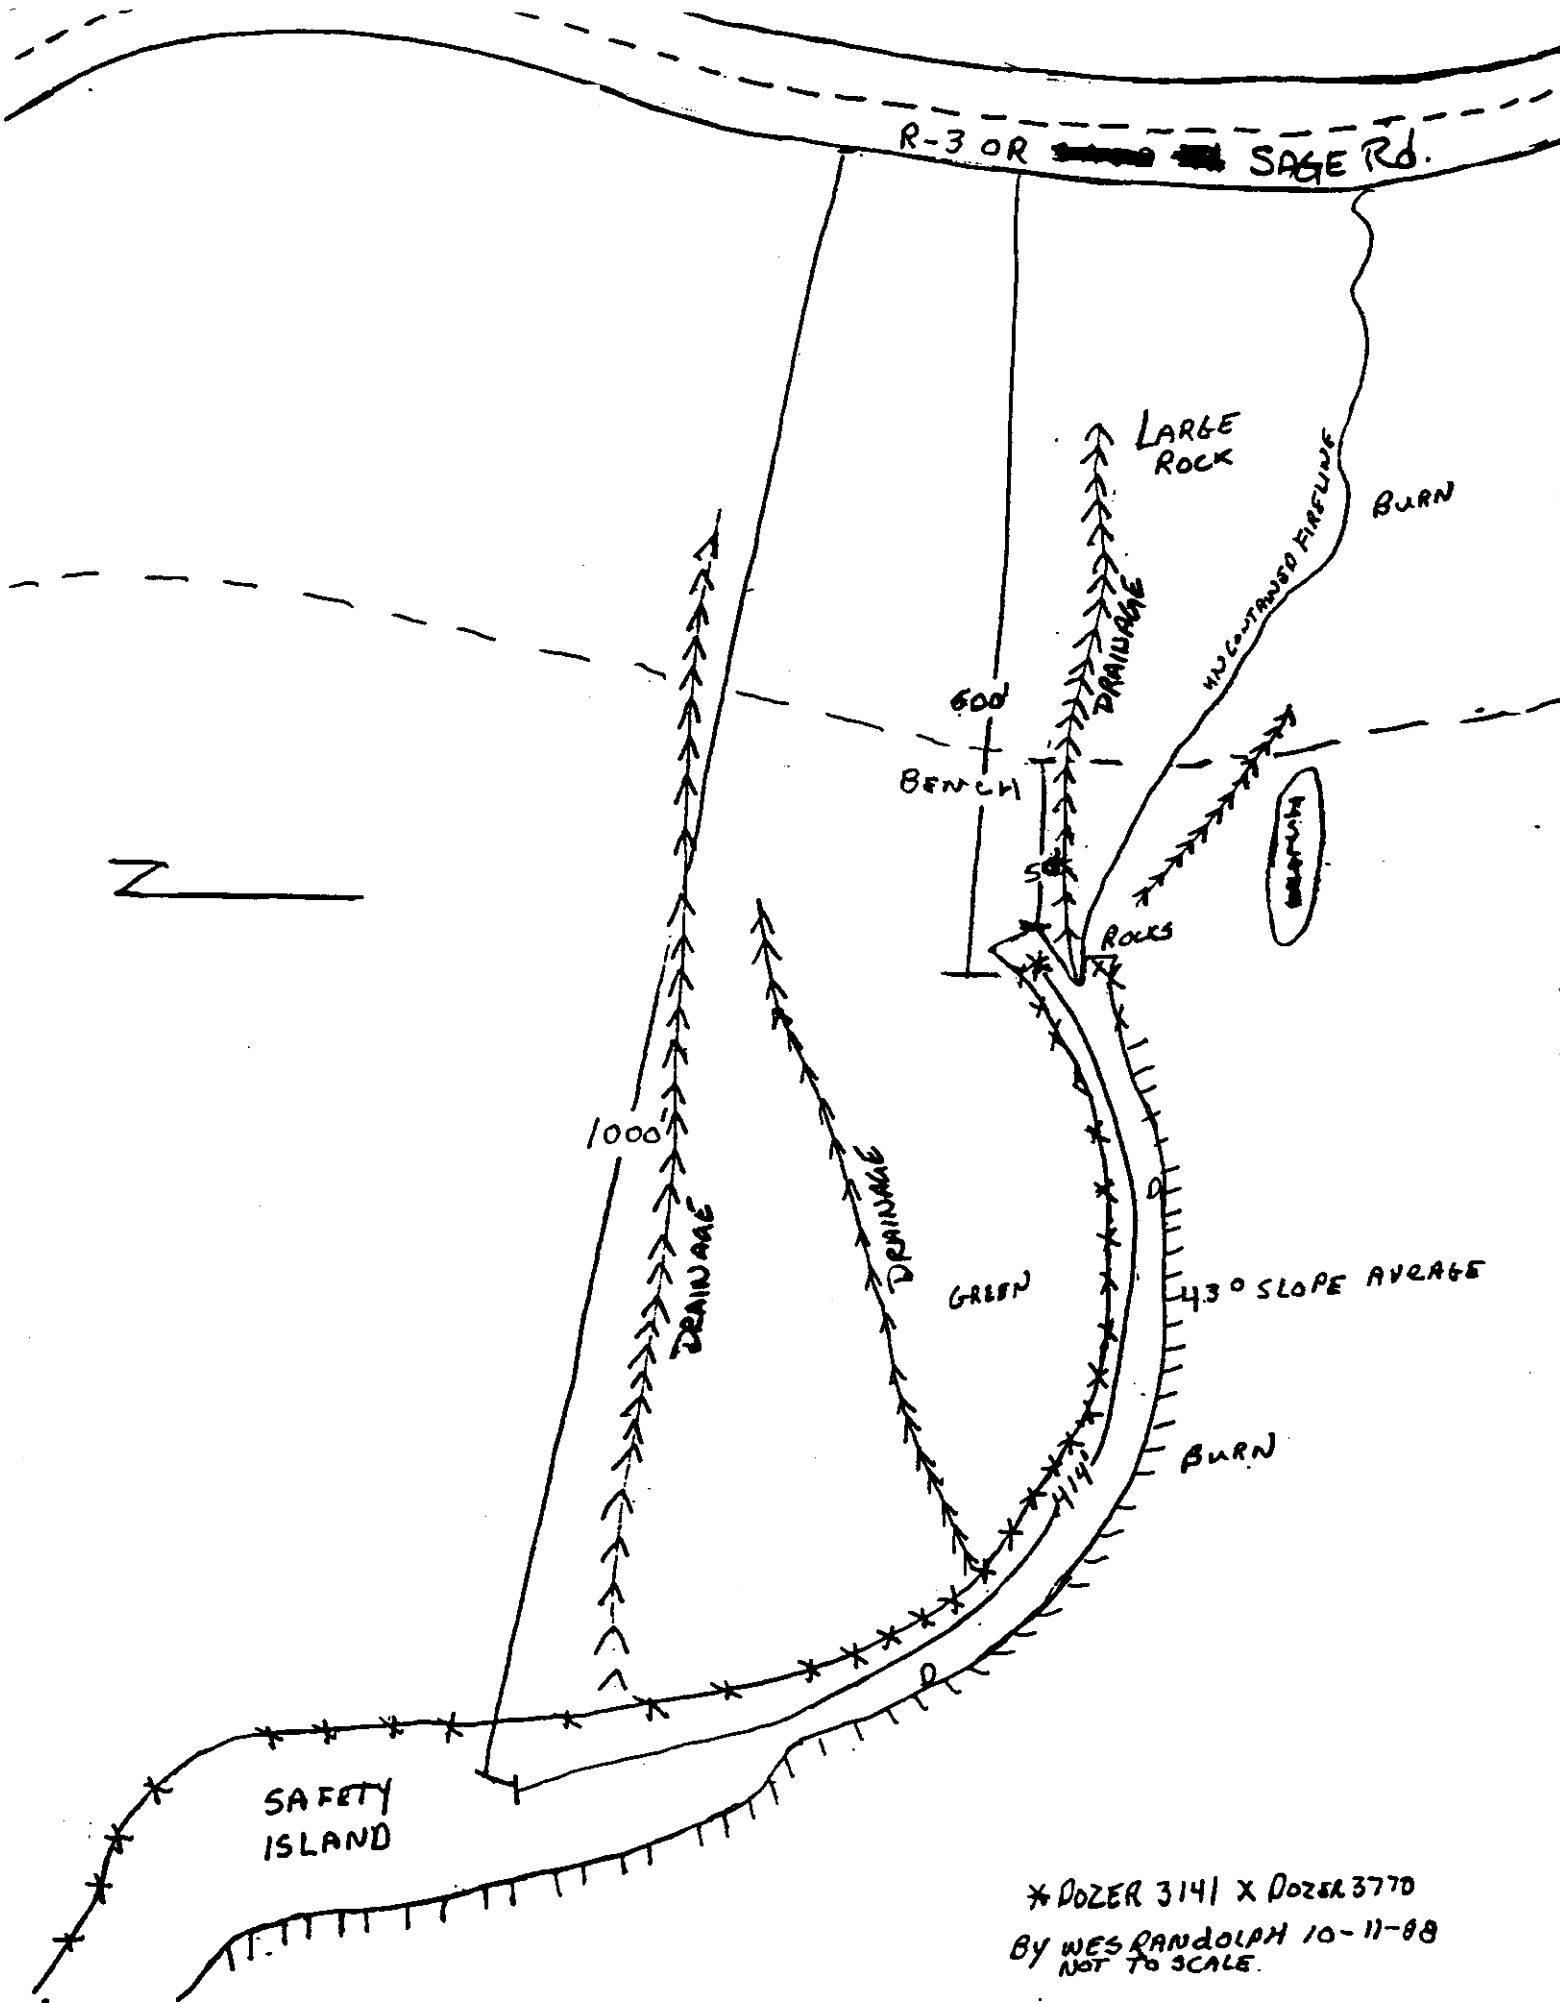
\* DOZER 3141 X DOZER 3770  
 BY WES RANDOLPH 10-11-88  
 NOT TO SCALE.

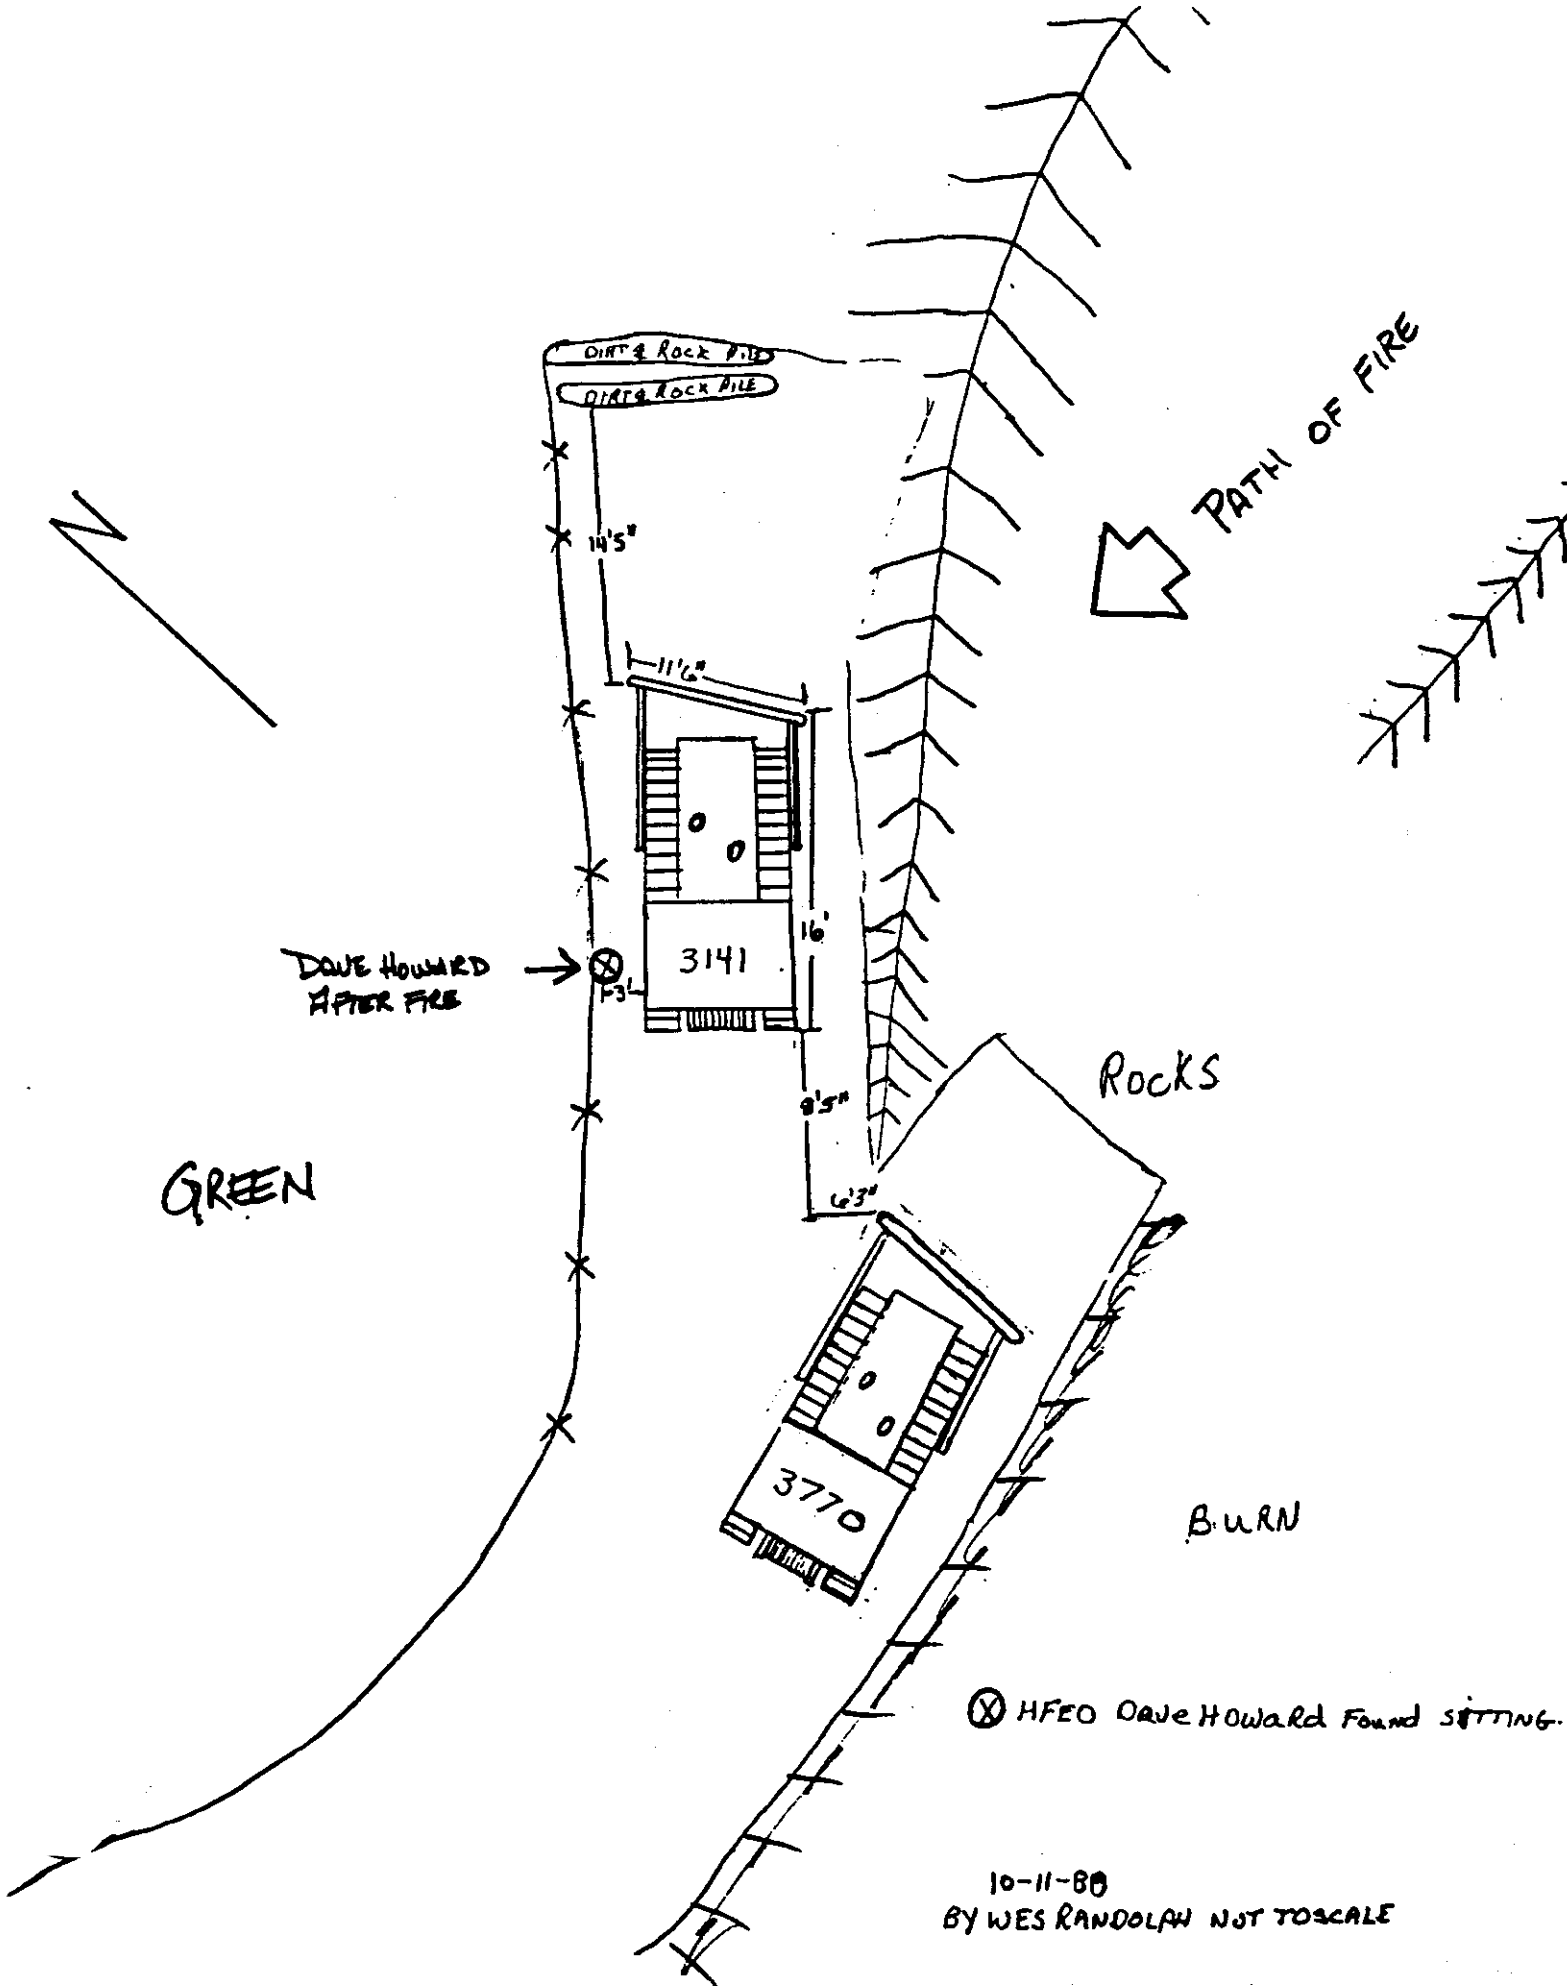
DAVE HOWARD  
AFTER FIRE

PATH OF FIRE

X HFOO Dave Howard Found sitting.

10-11-80  
BY WES RANDOLPH NOT TO SCALE
