Ice Canyon RX Burn Injury

Non-Serious Wildland Fire Accident Investigation

Farmington District Office - Bureau of Land Management

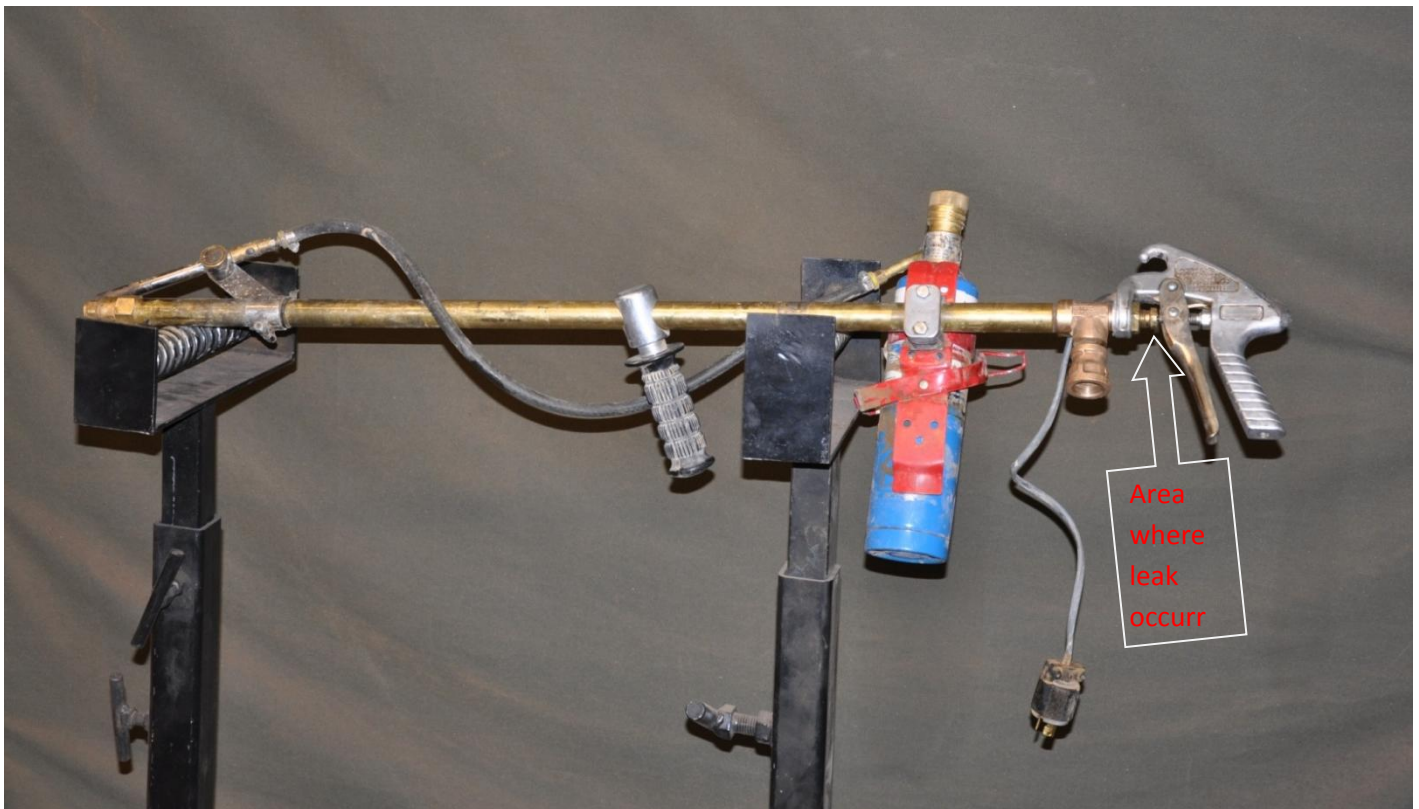
A district firefighter was operating a Terra Torch for ignition of the RX. The Terra Torch wand started leaking burn mix near the trigger handle. Burn operations were halted at 1623 to fix the leak.

The wand was taken apart to assess what was causing the leak. After replacing some O rings the leak was apparently stopped. At 1805, it was decided to continue ignitions with the Terra Torch. The Terra Torch operator began ignitions and within 30 seconds the wand began leaking again in the same area and spilled some burn mix on the operators right pant leg which he did not notice. The operator told the crewmember assisting with the Terra Torch to close the supply valve to the wand to stop the wand from leaking and notified the driver to stop. The driver pulled forward an additional 100 feet, which is normal operating procedures to get the torch away from active flames. The crewmember could not understand directions given to him by the Terra Torch operator due to engine noise of the Terra Torch and thought that the operator wanted him to close the recirculation valve. This caused burn mix to

continue to drip and make a trail to the vehicle, instead of closing the valve to the wand which would have stopped the wand from leaking.

1. Ensure that all personnel assigned to the Terra Torch operation review the operator's manual, are trained on proper use and operation, emergency shutdown and emergency response procedures before operation of the Terra Torch.
2. Setup a maintenance schedule for Terra torch, to ensure that all recommended parts are used and in proper functioning order.
3. Purchase spare wand and parts for Terra torch from the manufacturer that experience high wear and tear. No other parts should be substituted for repair. Recommended tools and spare parts to be located on the vehicle with the Terra Torch.

4. When doing field maintenance on Terra torch conduct a dry run with torch (No flames) to make sure machine is operating properly. Follow the recommended checklist startup procedures (Exhibit D) provided by the manufacturer.

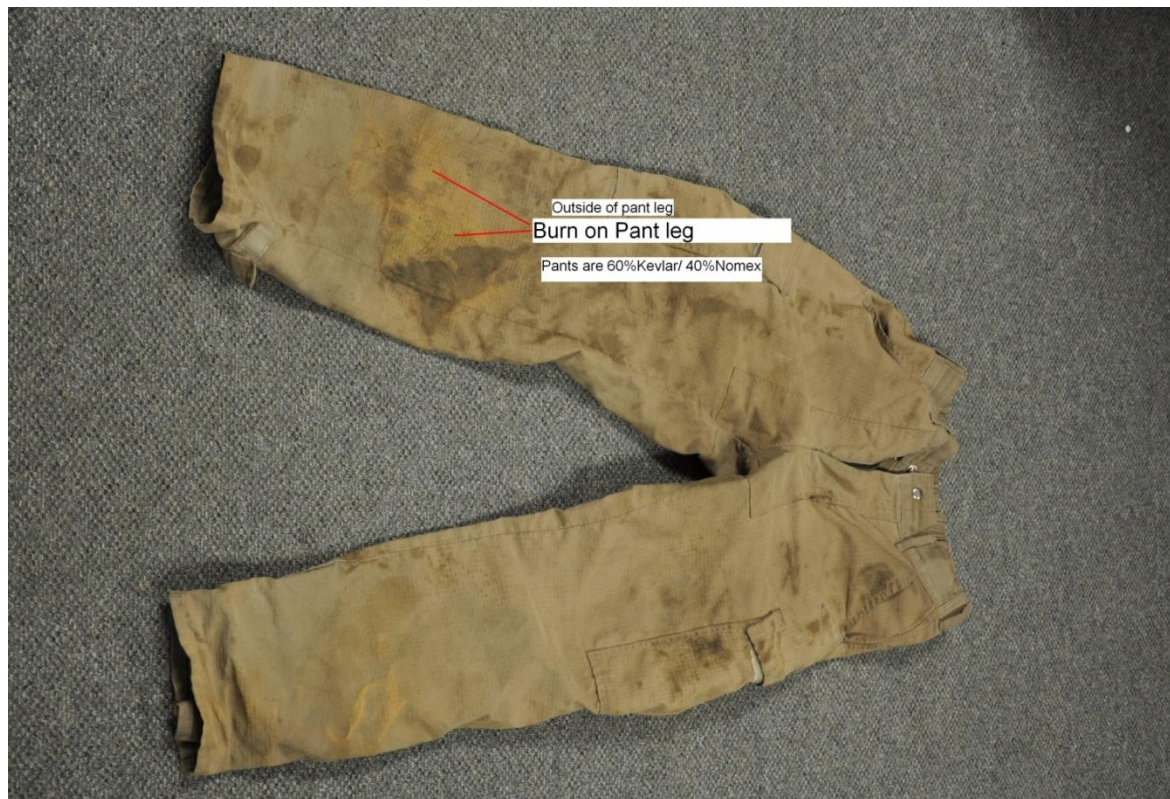
At 1806, when the vehicle stopped the operator stepped off the vehicle to close the supply valve. He stepped in the trail created by the leaking wand, which then ignited from the fire they had just lit. This trail of fire then ignited the burn mix on operator's pant leg.

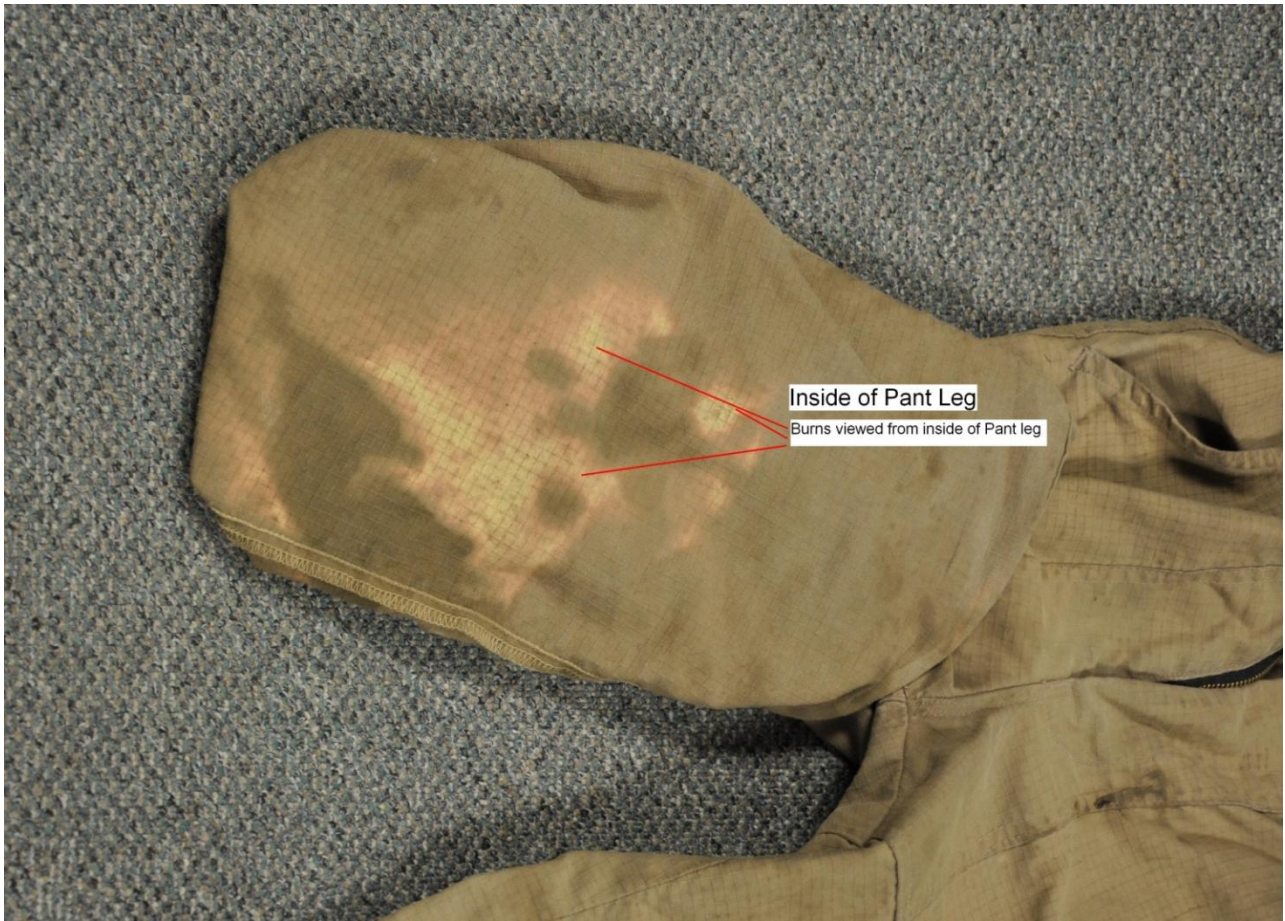
Immediately engines were directed to proceed to the Terra Torch and extinguish any flames, within 15 seconds the fire was extinguished and a crewmember from one of the engines noticed that the Terra Torch operator's pant leg was on fire. The fire was immediately extinguished using dirt by the operator and the engine crewmember.

EMTs from the engines assessed the Terra Torch operator for injuries and determined that he had received a 2nd degree burn to his right calf. Medical emergency procedures as discussed in the burn briefing were put into place and the EMT in charge took over the medical incident. The burn was cleaned and wrapped. It was determined that the individual needed to be transported to the hospital.
