# INFORMATIONAL SUMMARY REPORT

## FIRE FIGHTER FATALITY

### HAWKINS BAR VOLUNTEER FIRE DEPARTMENT

**JONES INCIDENT      OCTOBER 16, 1999**  
**9SHU008604**

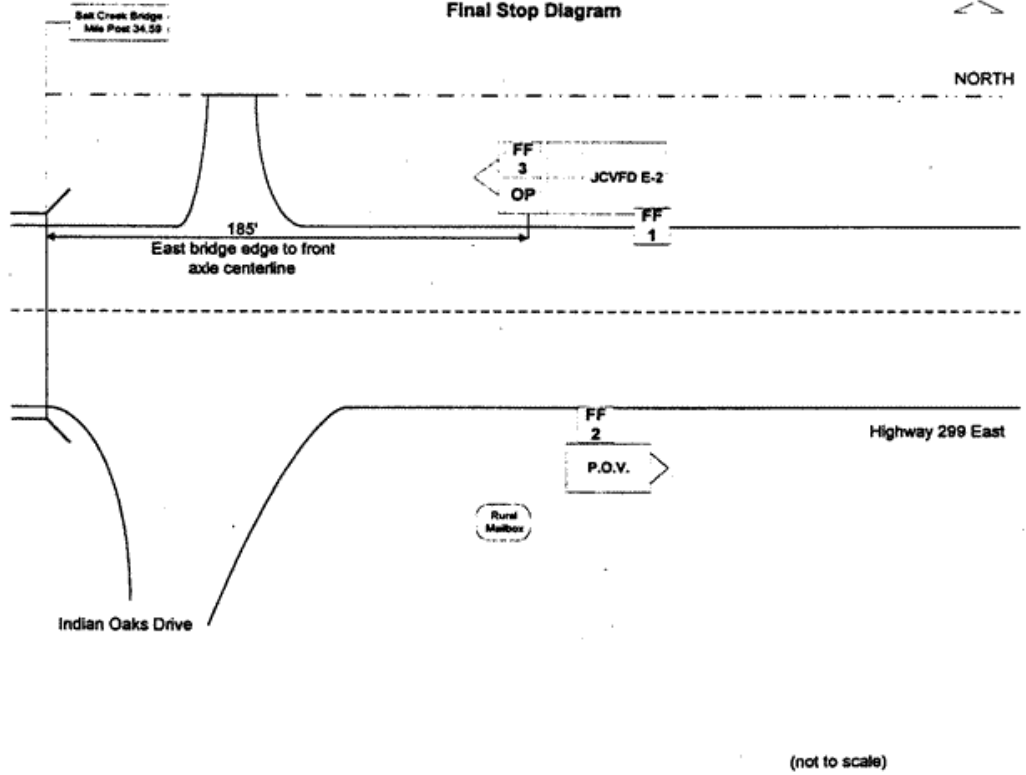
**Jones Incident Accident Site  
Final Stop Diagram**

At approximately 1330 hours, the decision was made to retrieve the personal vehicle and find a better location for it prior to going on to new assignments. Sometime between 1330 and 1340 hours, the engine stopped, across from the personal vehicle, facing west-bound. This placed the engine along the north shoulder of Highway 299E, approximately 200 feet east of the Salt Creek Bridge and post mile marker 34.59, across from the personal vehicle. While three of the crew members discussed how and where they would move the pickup, a firefighter dismounted the engine and walked across Highway 299 in a southerly direction toward the personal vehicle. After the determination was made to relocate the personal vehicle, a second firefighter also walked across Highway 299 in a southerly direction towards the personal vehicle. Without the knowledge of the engine operator, at approximately 1345 hours, the first firefighter returned, and was in the act of boarding the engine as it began to move forward. The firefighter was carrying a bag of refreshments in one hand and a large shoulder bag and open soda can in the other. The firefighter was unable to utilize the nearby grab bar. With the engine moving forward, the firefighter began to lose balance. The firefighter jumped from the engine and landed in such a manner that her loss of balance caused her to fall backward and land with her head underneath the driver's side step board, immediately in front of the rear duals. The firefighter was run over and died instantly due to blunt trauma to the head.
