**State of Alaska
Department of Natural Resources
Division of Forestry**

ACCIDENT INVESTIGATION FACTUAL REPORT

**Type of Incident:
Water Supply / Burns**

**Location:
AK-DOF, Fairbanks Area, Logging Slash Fire, Alaska**

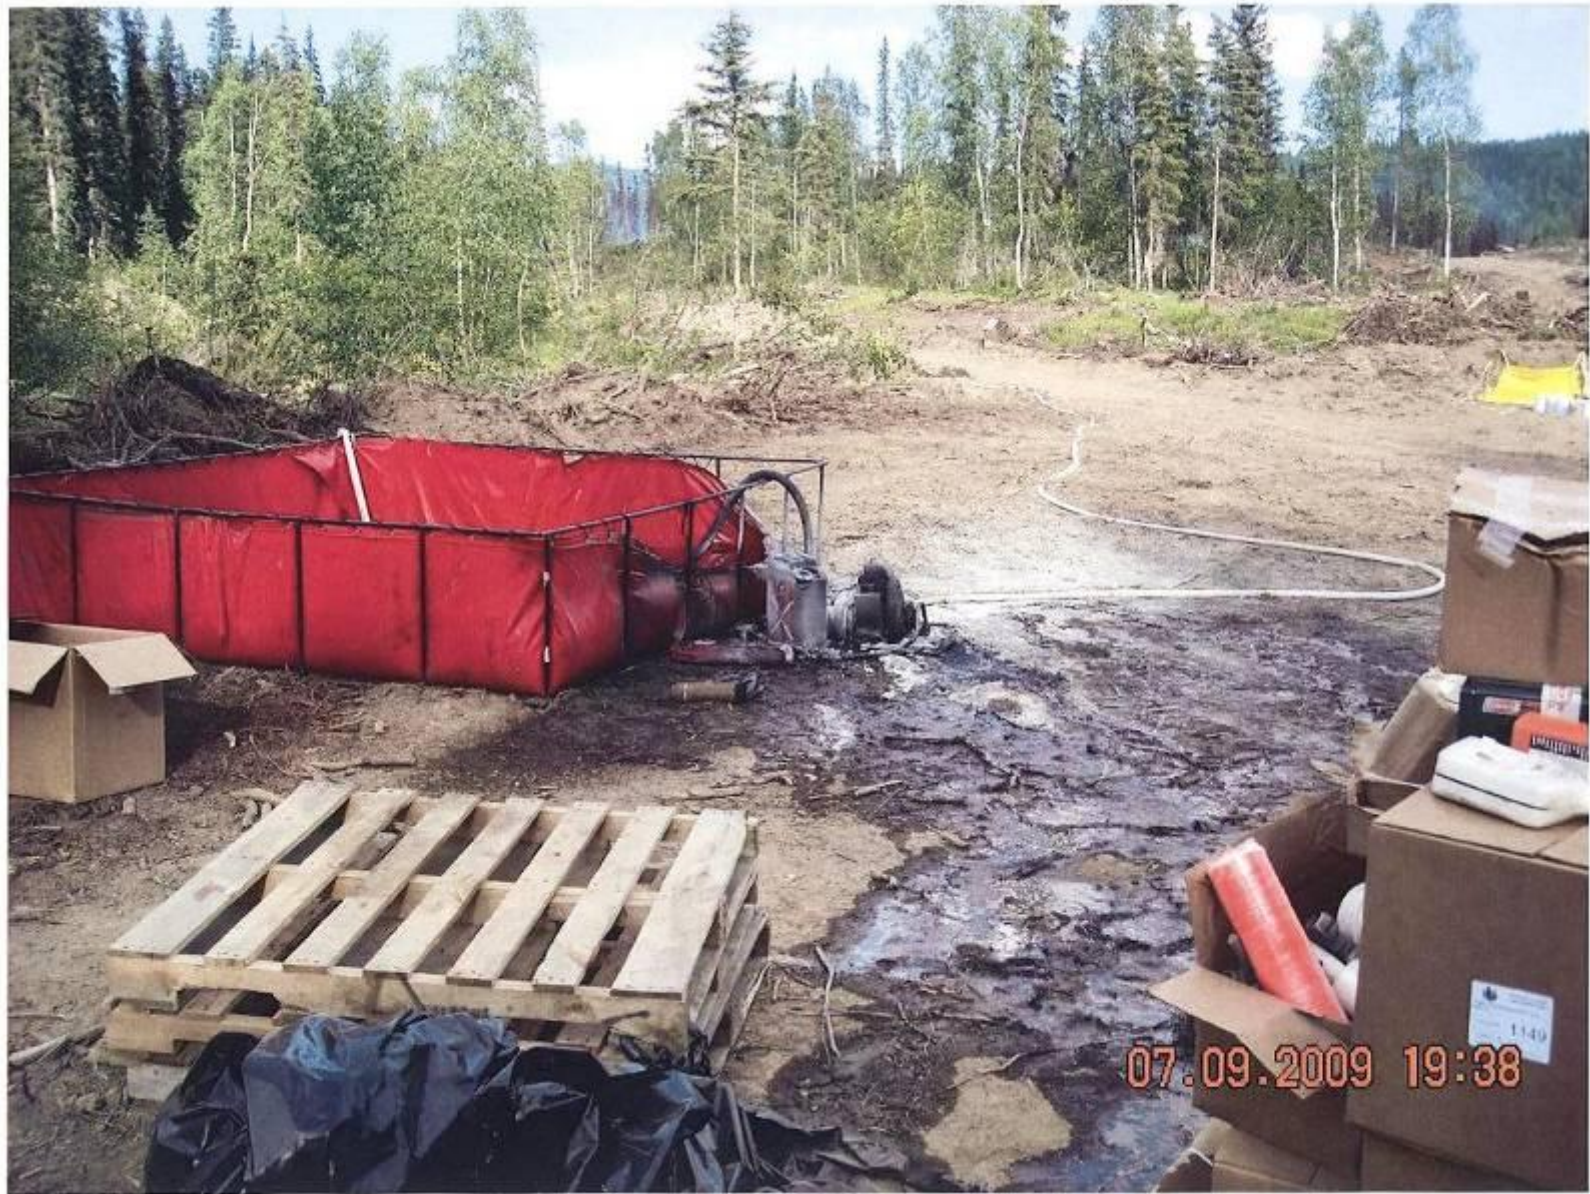
| Photo 1 | Mark 3 Pump, Jerry Can & Folda-tank |

- Placement of the jerry can in close proximity to Mark 3 muffler and in an angled alignment with the exhaust.
- Size/shape of fuel containment dyke may have been a contributing factor in the placement of the jerry can next to the muffler. The investigation team recommends additional research regarding whether the fuel containment dyke does readily lend itself to safe and practical set-up / operation while adhering to containment standards.
- Briefing IC-IHC received regarding very strict spill prevention and reporting may have been interpreted to include all incidents.

facility in Fairbanks. Detailed pictures were taken on scene shortly after the accident. Inspection revealed no mechanical deficiencies with the pump and/or fueling system. The air vent on the jerry can was open.

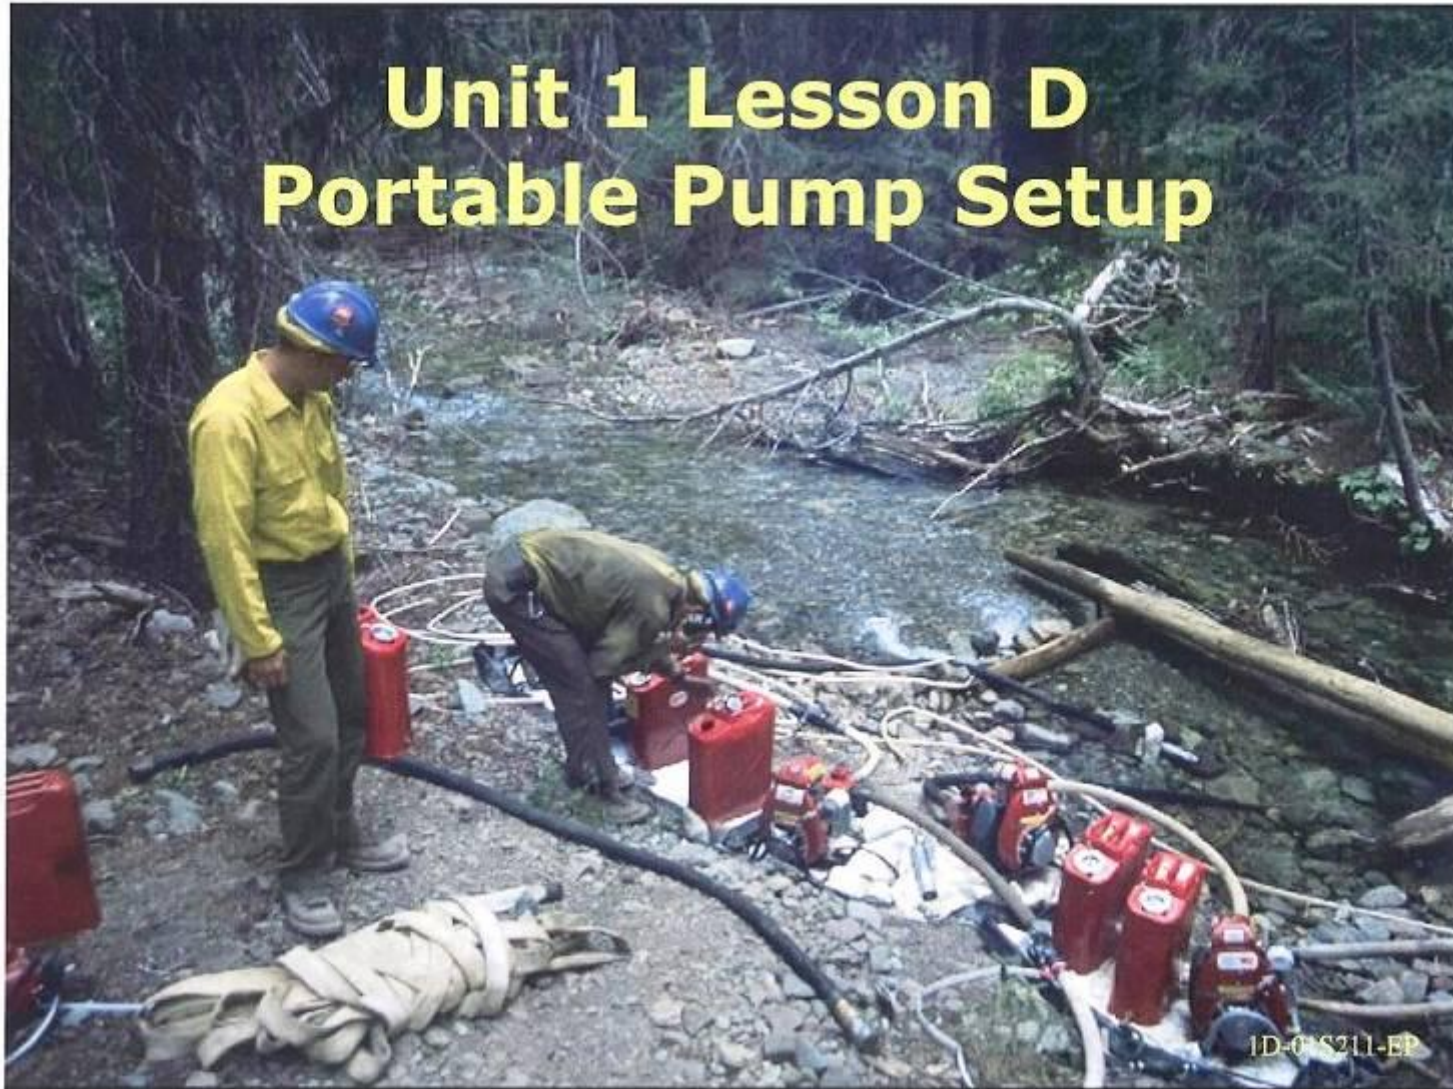
Unit 1 Lesson D Portable Pump Setup

| Photo 3 | Slide from Unit 1, Lesson D, S-211 Class |

- ✓ Educate all wildland suppression agencies and organizations of the Burn Injury Criteria that is present in Chapter 7 of the 2009 Interagency Standards for Fire and Fire Aviation Operations.
- ✓ Update NWCG S-211 course to include more information regarding the proper use of spill containment devices and importance of keeping the jerry can away from muffler side of pumps
- ✓ Place a label near fuel line port of jerry can stating “Do Not Place Can Near Exhaust”
- ✓ All training should emphasize the proper use of PPE including eye and hand protection during all fueling operations
- ✓ All training should address the utilization of Crew Resource Management during any emergency
- ✓ All wildland fire suppression organizations/agencies should develop a “Safety Gram” to emphasize the dangers of placing fuel containers too close to mufflers or other sources of ignition
