THE MARRE FIRE ENTRAPMENT

OCTOBER 2, 1993

A review of the entrapment incident that occurred on the Marre Fire,
September 25 - October 16, 1993. Los Padres National Forest, CA

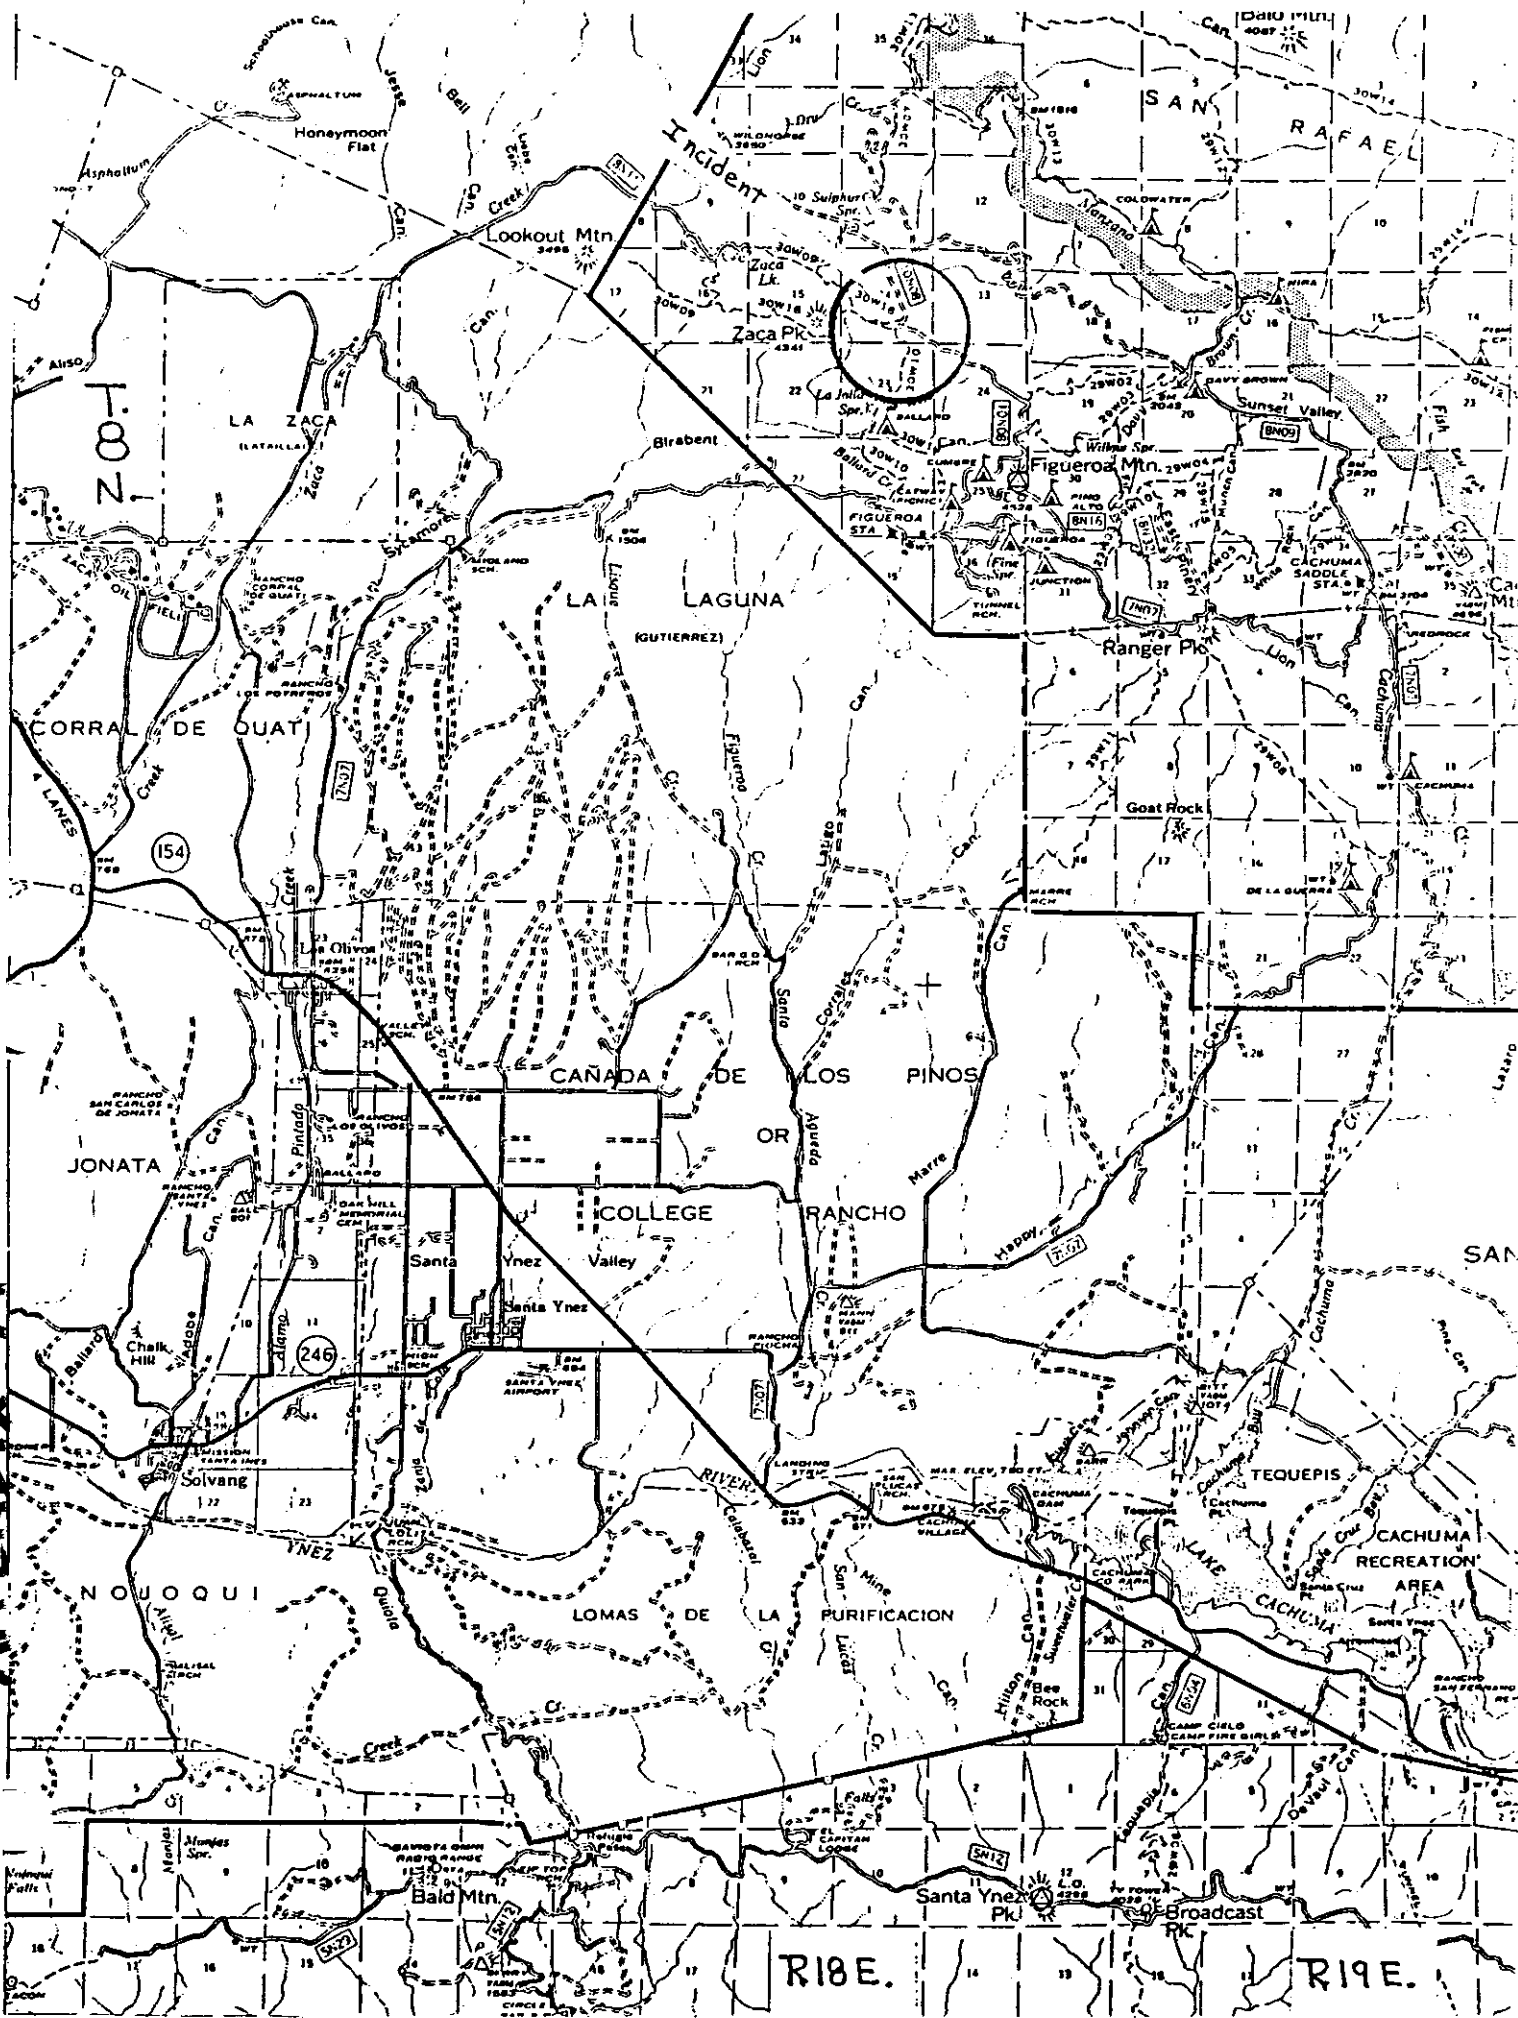
APPENDIX A

The entrapment occurred in Section 14, Township 8N, Range 18E. See Appendix A and B for mapped location.

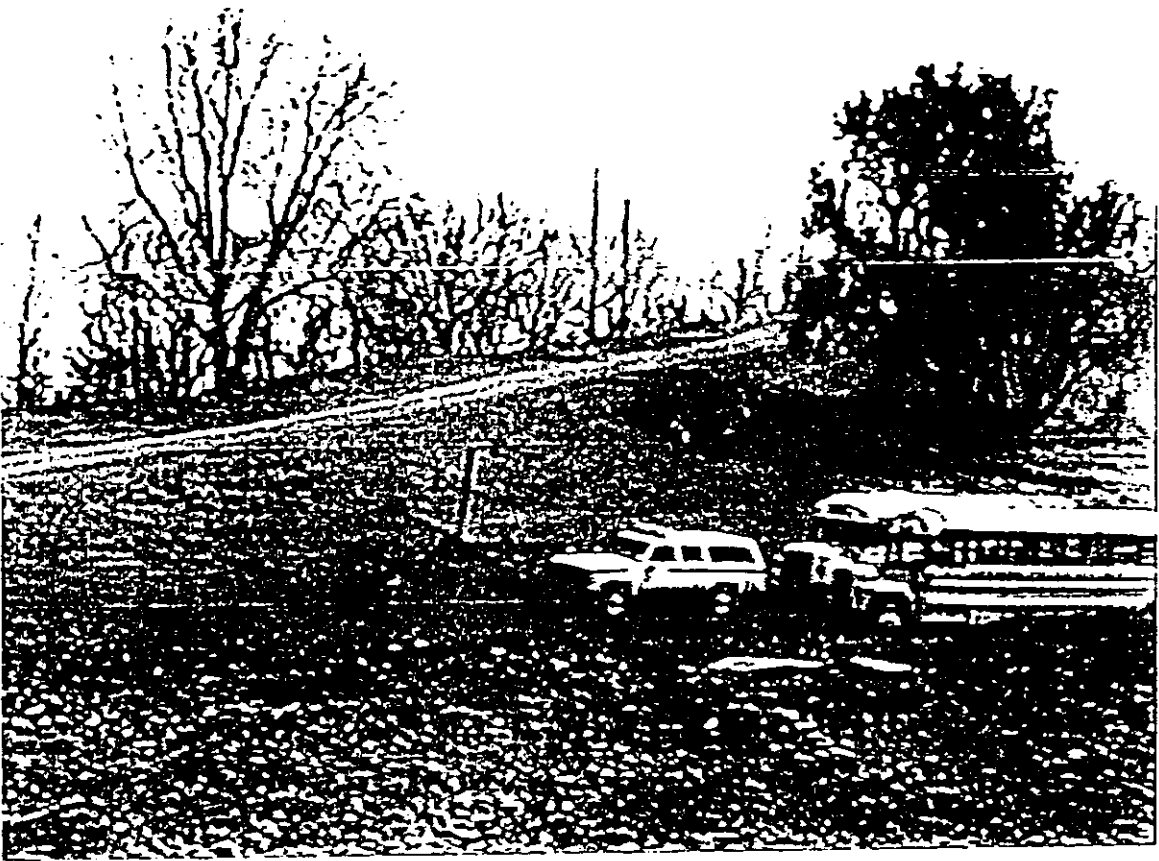
APPENDIX E

One feature of the Safety Zone and saddle that became important to the crews' survival was the presence of a significant depression in the top of the ridge. (See Appendix E and F.) Examination of the ridge, the burn patterns present, the witness statements, and the engines ultimately being located in the bottom of this bowl, are all indicators that the majority of the heat from the burnover passed over their heads. They still had to contend with a great deal of heat and embers (which were ingested through the intake of E-2-7 and disabled the motor), but not like they would have had to endure if the ridgetop had been rounded.
