LESSONS LEARNED

Ozena Lightning Strike Los Padres National Forest CA-LPF 2011-2382 Lessons Learned Review

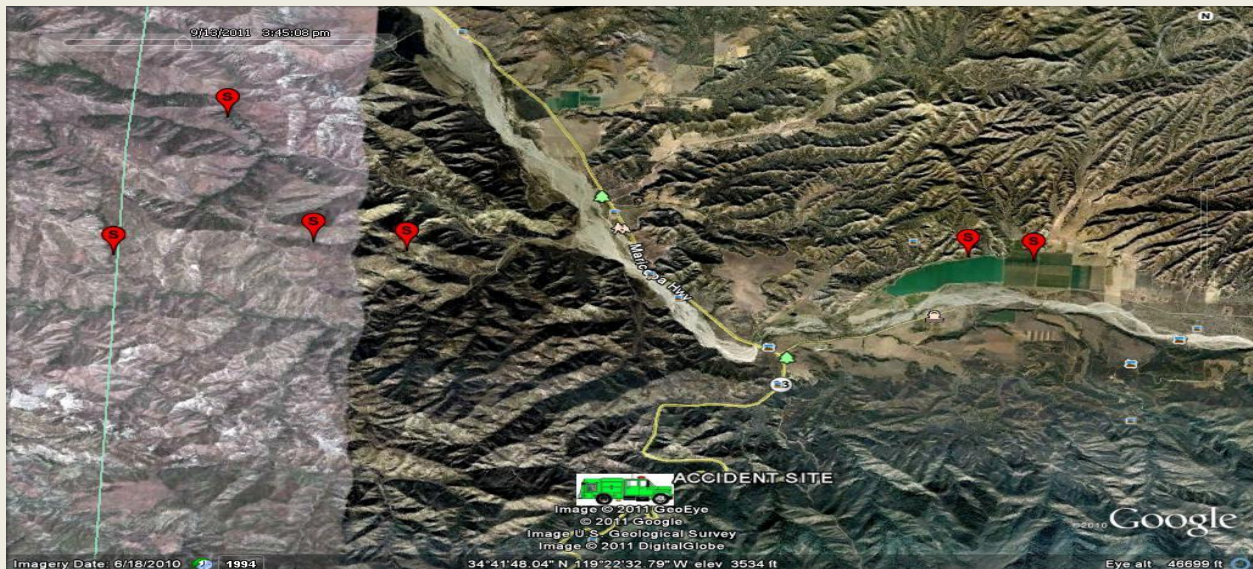
Image US Geological Survey/Accident site and recorded Lightning Strikes

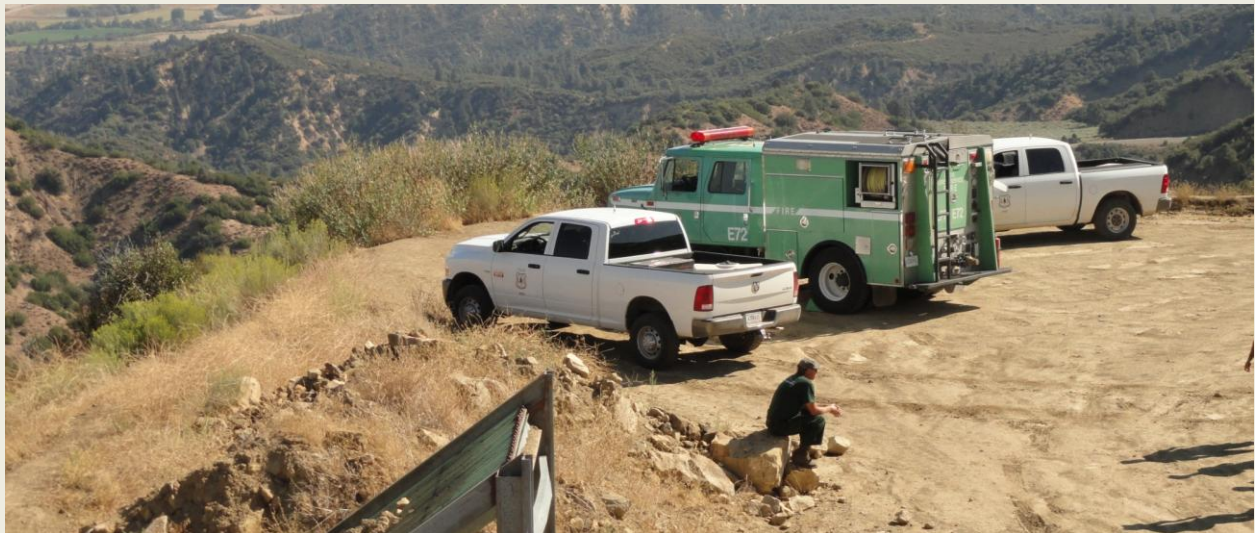
Vehicles parked at Observation Point

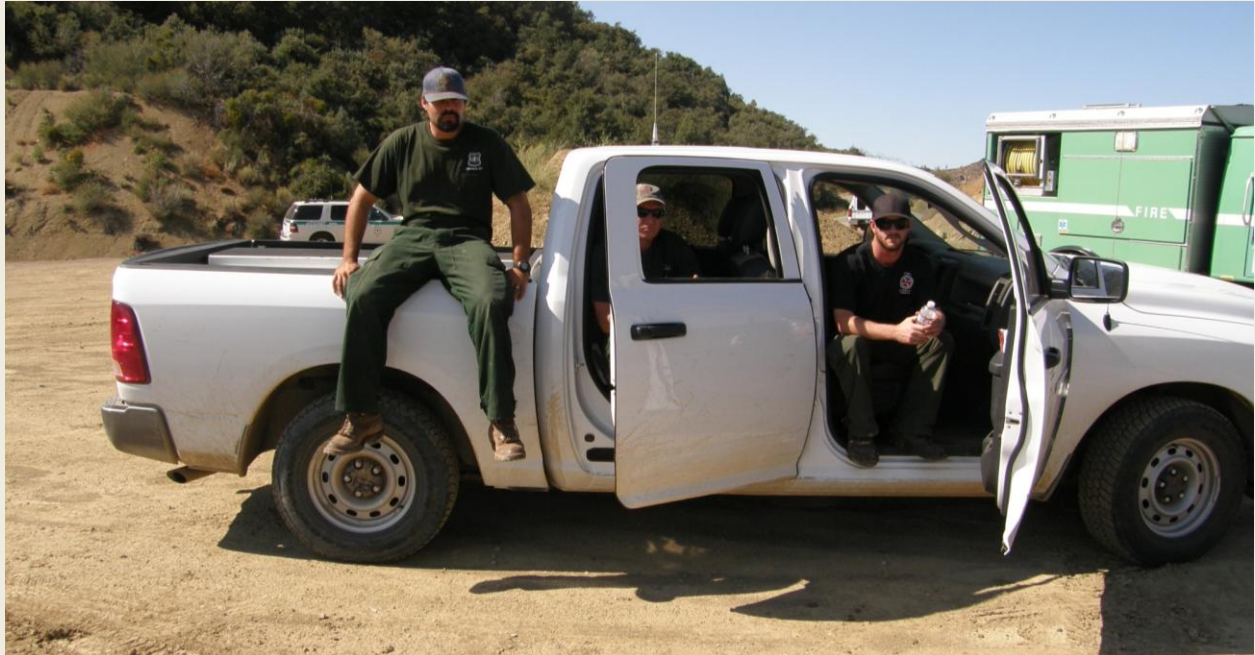
While at the observation point the Engine Captain and two members of his crew were outside the engine, at the edge of the turnout, observing lightning strikes to the North and East. The Engineer remained seated in the engine. Two members of the Type II Crew were seated in their truck and one was seated on the edge of the bed of the truck.

Positions of Type 2 hand crew overhead

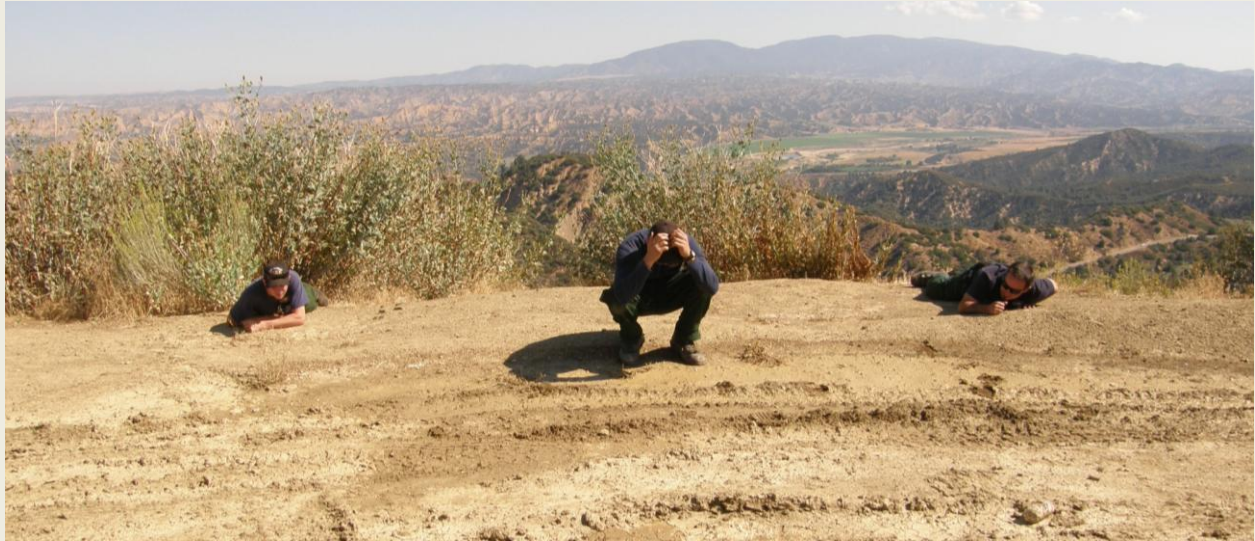
The engine operator was momentarily blinded by the flash. Within seconds he was able to focus and observed his Captain and crew on the ground. The Captain stated he thought he had been struck by lightning and the HT radio from his belt was found several feet in front of him.

The Engine Captain, one of his fire fighters, and the crew boss of the Type II crew suffered the effects of a nearby lightning strike, with no direct hit to any of them.

Positions of the engine crew after the strike.

- Evaluate if there is a need to exit your vehicle to observe down strikes. Staying in vehicle is a valid option.

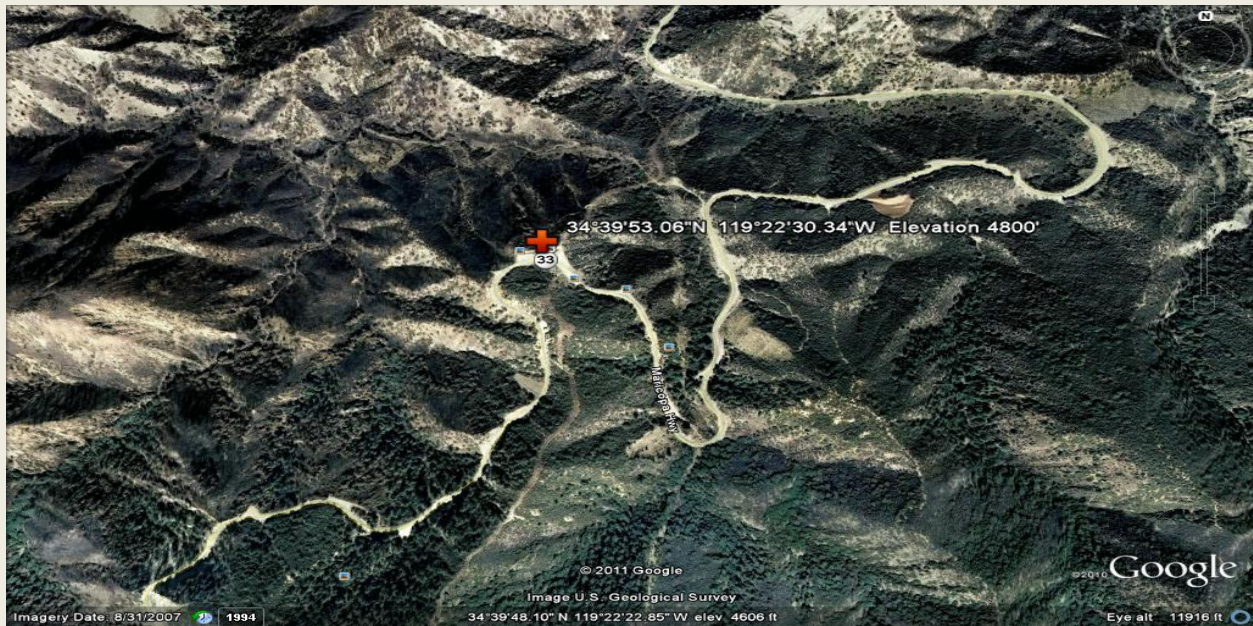
Red Cross marks the Accident site
