Informational Summary Report of Serious CAL FIRE Injuries, Illnesses, Accidents and Near-Miss Incidents

AEU Firefighter Serious Injury/Backing Incident

July 10, 2011

11-CA-NEU-015334

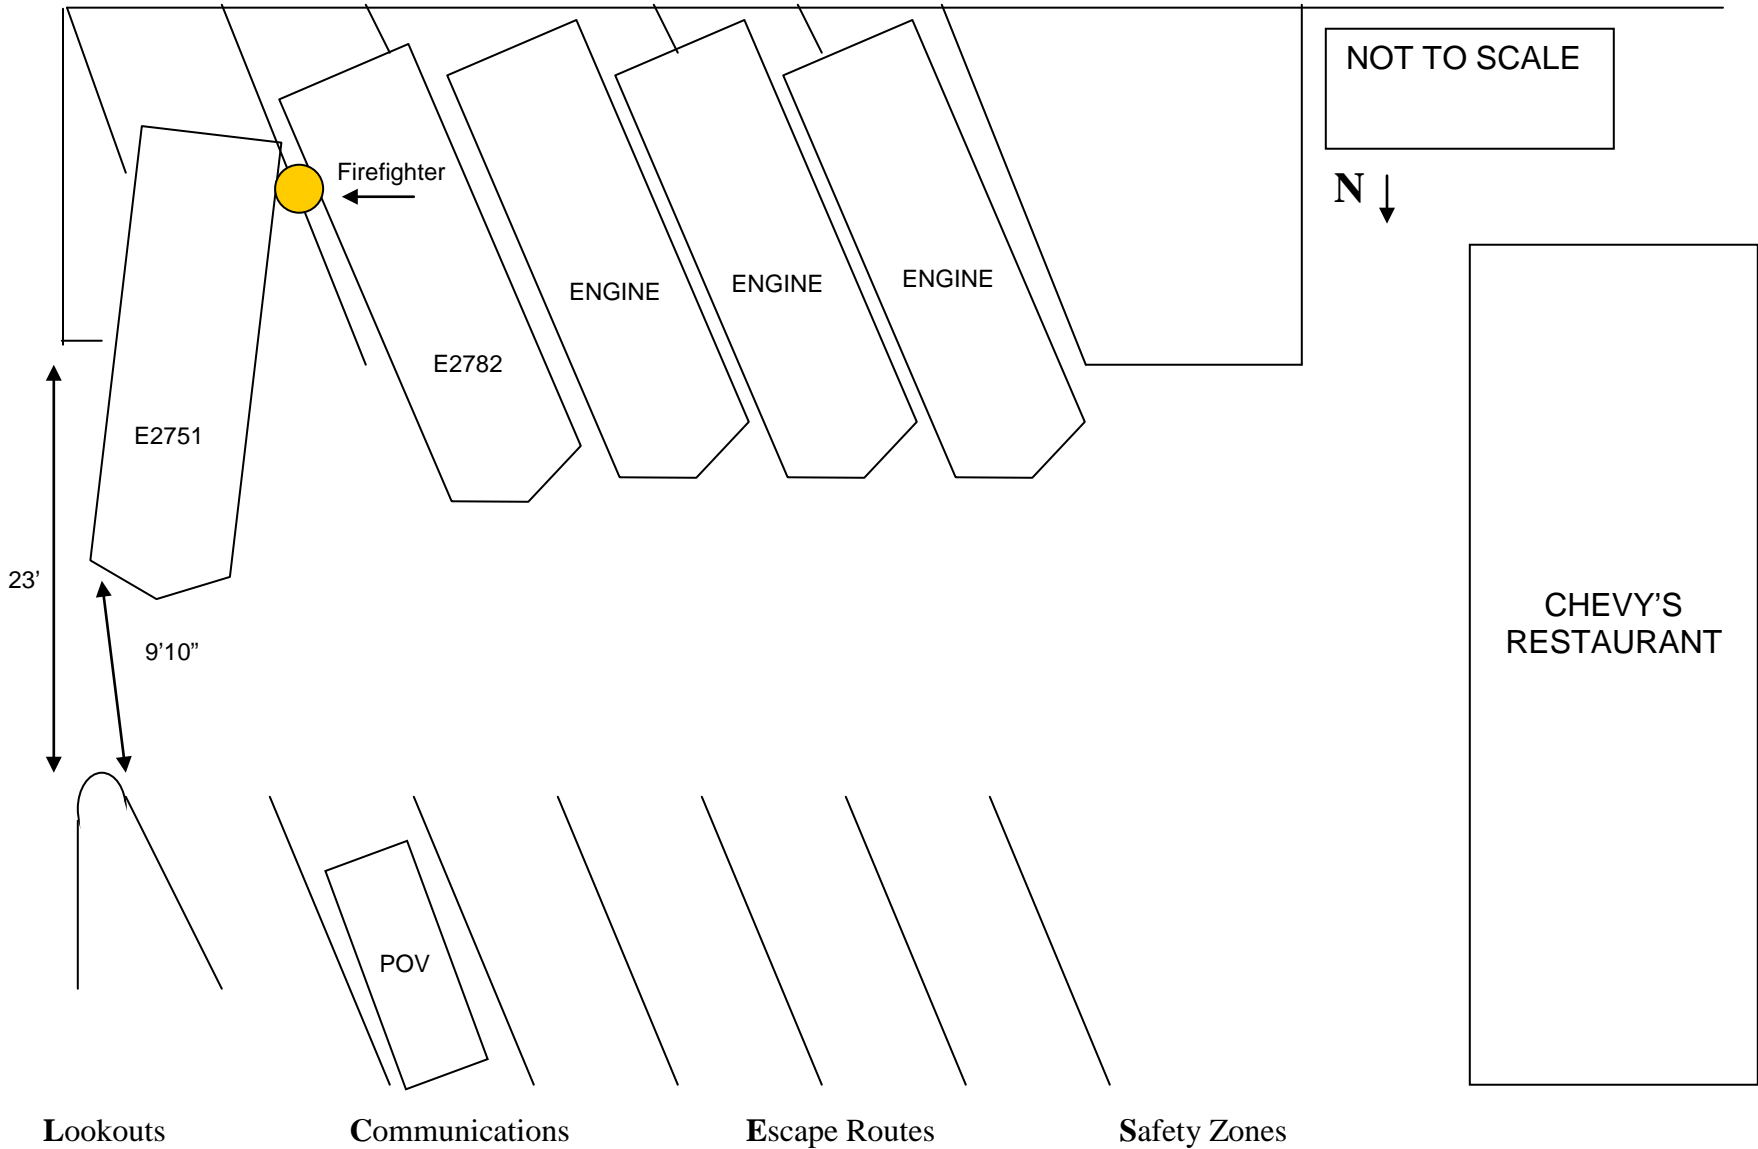
SITE MAP
11-CA-NEU-015334

The parking spot was bordered by E2782 on one side and a concrete curb with landscaping on the other. It was part of the operator's plan to back over the curb with the passenger's side rear duals in a backing "S" pattern in order to get the engine to fit into the parking space.

The operator of E2751 backed up at an approximate 45 degree angle to E2782. When he was about 2 ½ feet from E2782 and his passenger's side duals were up on the curb, the back-up person gave him the signal to stop. The engine needed to be pulled forward and repositioned in order to complete the backing turn into the space. As the operator placed the transmission into drive and took his foot off the brake, the engine rolled backward. This was due to the rear duals hanging over the curb to the rear but not touching the pavement. The movement to the rear was sudden and unexpected by the operator. The engine rolled back and struck the passenger rear compartment of E2782 with the driver's side rear corner of E2751's bumper, leaving a small dent and minor scratches.

In the process of repositioning himself after giving the stop signal, the back-up person was looking towards the rear of E2751 when the engine made the sudden movement to the rear. The back-up person got his legs out of the way of being caught between the bumper of E2751 and the compartment of E2782. However, his head got pinched momentarily between the driver's side rear compartment of E2751 and the passenger side rear compartment of E2782. The back-up person's left ear was caught in the door latch of the driver's side rear compartment of E2751 and his head left a small dent in the passenger side rear compartment door of E2782.
