FISH AND WILDLIFE SERVICE

Subject: Fire Entrapment and Fire Shelter Deployment

PHOTOGRAPHS OF INCIDENT SCENE - SUNSET FIRE BURN OUT

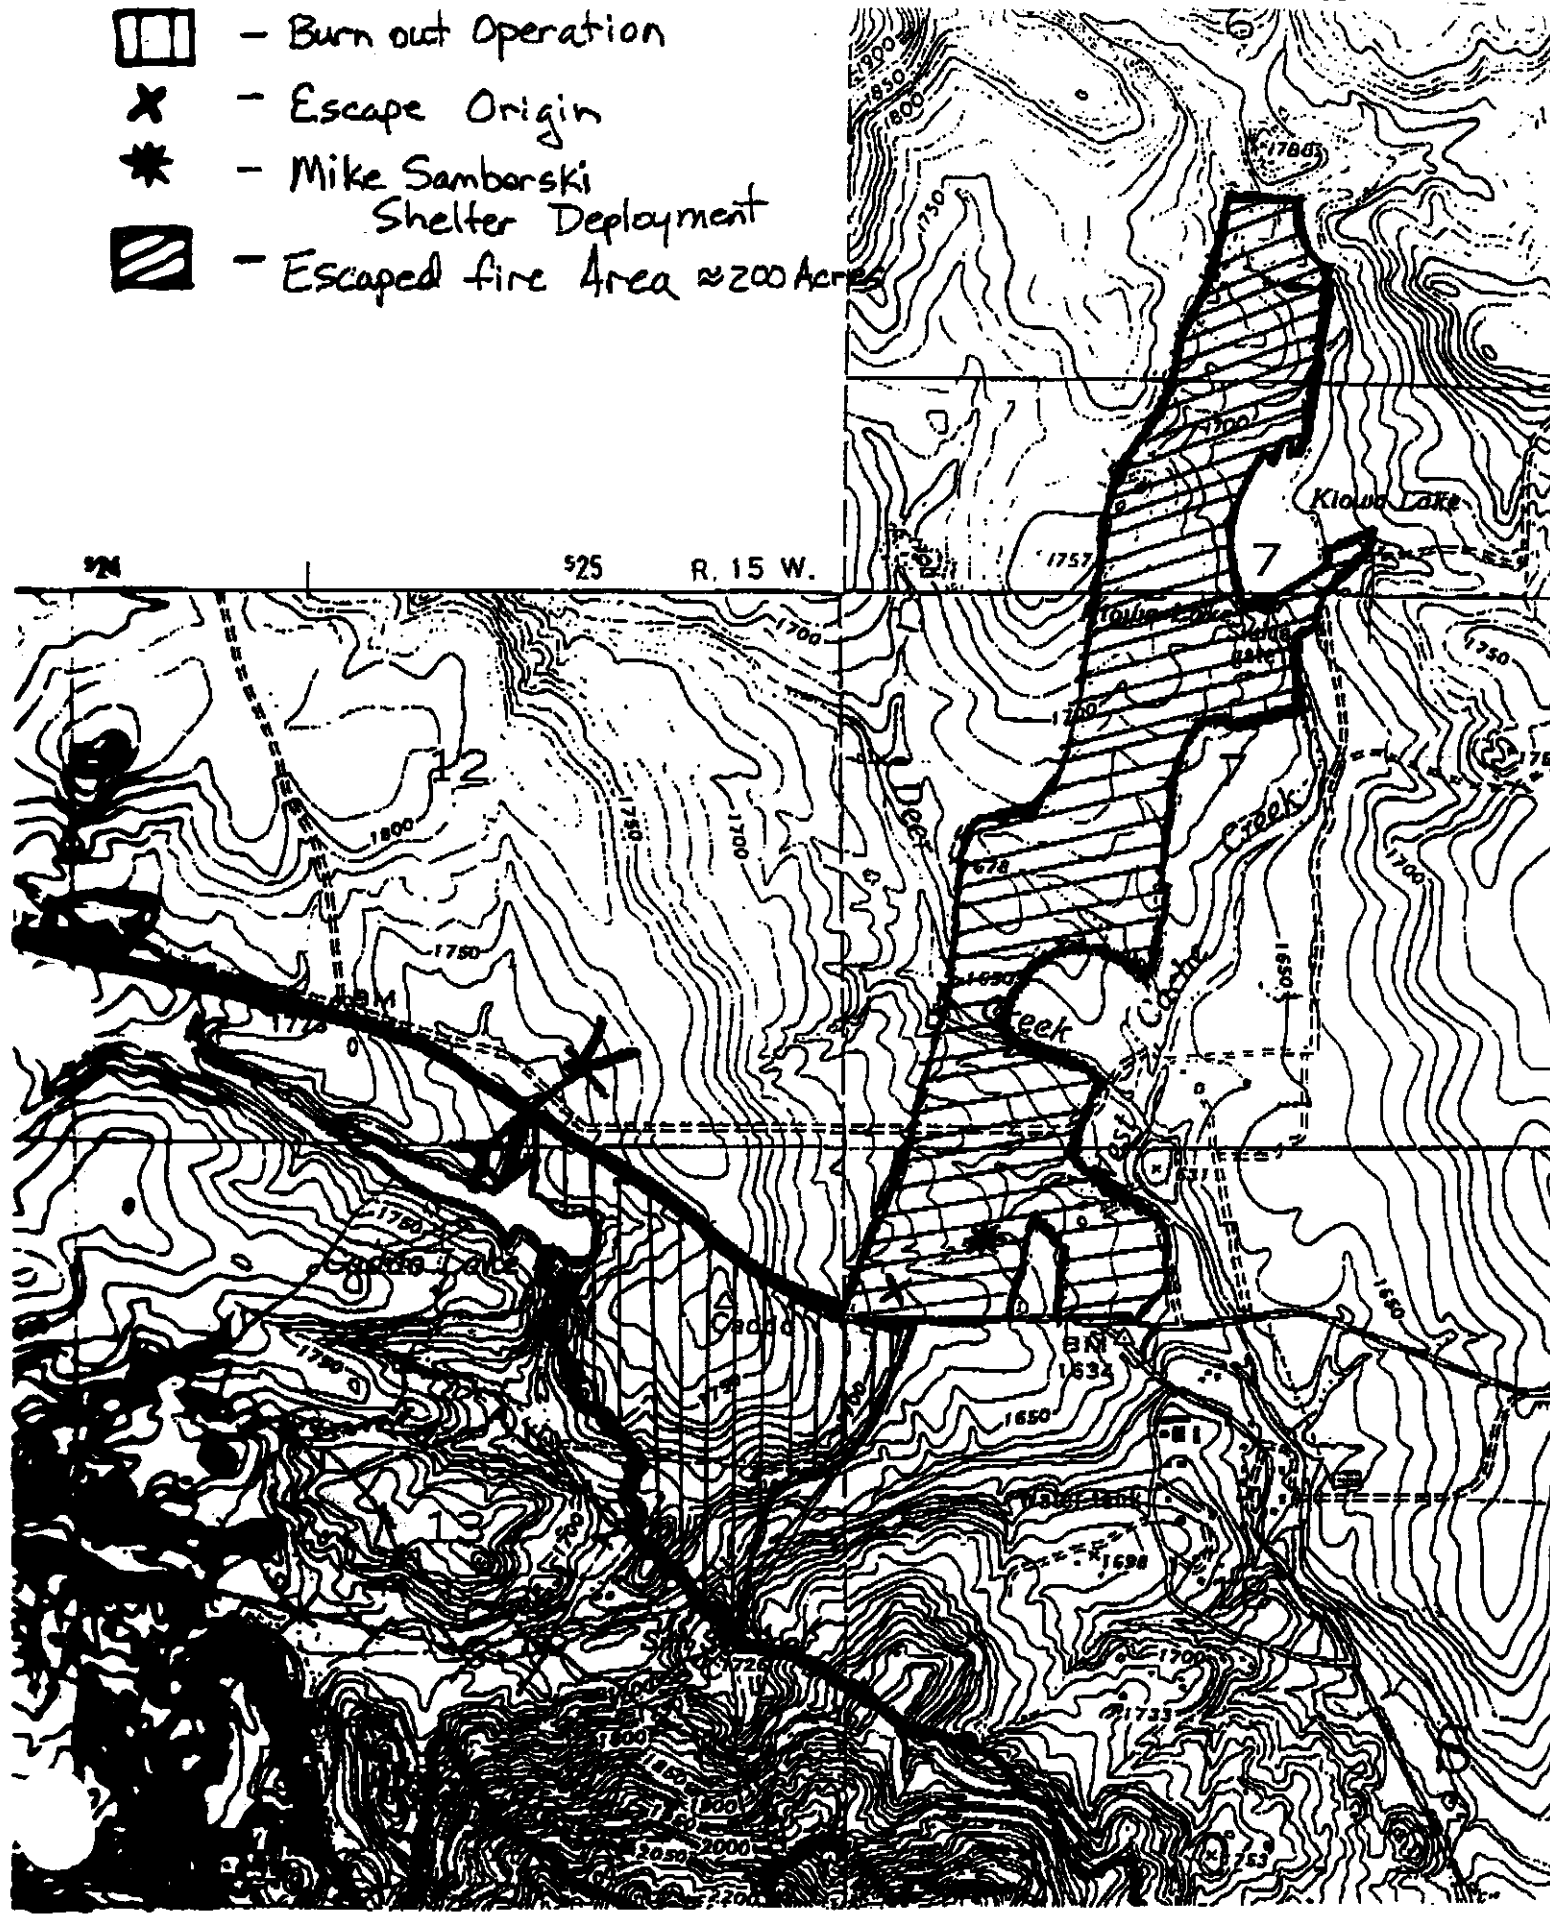
- Burn out Operation
-

- Escape Origin
-

- Mike Sambariski Shelter Deployment
-

- Escaped fire Area ≈ 200 Acres

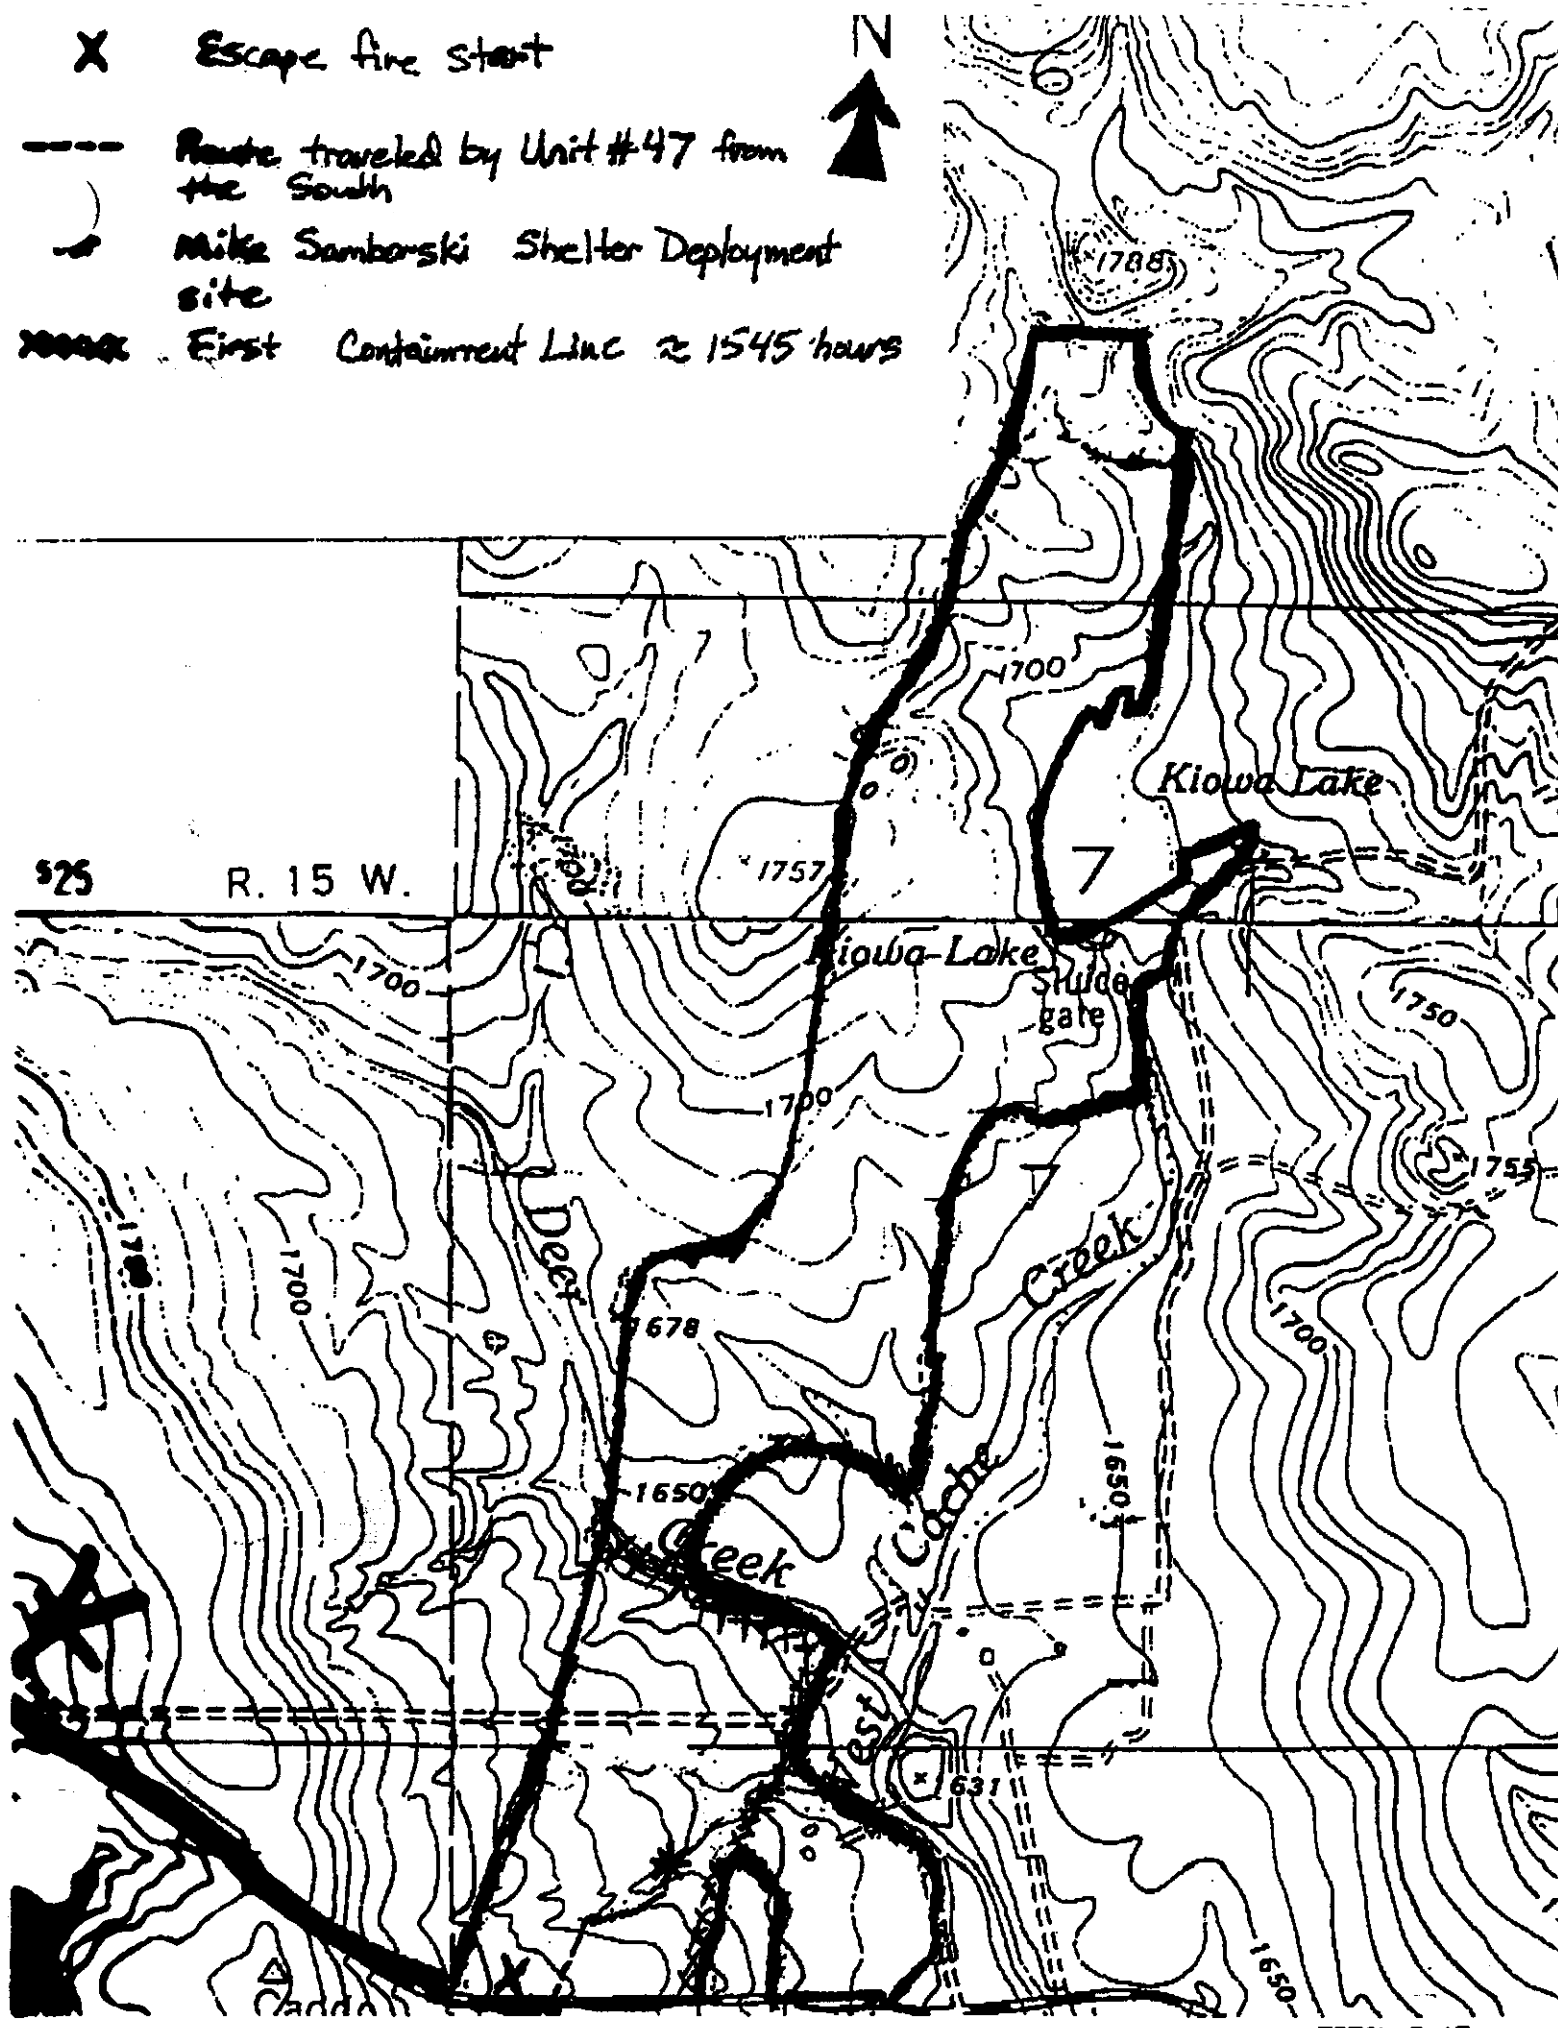
- X Escape fire start
- Route traveled by Unit #47 from the South
- ⌋ Mike Samborski Shelter Deployment site
- ⊞⊞⊞⊞ First Containment Line ≈ 1545 hours
