# Rapid Lesson Sharing

**Event Type:** Tree Falls onto  
Moving Vehicle

**Date:** August 27, 2015

**Location:** Chelan Complex,  
Washington State

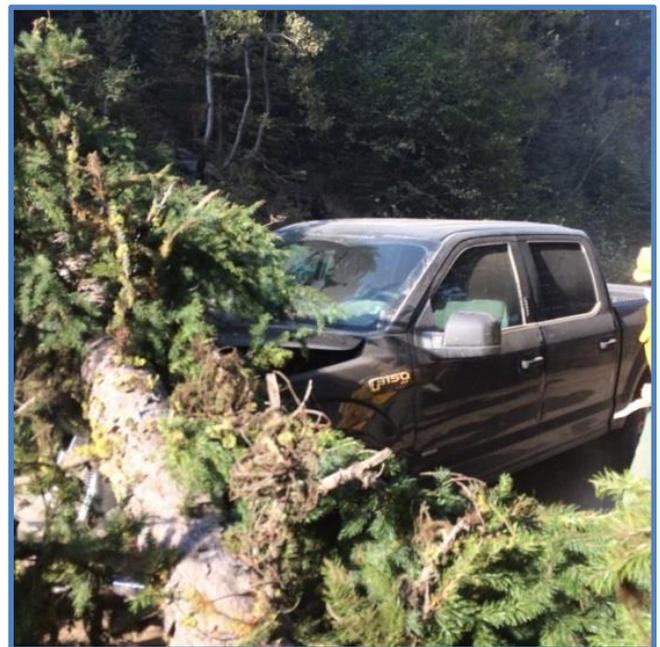
At approximately 0900 while traveling south on USFS Road 3107 from the Black Canyon Road to Drop Point 75 on the Chelan Complex, an incident rental pickup truck (2015 Ford F150) was impacted by a falling green spruce tree (estimated 14-inch DBH) that fell from a six-foot cut bank above the road. The tree landed directly on the vehicle's hood (see photo).

**Top Photo:** This green 14-inch DBH spruce tree (whose roots had burned through—see photo below) falls onto the moving rental vehicle. **Bottom Photo:** Burned out root system of the spruce, located above the road on top of a six-foot cut bank. The tree's base was not visible to the driver.

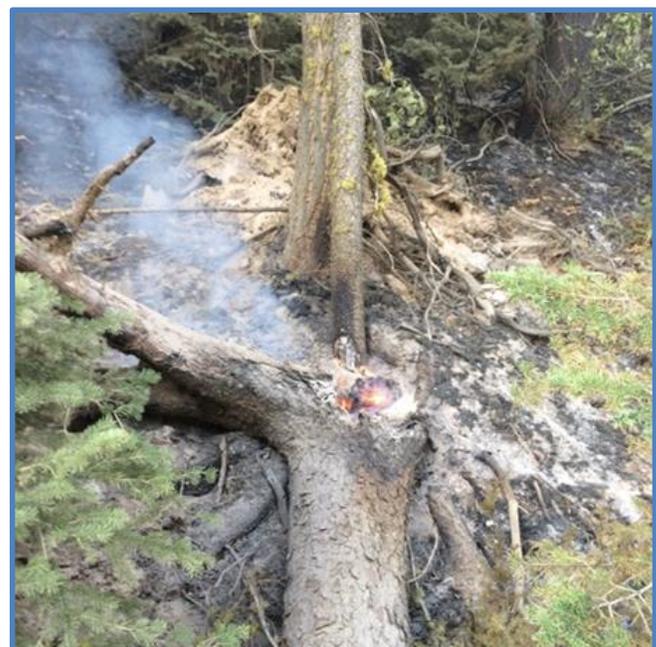
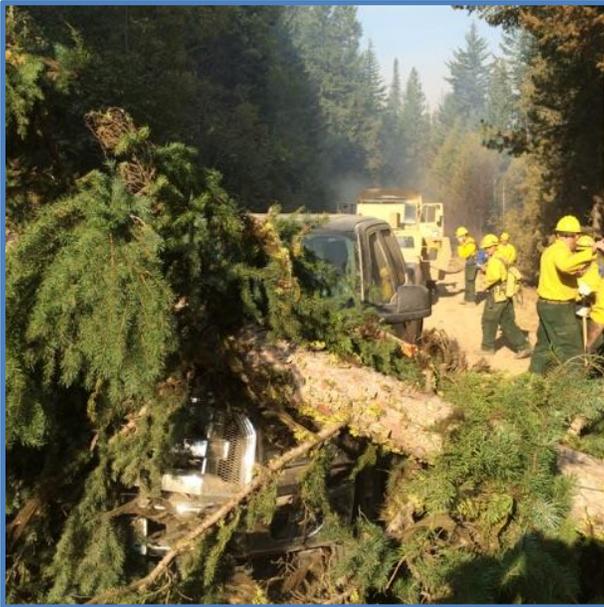
Crews used a chainsaw to cut the tree away from the vehicle.

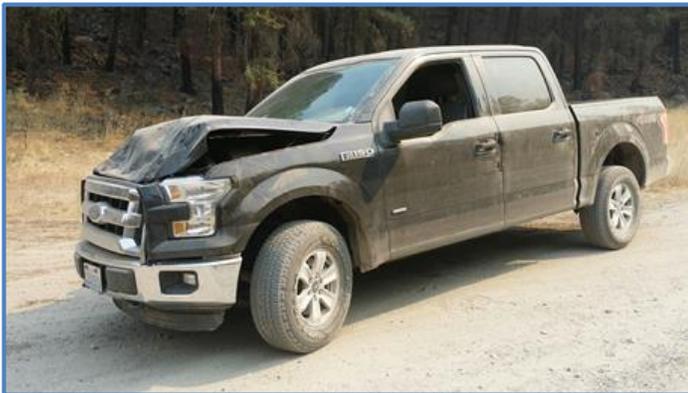
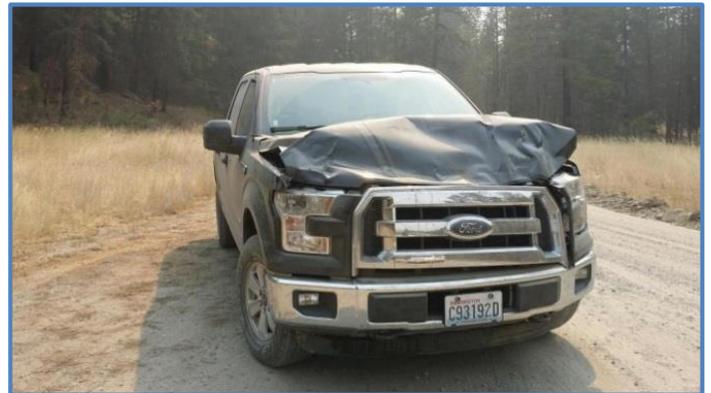
### Damage to the Rental Vehicle: No Human Injuries

Fortunately, the vehicle's operator was not injured. The vehicle received considerable front-end damage (see photos).
