# Rapid Lesson Sharing

**Event Type:** Fuel Geyser Incident

**Date:** April 27, 2020

## Insights and Lessons from a Fuel Geyser Event

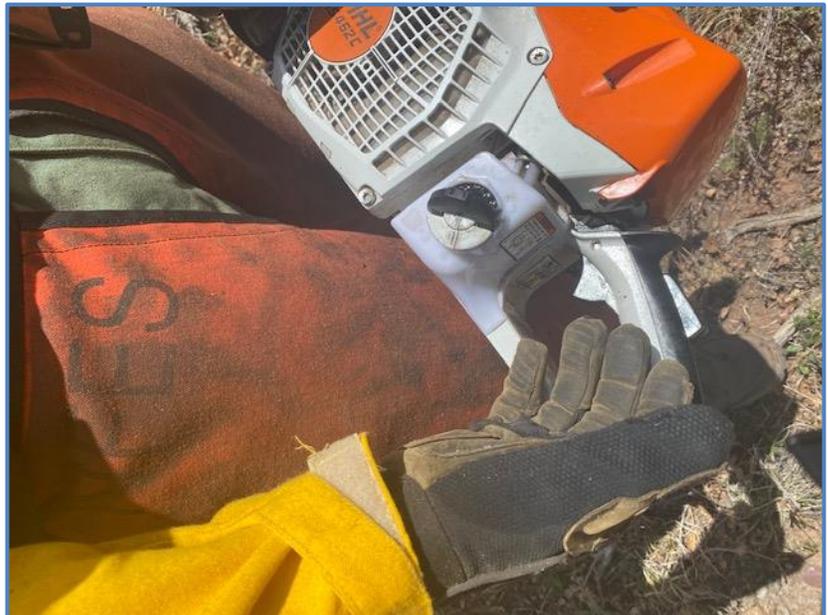
**The sawyer's gloved hand and chaps were soaked in saw gas from the fuel geyser incident.**

Several minutes later, the sawyer cautiously opened the saw's fuel tank—only to be greeted with a geyser of fuel. Because this is exactly what he had anticipated [see sidebar on right], he was able to reduce the geyser's volatility by careful placement of his hand over the fuel cap as he opened it.

Even so, this incident still resulted in his (gloved) hand and chaps becoming soaked in saw gas (see photo). While looking into the tank we were able to see the fuel actively boiling within it. I was able to capture the fuel boiling condition in this video clip:

This action deflected the spray of fuel (off my palm, into my chaps) as I slowly opened the tank, and then immediately closed it again. The saw was held level throughout, and the remaining pressure was relieved with substantially less spray upon a second careful opening. Inside the fuel tank, the fuel was boiling constantly.

This awareness was due to repeated discussions of this hazard over the last few years. Specifically, these similar symptoms were present when I experienced a powerful geyser on the fire line in 2017—although, those conditions were much more extreme (ambient temperature of 105 degrees or more). Thanks to the repeated LLC discussions, I have developed a habit of covering the fuel cap with a gloved hand when opening.
