Stanza Fire Engine 11 Accident Investigation Report

Accident Investigation Factual Report

Accident: Stanza Engine 11 Investigation
Location: Happy Camp Ranger District, Klamath National Forest
Date: July 28, 2002

**Accident Investigation Factual
Report and Management
Evaluation Report**

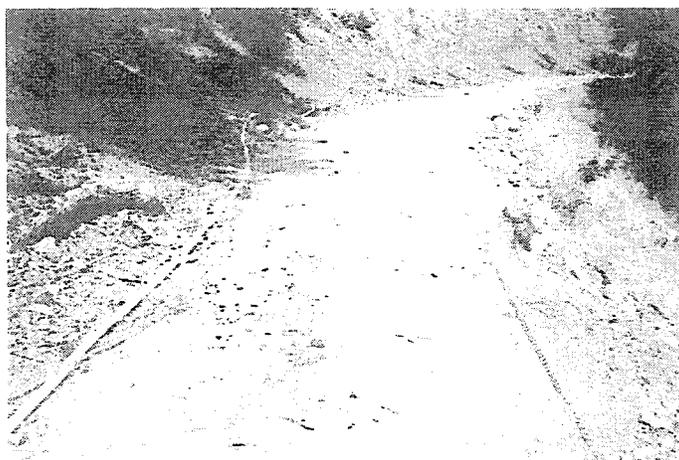
Figure 4b. Closeup of road surface on 15N03A. Note: Hose at left was not present at time of accident.

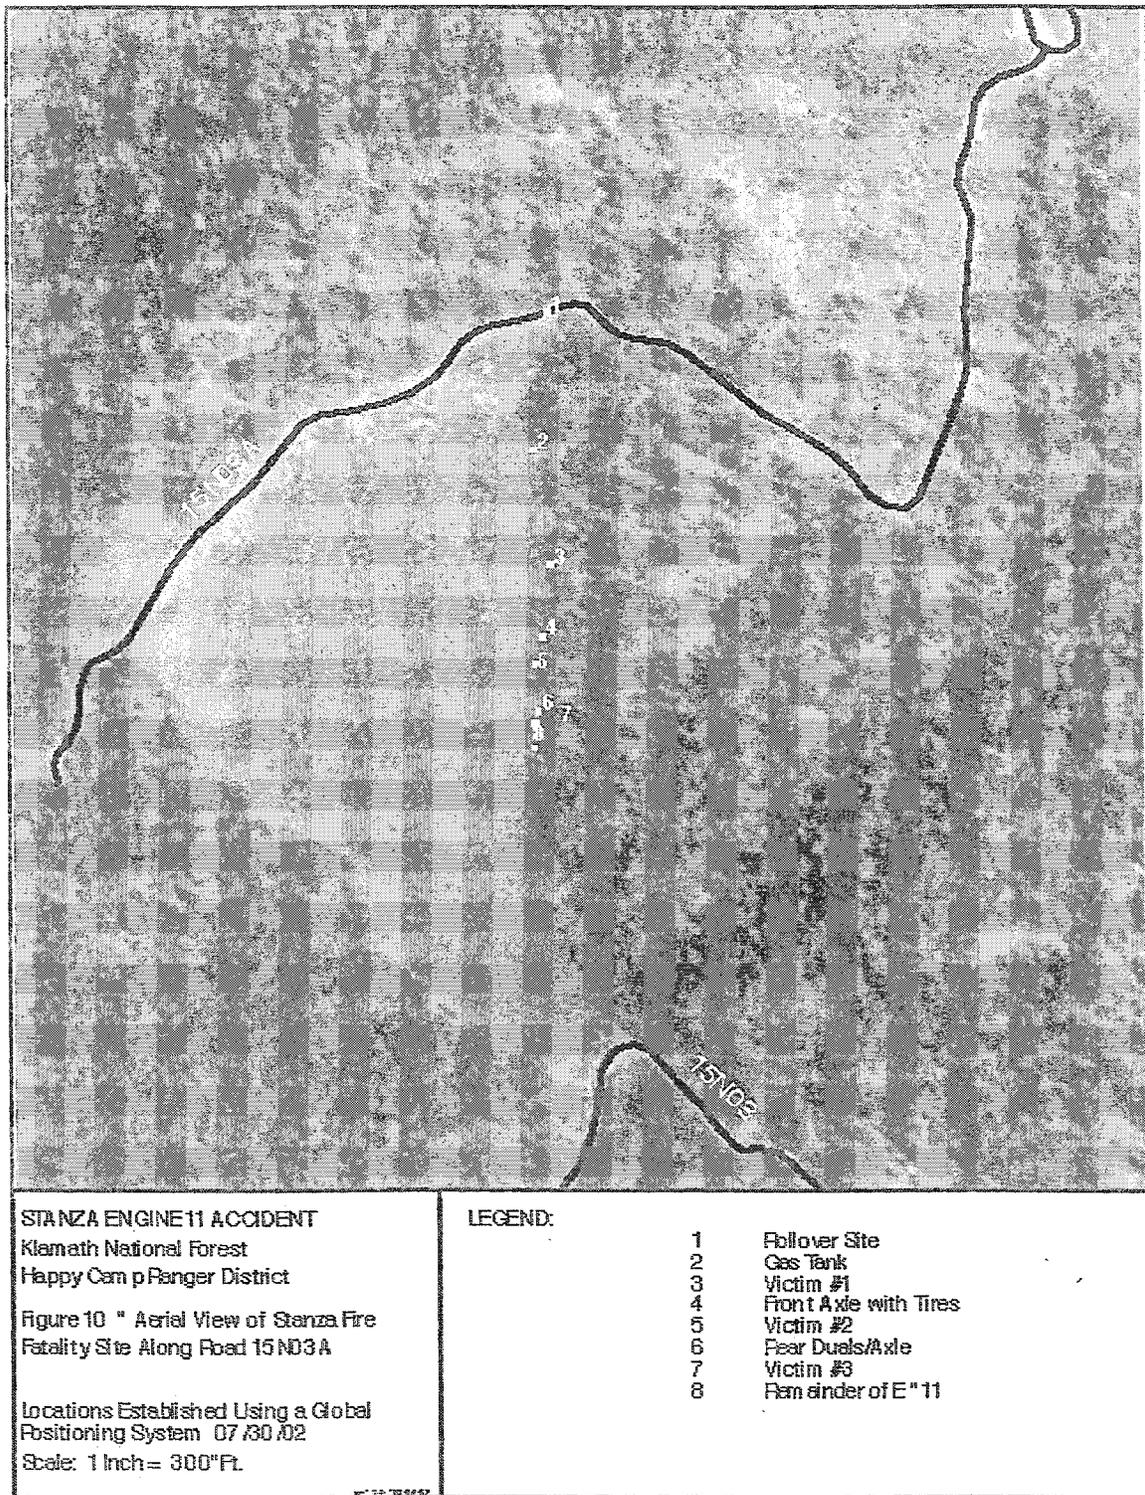
Figure 10. Aerial view depicting rollover route of E-11 down the hill.

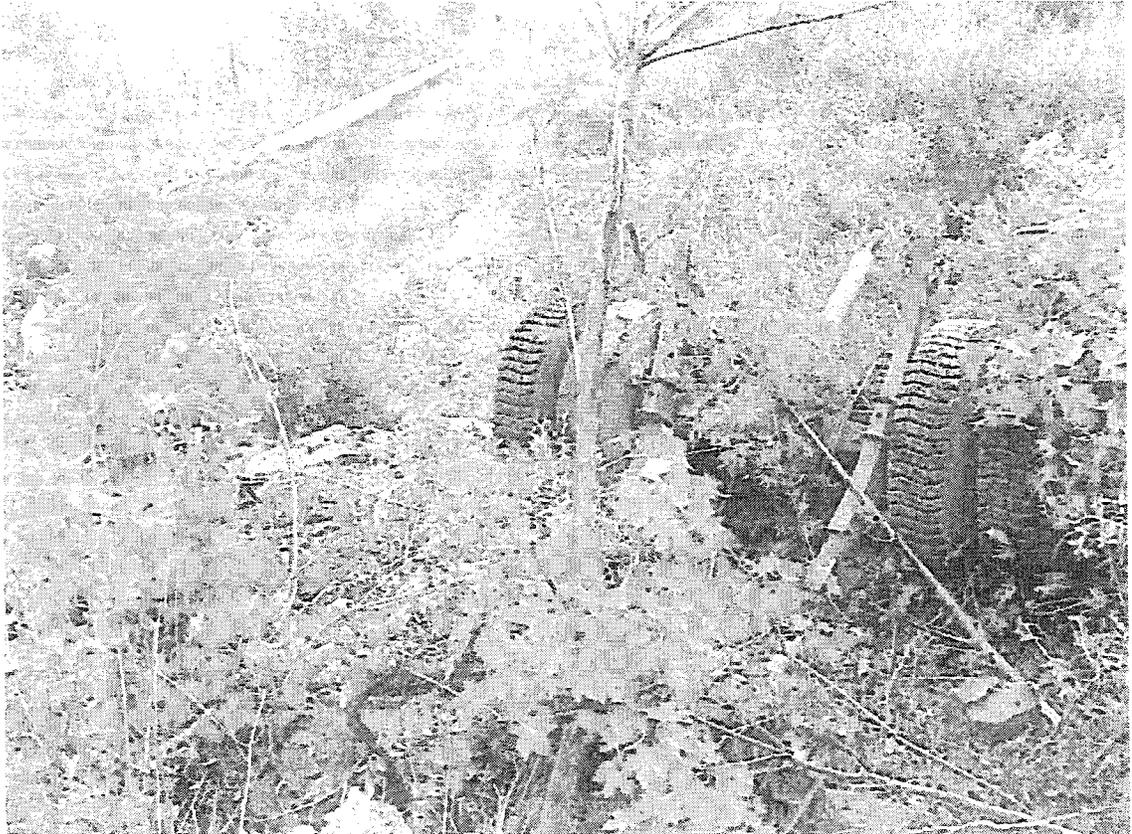
The forces generated on the Engine during its downhill roll caused the axle assemblies, motor and transmission to break away from the vehicle (Figure 12). The rear crew compartment, although deformed, remained relatively intact. Examination of the Engine revealed that all seatbelts had been in use at the time of the rollover. The front passenger seatbelt of Steve Oustad was severed by the force of the accident. The seatbelts holding Heather DePaolo and John Self were stretched, but the buckles were still engaged. The seatbelts for Smith and Glover were both still buckled when the Engine rolled to a stop, and were released by them to exit the vehicle.

Figure 12. Rear axle of E-11 looking downhill; passenger compartment is beneath horizontal log at upper left.

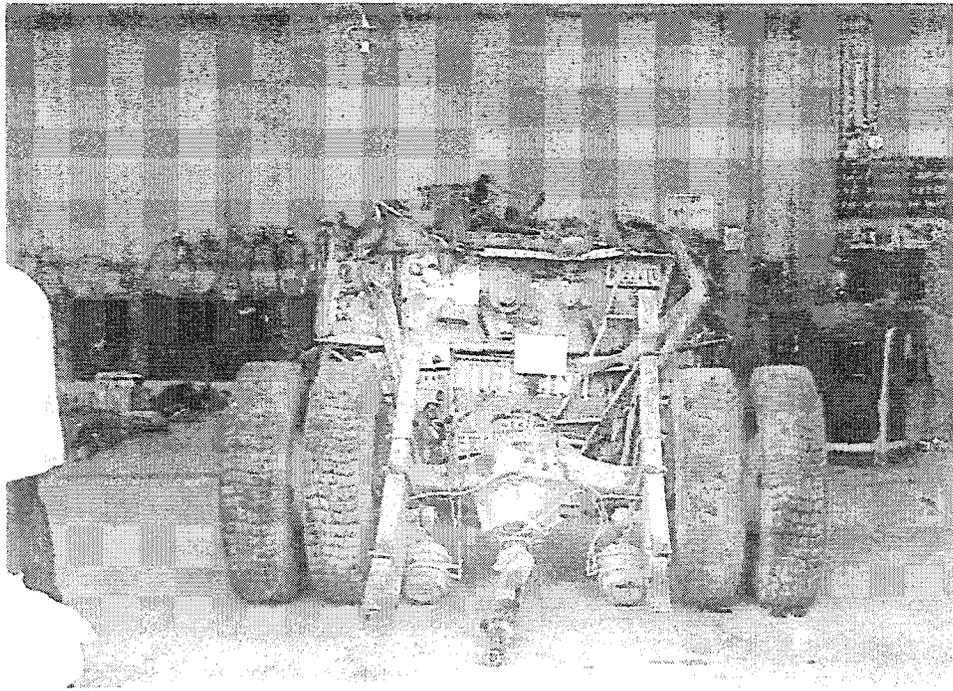
According to maintenance records, the tires on E-11 had approximately 22,000 miles on them. However, examination at the accident site found the left rear inside dual tire was very worn (Figure 13a and 13b). The condition of this tire does not match the others; it appears to have been installed as a spare tire, but there is no documentation as to when it was installed. It is not mentioned in the latest Preventive Maintenance check. The tire that should have been on the Engine was later found in the warehouse at the Almanor Ranger District.

Figure 13a. Rear wheel axle of E-11. Driver's side dual tires are on the right.

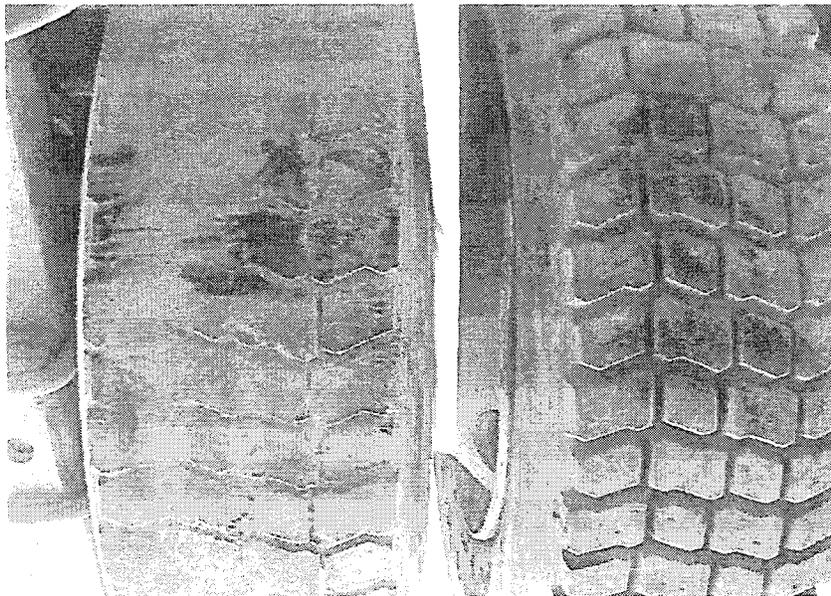
Figure 13b. Rear driver's side dual tires. Outside tire is on the right.

5. The replacement tire on the left rear inside dual tire has significantly less tread than the other tires (not enough tread to meet acceptable standards). (Photographic Evidence Figure 13b)

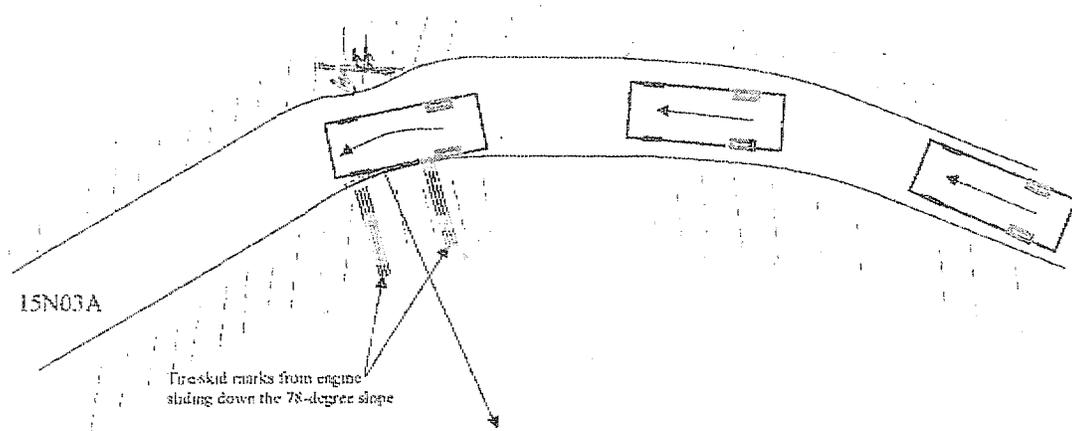
- The Engine position at this time was to the left edge of the road. As the Engine continued through the curve, tracking of the rear drivers' side dual cut the curvature and this combined with the position of the Engine on the outside edge of the travelway caused the tires to slide off travelway (Figure 16).

2. The combination of changed position due to adjustment for people on the right and the visibility issues associated with darkness and the restricted view immediately in front and to the left of the Engine caused a momentary lack of orientation relative to the safe positioning on the travelway at the curve. (Figure 16)

3. The Engine position at this time was to the left edge of the road. As the Engine continued through the curve, tracking of the rear driver side dual tire cut the curvature and this combined with the position of the Engine on the outside edge of the travelway caused the tires to slide off travelway. (Oney Statement, Goad and Gabbard Statement, Glover Statement, Smith Statement)

Figure 16. Projected drive path of E-11 at time of rollover (drawing not to scale)

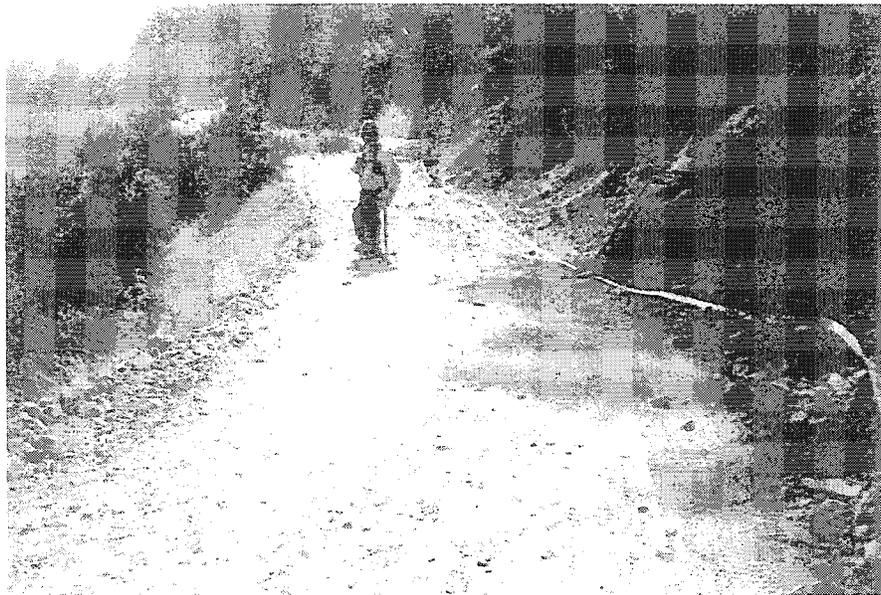
3. There was no vegetation close to road 15N03A within 200 feet of the rollover site in either direction that would impair driver vision. (Photographic Evidence Figure 17)
4. Two people sitting or standing above the road approximately 4 feet from the travelway were in the direct view in the headlights of E-11 as it approached the rollover site. (Wilkenson Statement, Smith Statement, Glover Statement)
5. The surface of the road is not visible less than 28 feet from the driver position due to the Engine hood configuration. (Measurements)

Figure 17. View of rollover site. Note that there is no vegetation along edge of Road 15N03A to affect visibility.

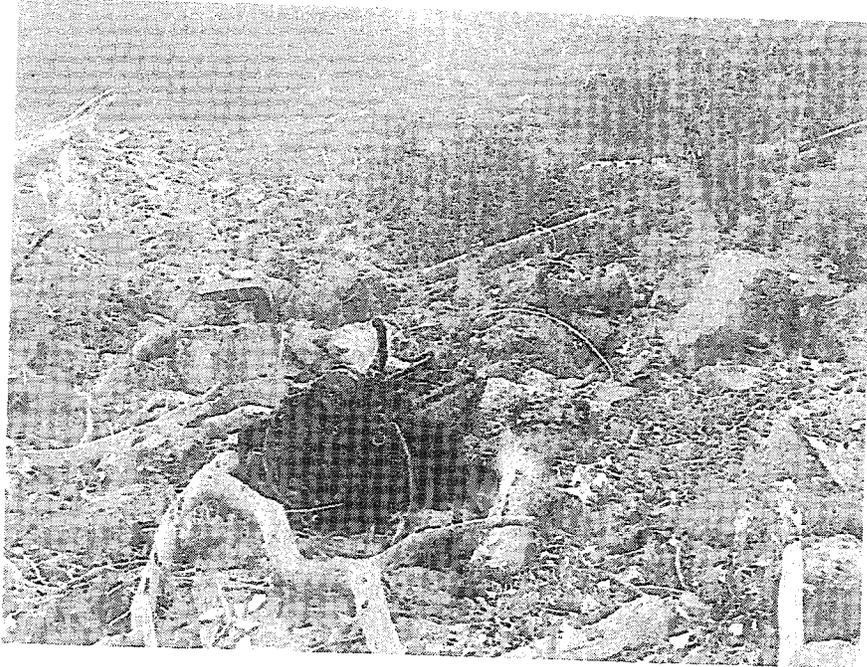
this down hill roll caused E-11 axle assemblies, engine, and transmission to break away from the vehicle. (Photographic Evidence Figure 20)

Figure 20. Motor from E-11.

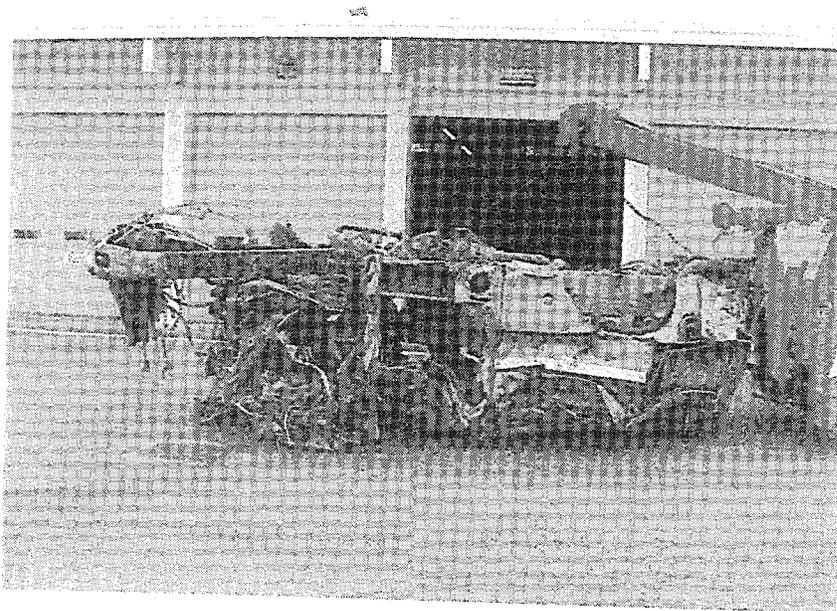
9. All seat belts had been used. The front passenger seat belt was severed during rollover. (Photographic Evidence)
10. The crew compartment (rear portion), with two surviving passengers, was relatively intact with the doors missing. (Photographic Evidence Figure 21)

Figure 21. Passenger side view of E-11 (vehicle is upside down).
