Rapid Lesson Sharing

Event Type: Road/Egress Blockage

Date: September 10, 2017

How Do You Adjust Your Plan When Your Egress has been Effectively Blocked?

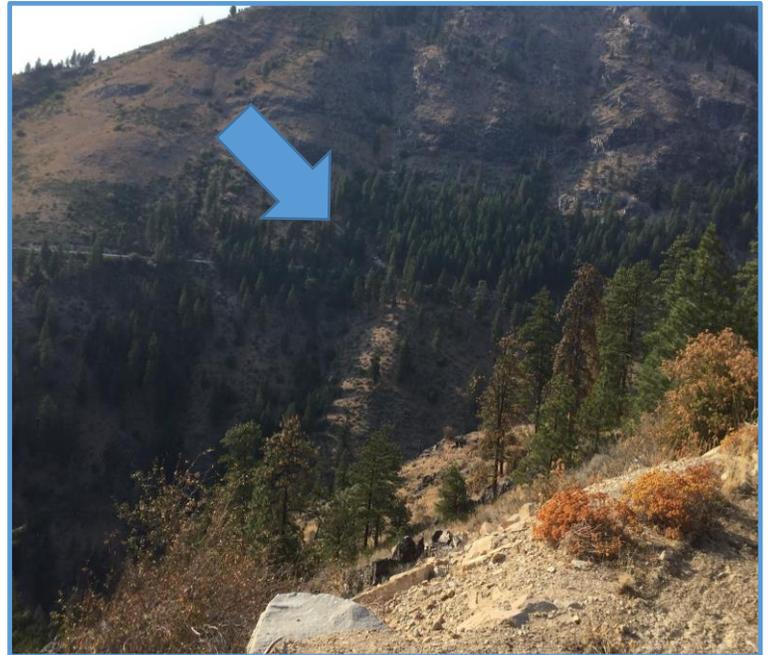
Example of the steep topography along the Grade Creek Road. Blue arrow approximates where the excavator was blocking the road across the canyon in the timber.

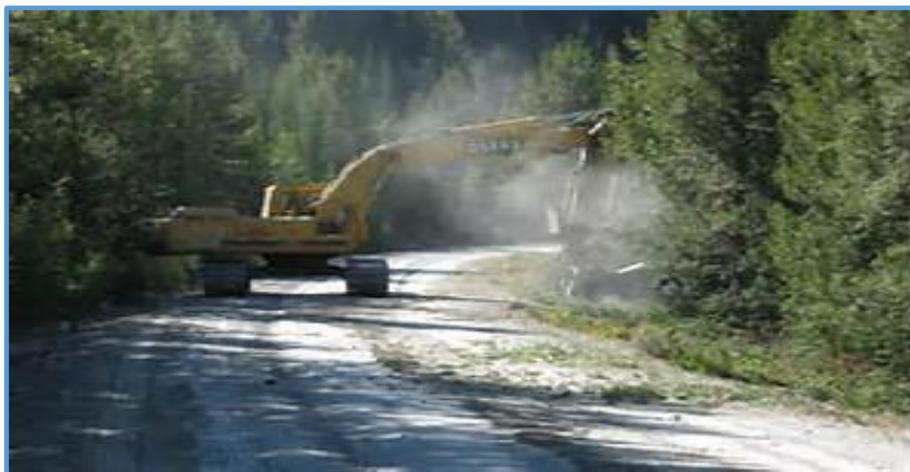
Example of how an excavator with masticator can effectively block a narrow road. (This is not the excavator from this incident.)

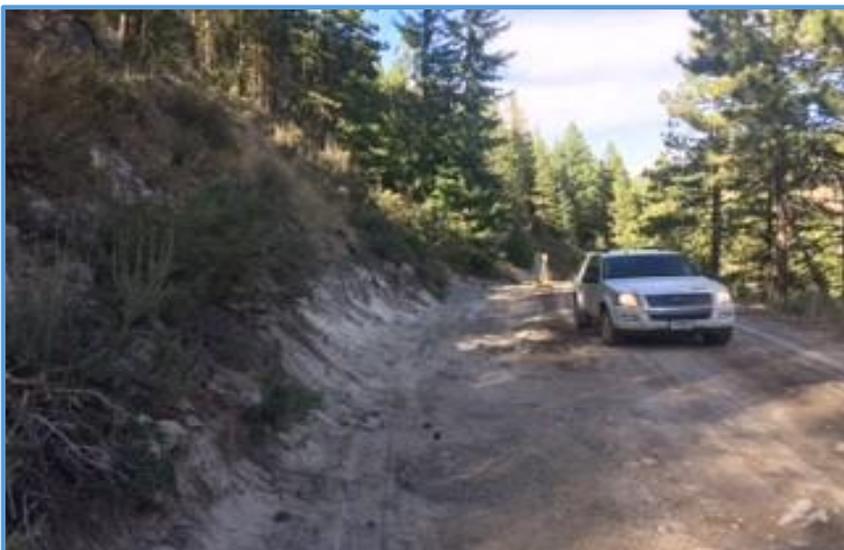
At approximately 1630, while walking the equipment closer to the fire, the larger of the two excavators had an equipment failure. The operator was unable to move the machine—that was now blocking the primary egress from the fire.

The vehicle is parked where the broken excavator located. Notice the narrow shoulder to the right and the improved detour to the left.

It was determined that the excavator needed a new fuel pump to become functional again. The operators were able to obtain the part the next day, fixing the piece of equipment within 24 hours of the initial breakdown.

The Group Supervisor and Safety Officer were promptly notified of this situation. As the operator and mechanics attempted to get the excavator running again, it was determined that the cut-bank could be dug out and the road widened sufficiently for a standard-sized pick-up to be able to pass by. The next morning, this area was widened even more, allowing Interagency Hotshot Crew vehicles and tenders to pass by. Approval to do this was granted and a back-hoe was utilized for this operation.
