LOOP FIRE REVIEW
ANGELES NATIONAL FOREST
NOVEMBER 1, 1966
TWELVE FATALITIES

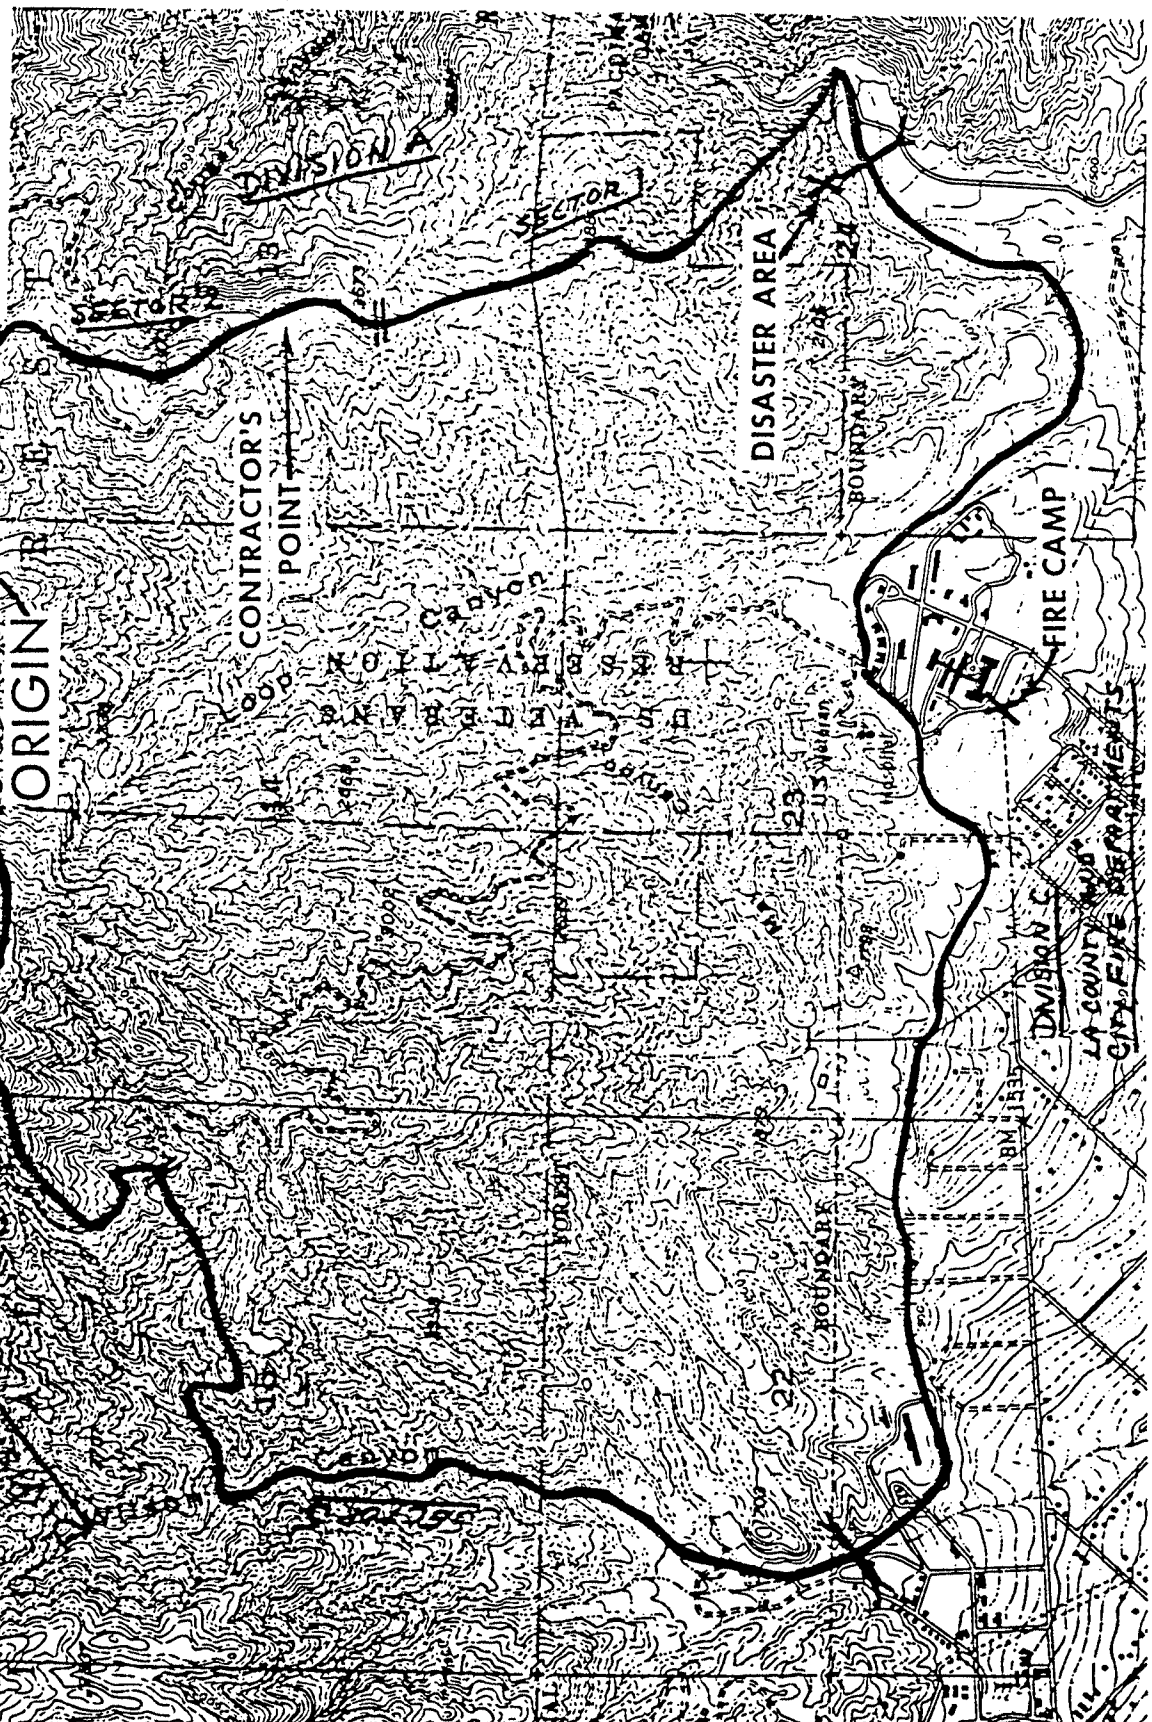
FIGURE 1

The Loop Fire started on November 1, 1966 in a canyon near the boundary of the Angeles National Forest (see Figure 1). It was caused by a faulty electric distribution line and was spread rapidly by Santa Ana winds. Many factors came together culminating in an accident, later that day, which took the lives of twelve firefighters.

foothills, was the responsibility of the Los Angeles County and City Fire Departments (Figure 1).
