Rapid Lesson Sharing

Event Type: Engine Tire Fire

Date: June 18, 2016

Location: Deer Creek Fire, Wyoming

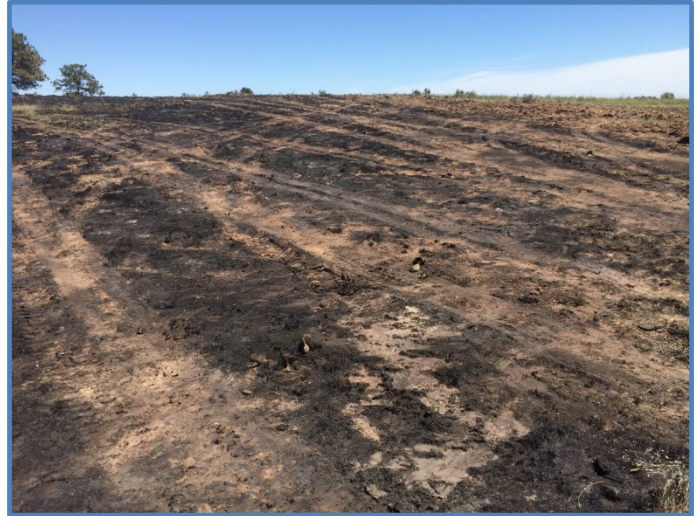
The black where the Type 4 Engine was parked.

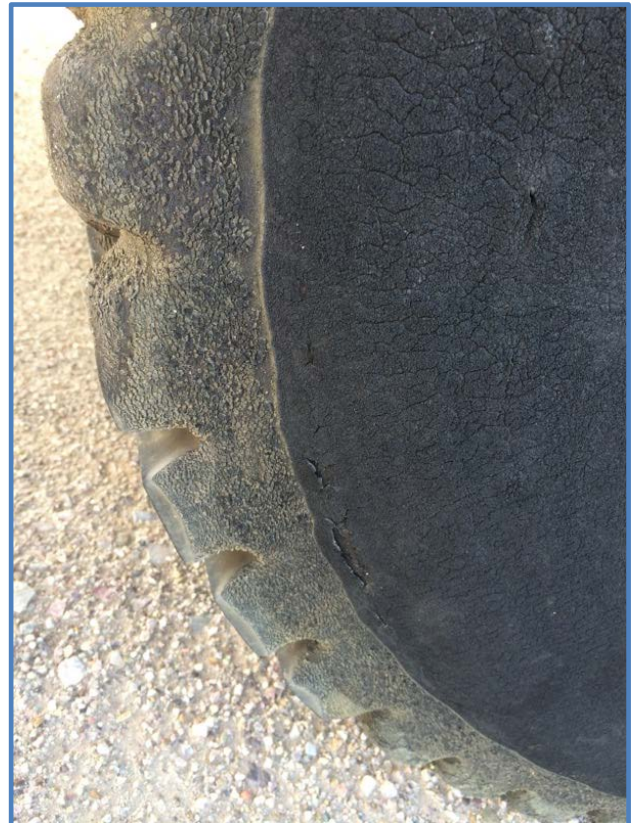
Burn effects on one of the dualies.

Next, the crewmembers began to assess the damage. They initially noticed cosmetic damage to the tires, wheel well, fender flares, and paint. After this initial assessment, they began mechanically assessing the Type 4. At first, they didn't notice anything obvious—until they started-up the Type 4's engine.

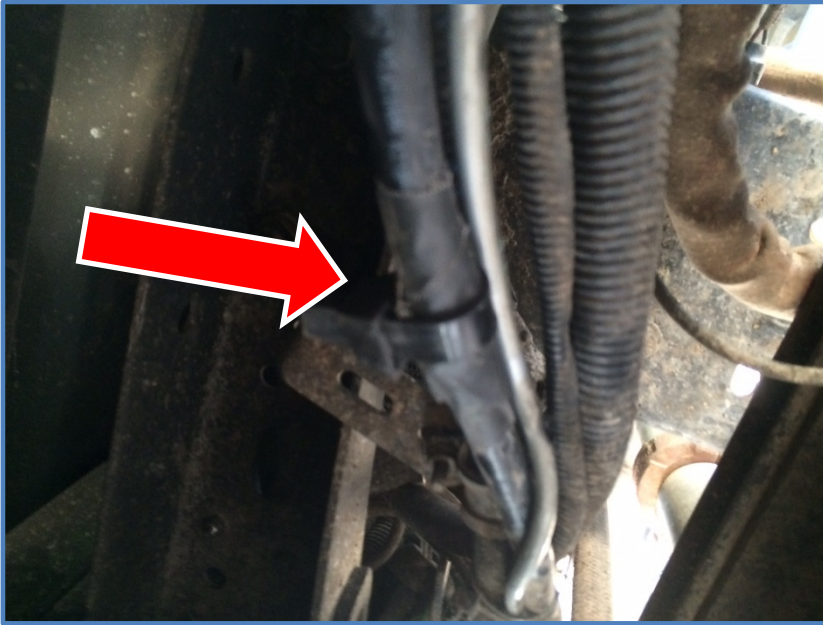
They discovered a hole in the brake air line located approximately three to four feet in front of the right rear axle in the middle of the frame. (Arrow points to where they patched the damaged line with electrical tape and zip tie.)

They heard a noise that resembled an air leak and decided to inspect the entire undercarriage. In doing so, they discovered a hole in the brake air line located approximately three to four feet in front of

the right rear axle in the middle of the frame.

Once they successfully moved the Type 4 into a safer, workable location, they began to assess the damage more thoroughly. At this time, they patched the air line using electrical tape, duct tape, and a large zip tie. This repair was adequate enough to build air pressure in the lines and allow them to safely drive the engine approximately three miles to a more suitable location on pavement where a tow truck could easily access and retrieve the Type 4.
