FILE: FATALITY - 8/11/73 73 DO 12
MARK ARROLLADO, IFF
SAN DIEGO CA

REPORT OF INVESTIGATION
Fatality
Steve Mark Arrollado
Firefighter

Accident
Steve Mark Arrollado
Firefighter
Fatality

August 22, 1973

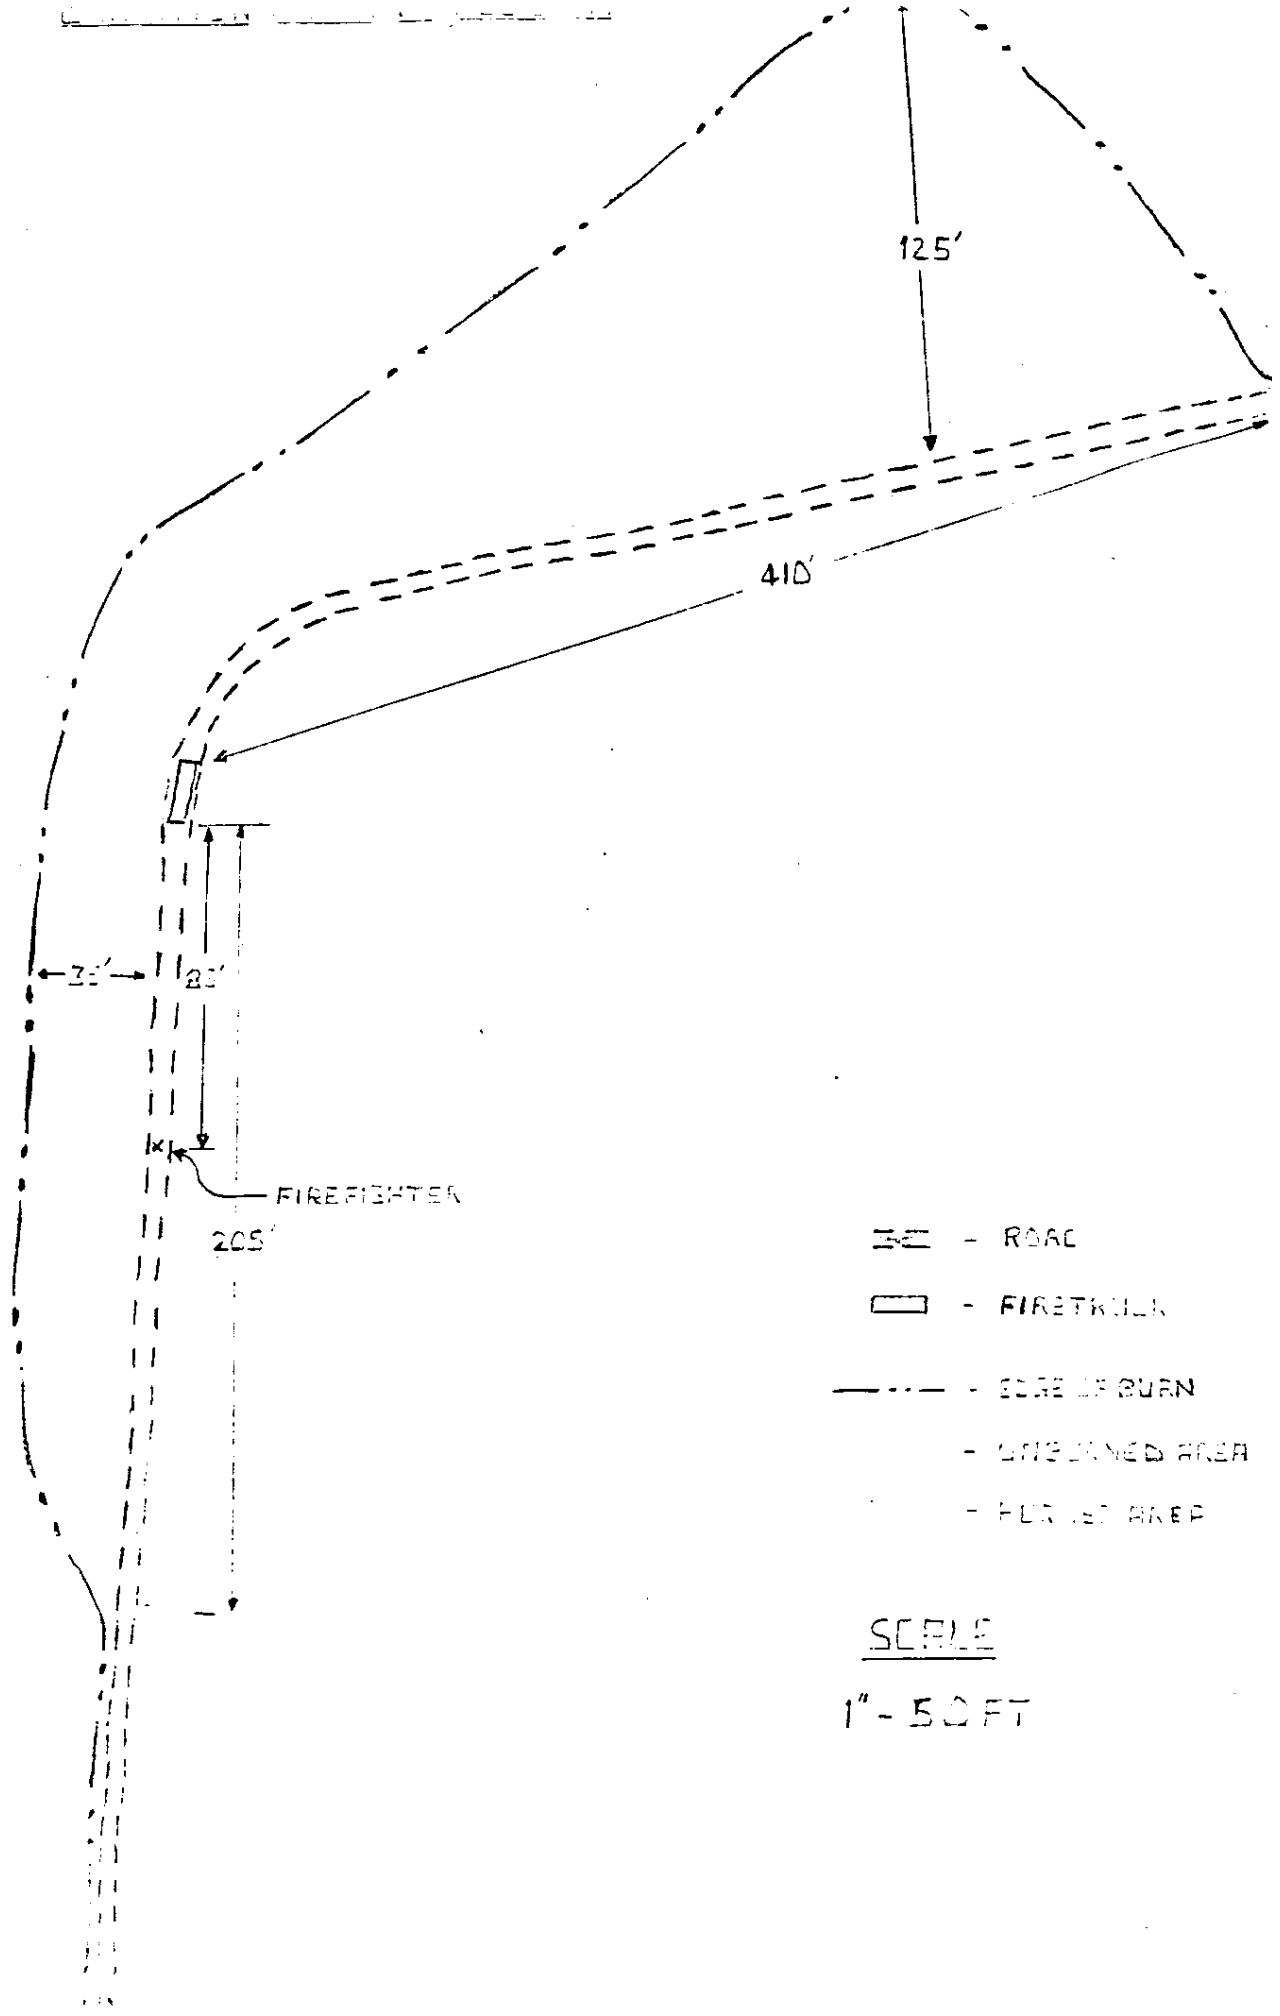
Following the reassignment of Eberhardt, the situation was then as is shown on exhibit 4a with the fire truck commanded by Linton spotted as shown and a single length of 1-1/2 inch hose laid from the fire truck to a point between figures 5 and 6 on exhibit 4. Photograph 1 is the hose lay as seen shortly after the accident. Photograph 2 is a reenactment of the hose lay as it looked to Engineer Linton at the time of the accident. Photograph 3 is a reenactment showing where Arrollado stood as he sprayed the unburned fuel. The hose line was charged with 125 pounds of pressure supplied by the mid-ship pump on the fire truck. The nozzle was equipped with a 3/8's inch tip.

By know flames were crossing the road south of Arrollado with a height of five to six feet and were beginning their sweep to the road directly in front of him. With the public address system on the truck Linton ordered Arrollado, "Get out of there, come to the truck. Get out of there, come to the truck." One or two seconds later Arrollado rose to a crouching position, shut off the nozzle, dropped it, ran over the edge of the road, roughly between points 5 and 6 on exhibit 4, directly into the on coming flames. Footprints and other evidence gathered after the accident show that Arrollado ran down the slope from point 28 on exhibit 4 to the bottom of the gully between points 24 and 25. Photograph number 5 is a reenactment of Arrollado leaving the roadway and beginning his run into the fire. Photograph number 6 is a reenactment of him running down the steep slope below the roadway. During this time, Arrollado covered a linear distance of approximately 30 to 40 feet, traveling through heavy flames. Upon reaching the bottom of the gully Arrollado climbed up the very steep western bank of the dry wash, passing the rock located near point 22. This area is characterized by loose, very rocky soil. Photograph 7 is a reenactment of Arrollado traveling up the western slope of the gully. At the time Arrollado was in this location, the area was still very hot as a result of the fire which had earlier burned through this location. At a location near point 22 pieces of burned cloth from Arrollado's clothing were found. (Photograph 8 and exhibit 4.)

Meanwhile, it is presumed that Arrollado continued to travel from point 22 on exhibit 4 to point 19. Upon his arrival at point 19 Arrollado leaned on a large rock at point 19. (See photograph 9.) An imprint of one knee and one large piece of cloth and three small pieces were found in this immediate vicinity after the accident. Photograph 10 shows the large piece of cloth. Photograph 11 and 12 show the three smaller pieces of cloth found in the same vicinity. Point

30 on exhibit 4 is a smaller rock located adjacent to the larger rock on which Arrollado leaned. Drops of hardened material were found on the east face of this rock. (See photograph 13.) The drops of material at point 30 and shown in photograph 13 are believed to be residue from melted polyester material which made up the clothing worn by Arrollado.
