Rapid Lesson Sharing

Event Name Cutting Project

Location Cutting project site

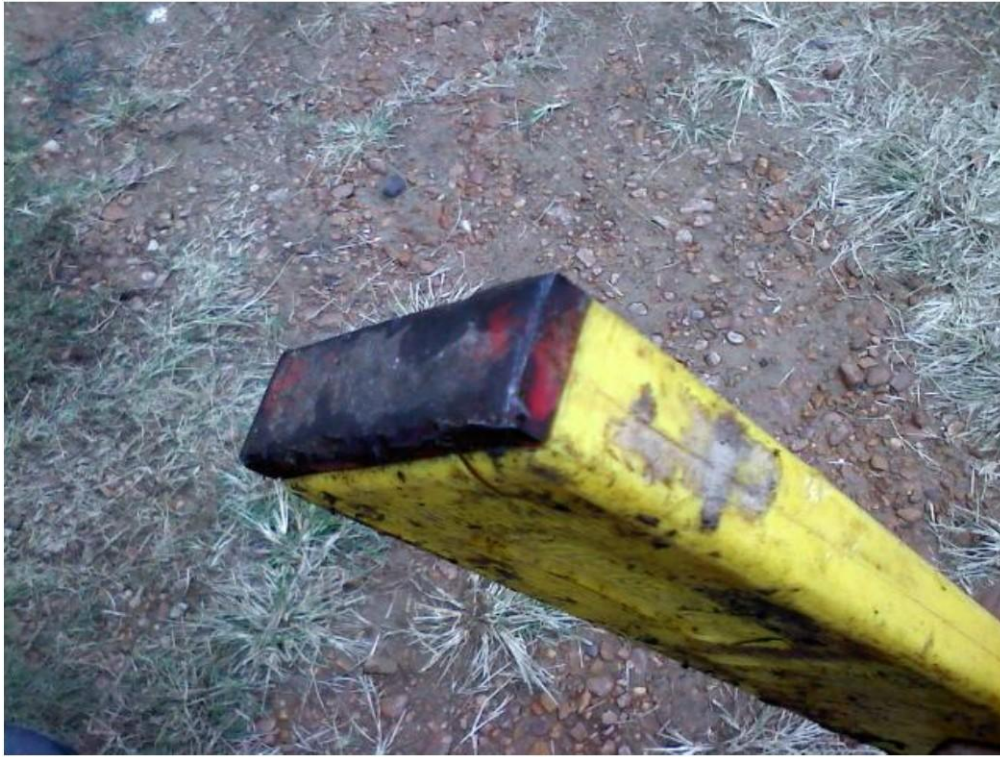
What happened Concerning the wedges with the metal strike plate (1st attachment). While felling an elm 18" DBH, 4'-5' back lean, I did not hit the wedge strike plate flush causing it to break off (2nd attachment). I looked at the wedge it appeared serviceable (less the strike plate) and like any other of the plastic type wedges we use. The tree was set-up and ready to go, so I continued to drive the wedge. Huge mistake, when I struck the wedge the next time the recoil of the ax was violent and unexpected; literally it was all I could do to avoid/stop the ax, narrowly missing the right side of my head.

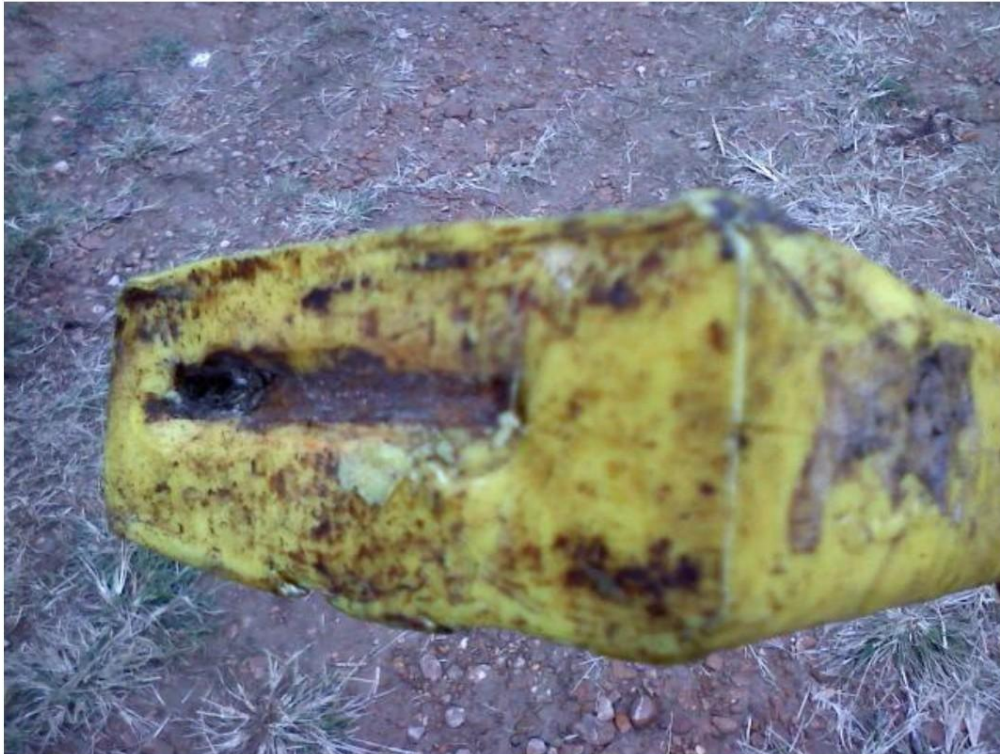
Lessons If you find these type of wedges with the strike plate missing remove them from service, the second image will help you to identify. With the strike plate missing there will be a thin piece of metal embedded in the center of the wedge.
