## ***Appendix D—Equipment Found at H-2 and the Fatalities Site***

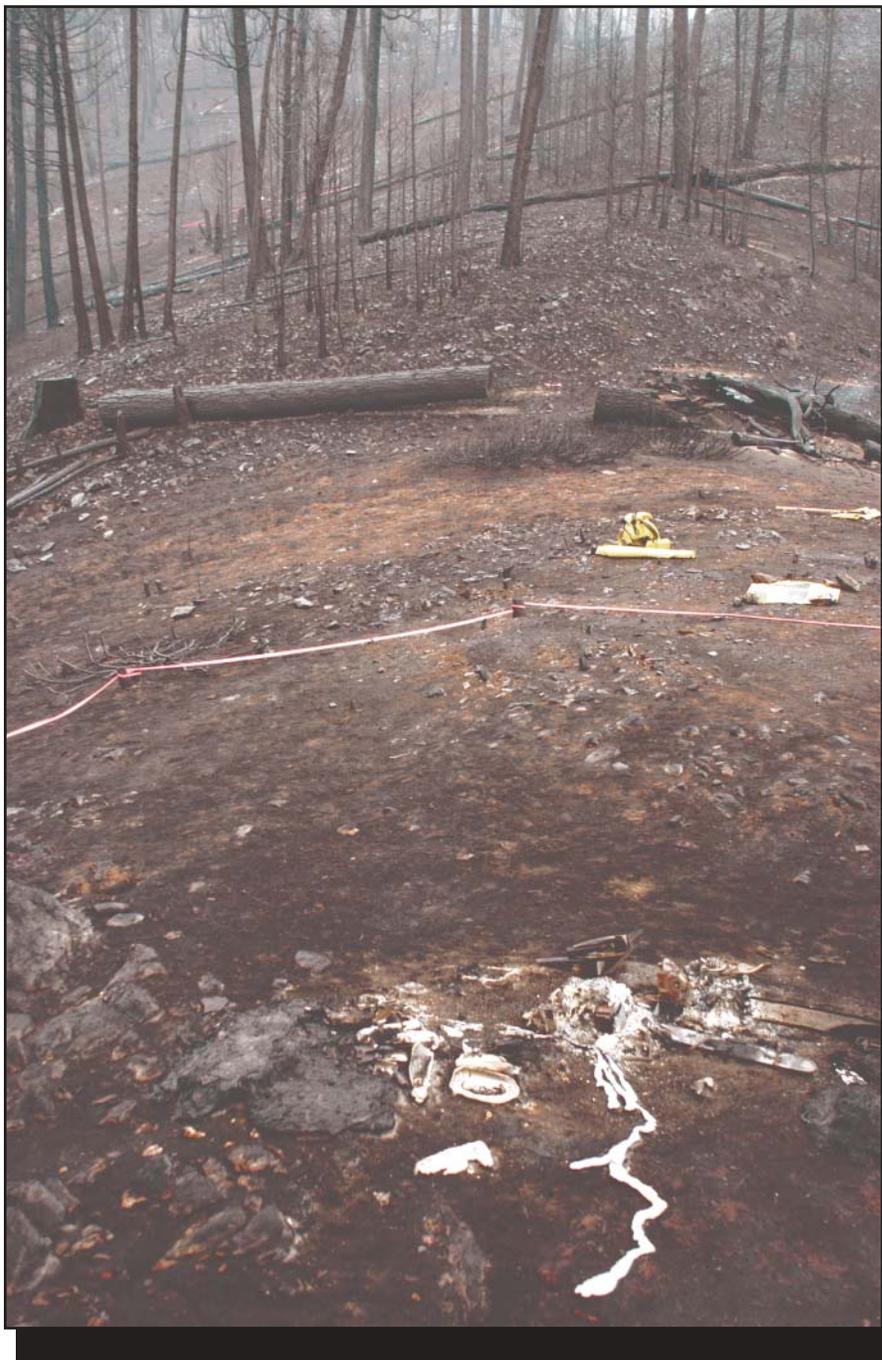
Equipment used by Jeff Allen and Shane Heath for rappelling from H-193 to the ground and for construction of the helispot was found at H-2. The equipment had been readied for transport. One of the saws had been wrapped with chain saw chaps, the hand tools had been wrapped in fiberglass tape, and all of the equipment was stacked in a single pile. Though severely damaged by fire, the stack appears to have contained helicopter rappel equipment, a radio, three hand tools, and two chain saws with associated maintenance tools. Only steel, glass, brass, and some aluminum were still intact. The rest of the material was either consumed or melted by the fire. Some pieces of cast aluminum melted, indicating material temperatures of at least 1,000 °F (photos 1 and 2).

*Photo 1—H-2, chain saws, and rappel equipment.*

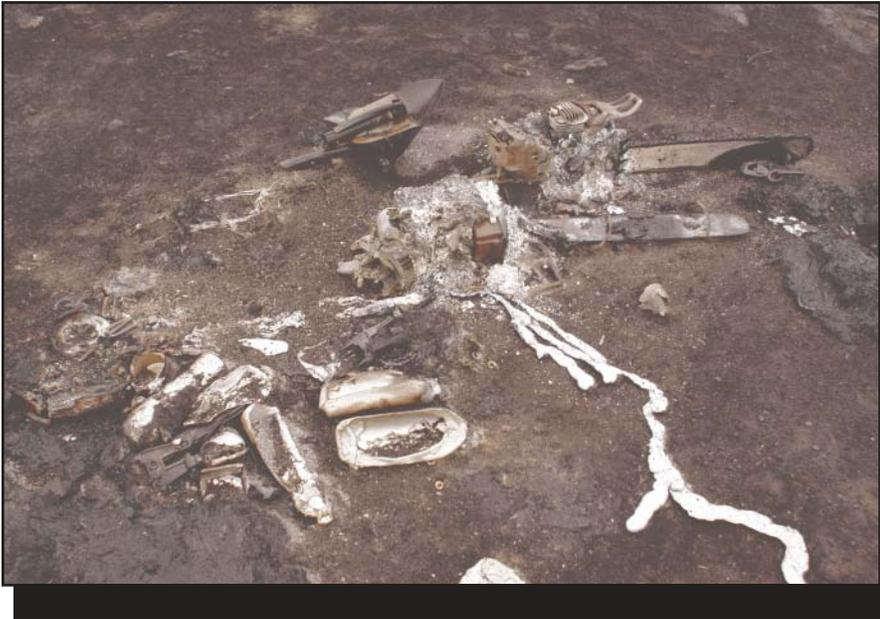
Photo 2—H-2, chain saws, rappel equipment, and melted aluminum.

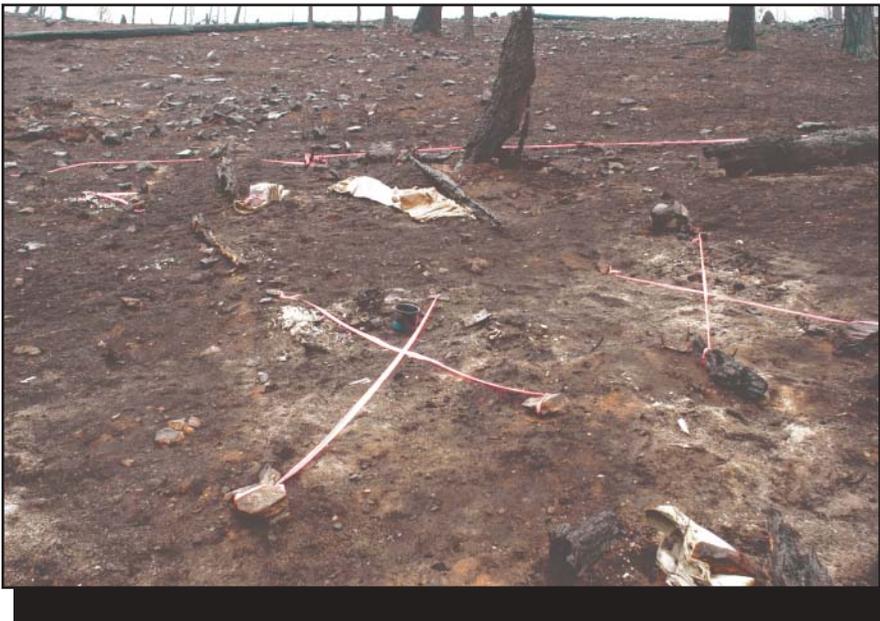
The remains of two fire shelters, personal items such as watches, cameras, keys, and belt buckles, and work-related items, including a radio, carabiners, and batteries were found at the fatalities site. Only steel, glass, and brass items were intact. The glass watch face was distorted as if it had softened. Glass begins to soften when it reaches about 1,100 °F. Two flight helmets on the site were charred, easily compressed, and brittle (photo 3).

Photo 3—Fatalities site, fire shelters, and flight helmets.

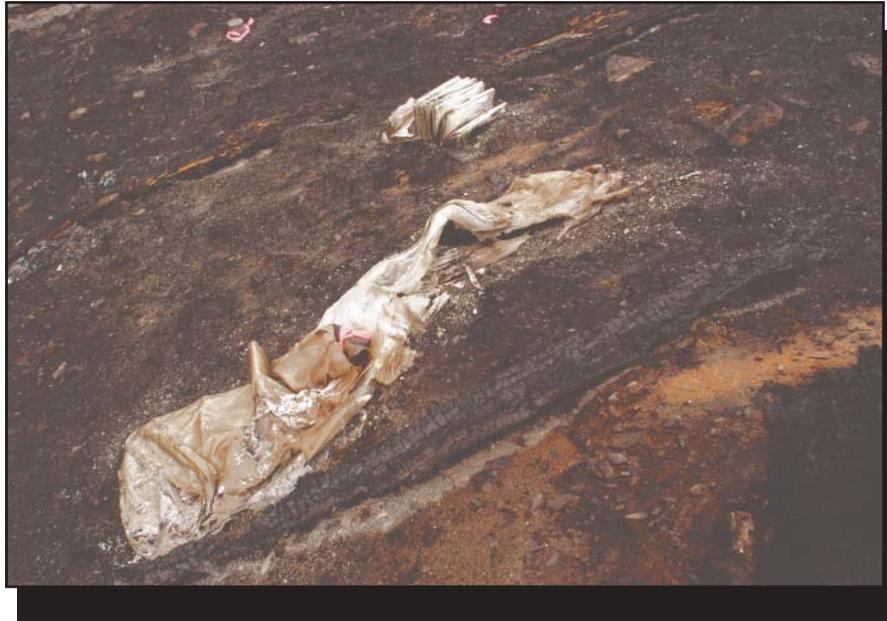
The fire shelters were the older style (NSN# 4240-01-121-8698, NFES# 0169), which meet agency requirements (photo 4). The shelters were separate from other materials, which indicates they had been removed from their packs. One of the shelters was accordion folded in the same shape in which it was packaged, indicating that it had not been unfolded prior to the burnover. The exposed top layers of the folded shelter had no remaining foil and the fiberglass layer was white and

very fragile. Where foil was present on the more protected layers, it was completely delaminated from the fiberglass cloth. Aluminum used in the shelters melts at about 1,200 °F. The fiberglass used in the shelters softens between 1,350 and 1,611 °F. The condition of the exposed fiberglass indicates that material temperatures were within this range.

The second fire shelter was unfolded lengthwise but almost completely folded width-wise. This indicates that the shelter was removed from its plastic bag and partially unfolded prior to the burnover. The foil had melted from 10 of the 12 layers of the shelter and was present on the two layers that lay closest to the ground. Foil that remained had completely delaminated from the fiberglass layer. The fiberglass cloth was white and extremely brittle, indicating that it had reached a softening temperature between 1,350 and 1,611 °F.

Crown fires studied with instruments by MTDC have reached temperatures over 2,000 °F. Temperatures from approximately 1,300 °F have damaged fire shelters, melting aluminum, and fracturing and disintegrating fiberglass cloth. Conditions inside fire shelters tested in these conditions were not survivable. The condition of the partially unfolded fire shelter found at the fatalities site resembled fire shelters tested under these severe conditions. This indicates that the shelter was subjected to temperatures from 1,300 °F to potentially over 2,000 °F.

*Photo 4—Fatalities site where fire shelters were not deployed.*
