# GREEN SHEET

## Shelter Deployment with Burn Injury

Gold Incident

20-CA-LMU-003917

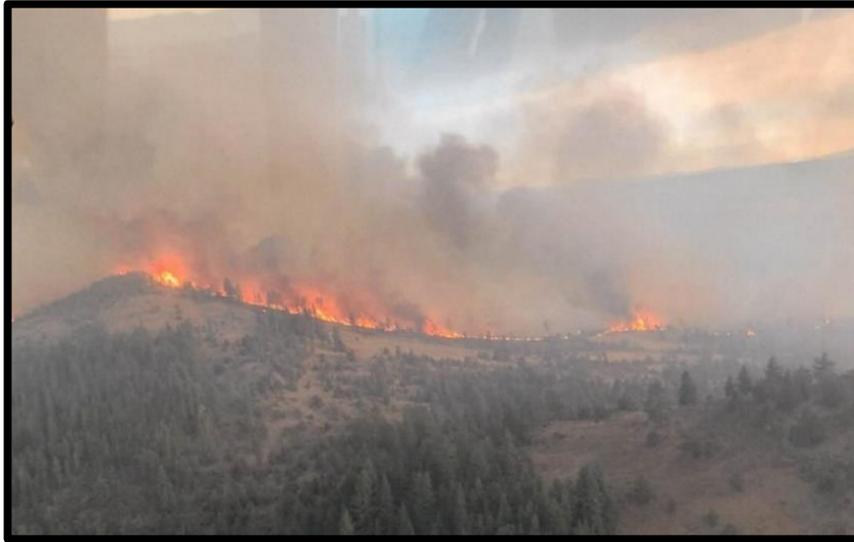
*Photo 1: Aerial photo of fire behavior during initial attack.*

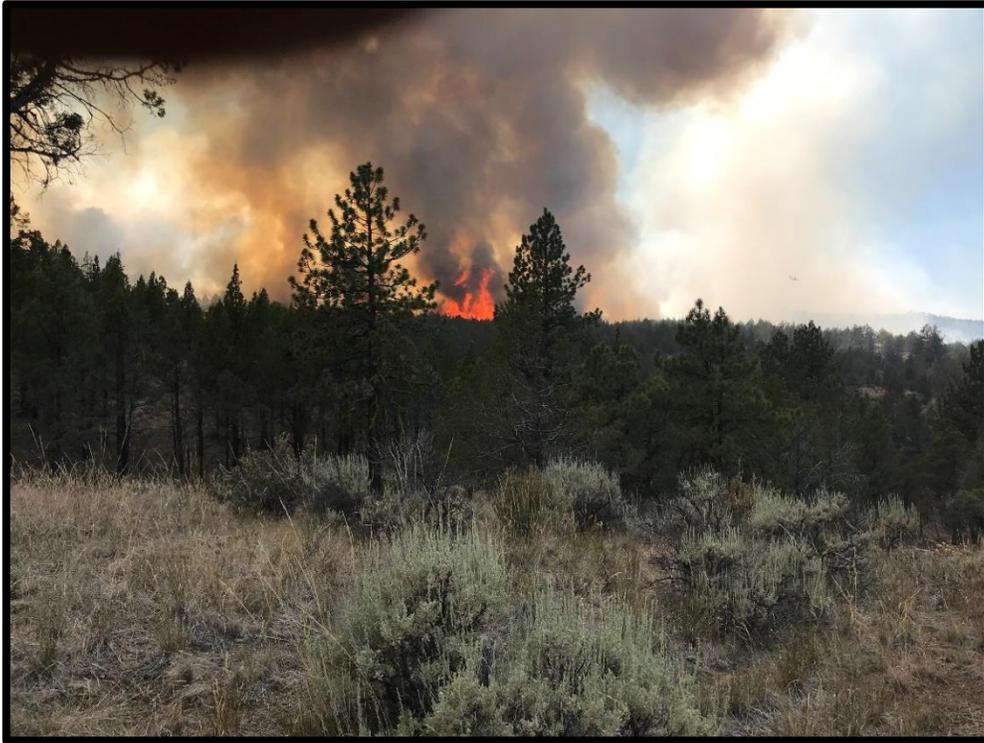
*Photo 2 taken near Green Cabin by E4 personnel prior to assignment.*

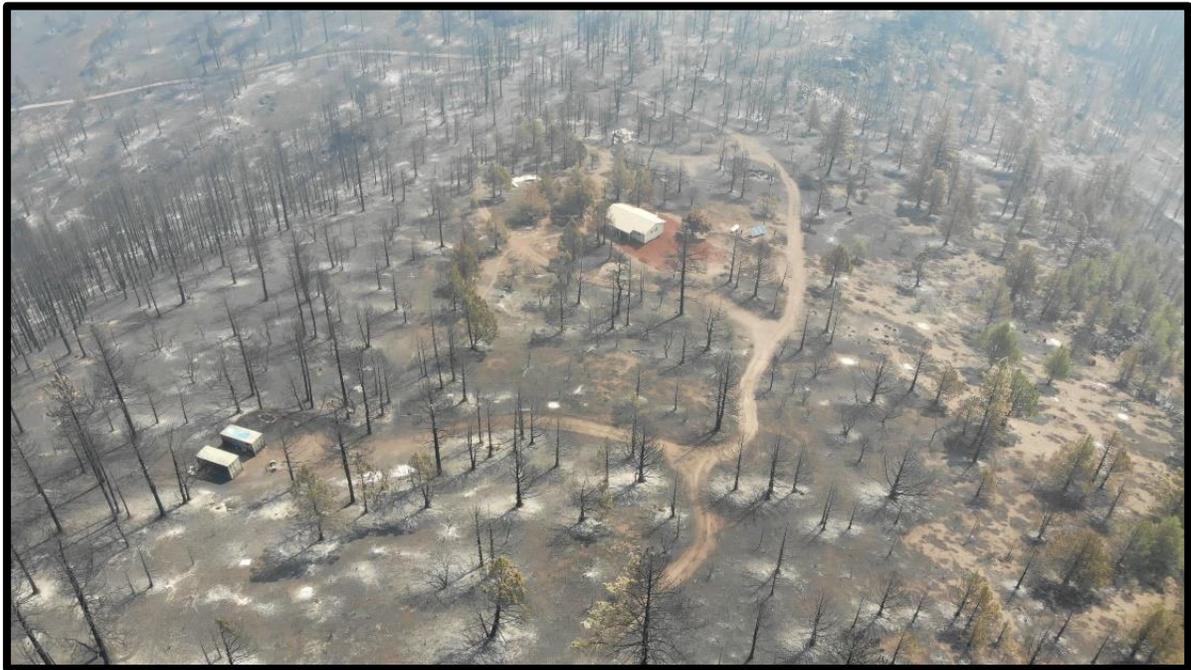
*Photo #3 Aerial of Upper House.*

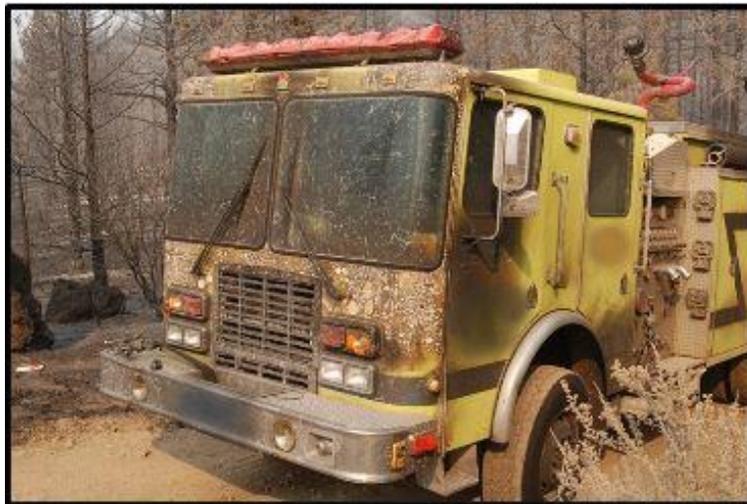
E4 drove through the extreme heat of the flaming front causing the windshield to fracture. The windshield wiper blades and tires caught on fire, as the air brake “low-air” alarm began to sound.

Due to the loss of air pressure from melted air lines, E4 came to a stop on a slight incline. C4 and FF4 decided to exit the cab and deployed their fire shelters.

*Photo #4 Final resting spot of E4.*

- C4 suffered second degree burns to the left side of his face, left eye and left arm while driving through flame front.
- FF4 was treated for smoke inhalation.
- E4 sustained major heat damage.

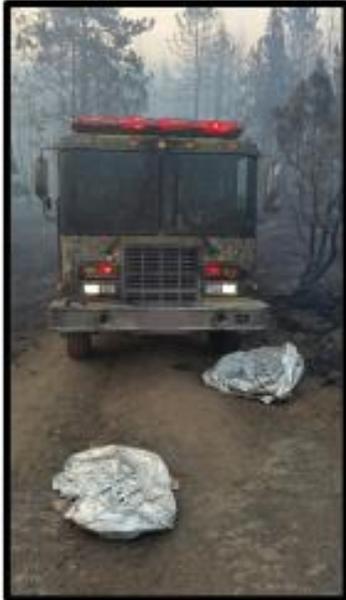
The deployment site selected was in front of the engine, side-by-side, in the ruts of the road. C4 and FF4 had to enter shelters from kneeling low as the wind was too strong to deploy standing.

Photo #5 Deployment site.
