Informational Summary Report of Serious or Near Serious CAL FIRE Injuries, Illnesses and Accidents

GREEN SHEET

Limbing Accident

18-CA-TUU-000116

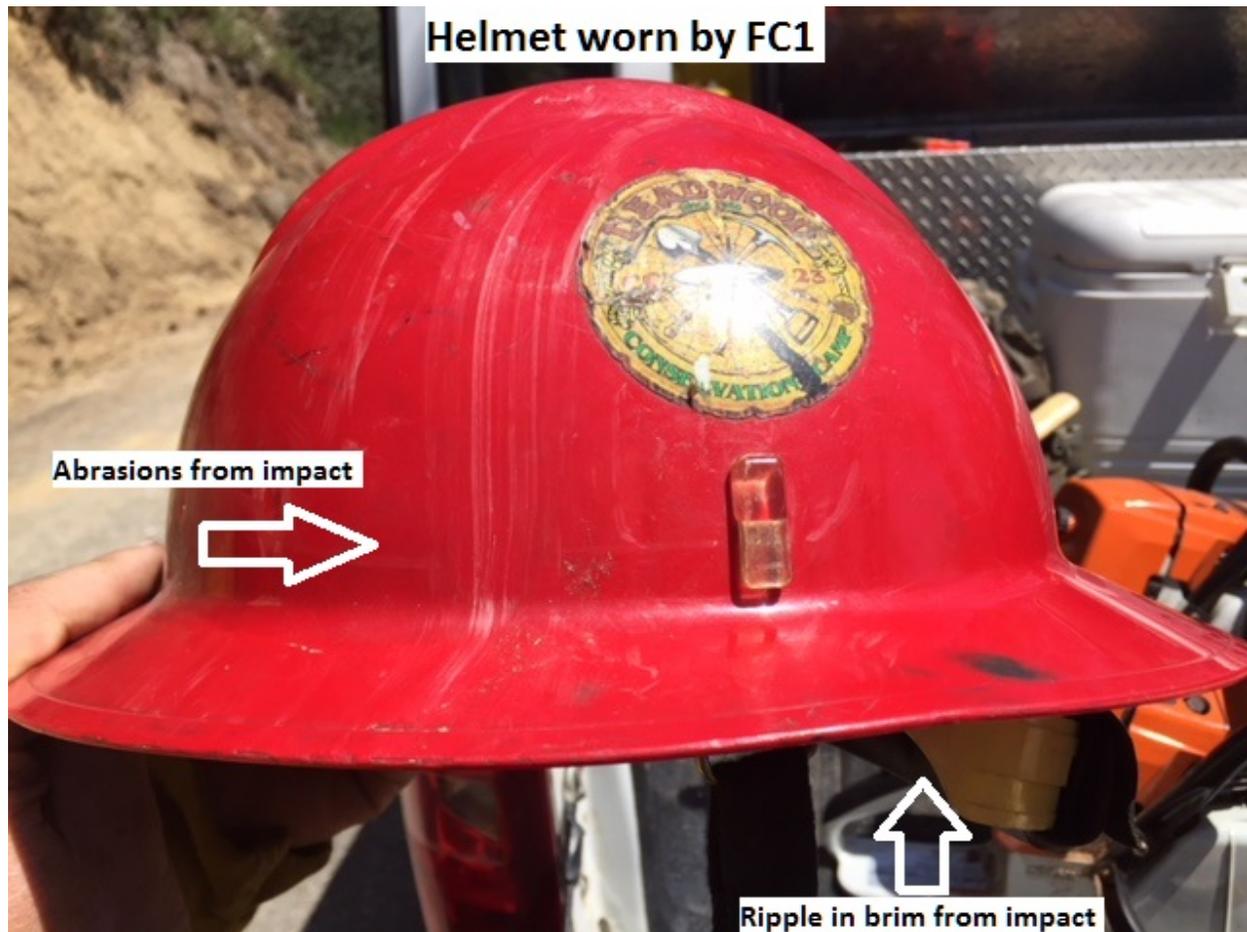
- FC1 was wearing full, appropriate PPE for chain saw operations. His PPE performed as expected, and was instrumental in limiting the extent of the injuries, specifically the helmet.

Figure 1: The helmet worn by FC1

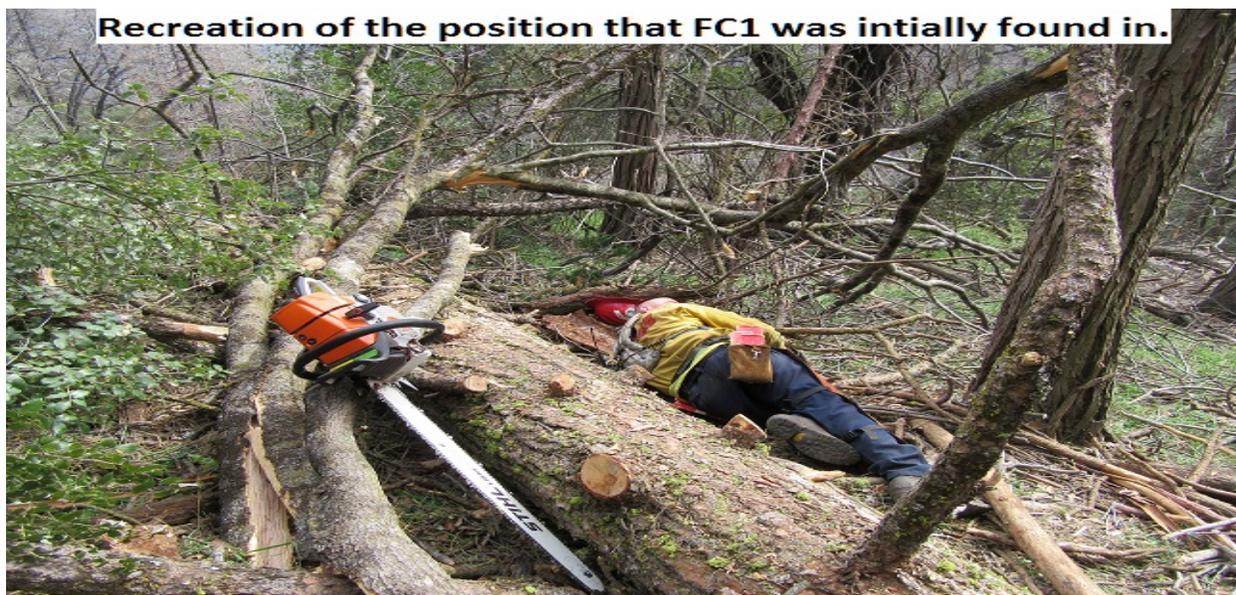
Figure 2: Recreation of the position FC1 and his equipment was found.

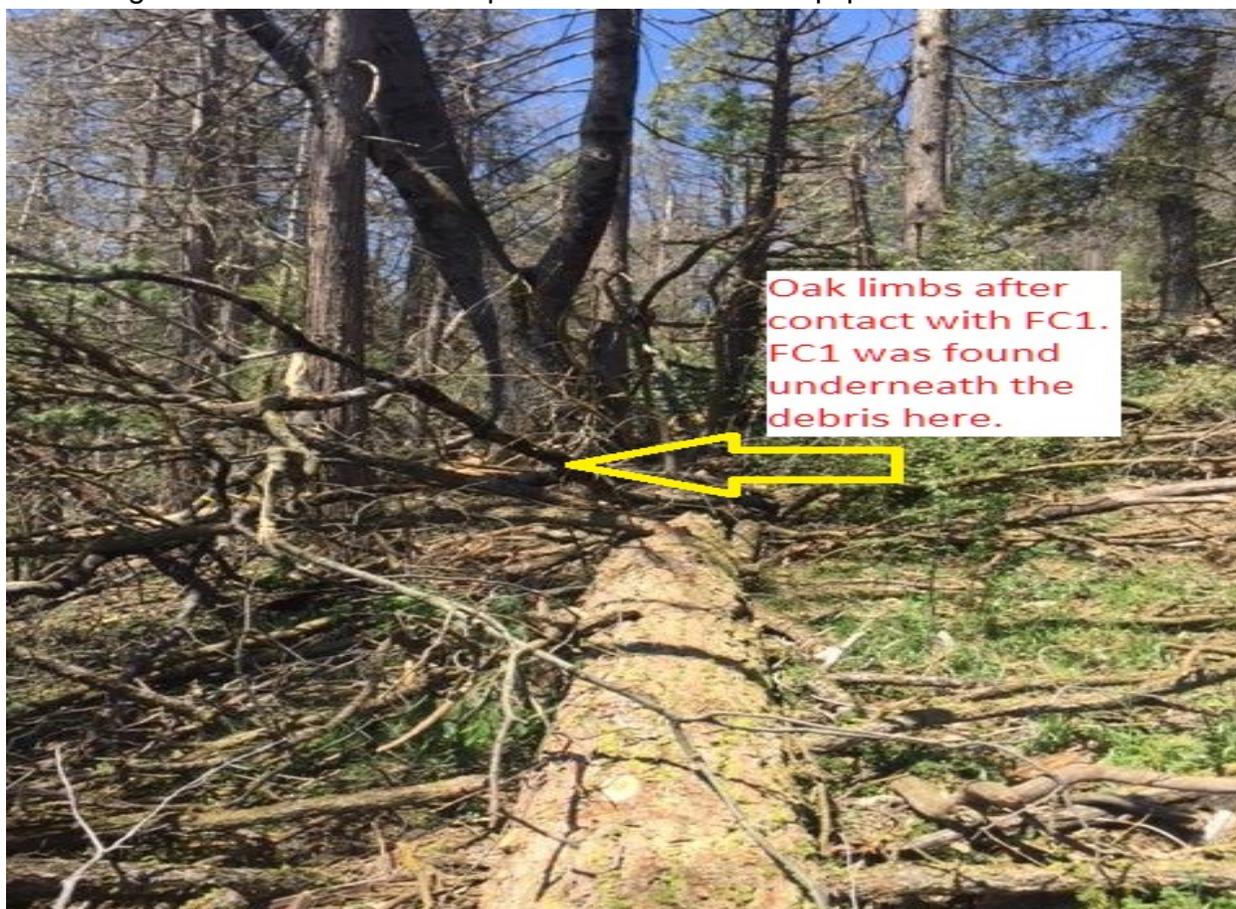
Unbeknownst to FC1, when the pine broke the oak limbs loose, and they fell ahead of the tree, the broken end of the oak limb contacted the ground first (likely due to weight) and stuck into the soil approximately 18 inches deep. This suspended the limb and the multiple forked branches of the limb into the air only to then be contacted by the falling pine as it came to rest on the ground. As the pine came to rest, it lay atop the broken end of the oak limb and placed the entire load of the felled pine onto the limbs. This downward pressure and the fact that the oak was a live tree allowed the limbs of the oak to bend under extreme pre-loaded tension and pressure. The felled pine tree limbs also directly contacted multiple sections of the oak limbs providing for additional tension. As FC1 proceeded to limb the tree, he reached the oak limbs and with a single, partial cut released the full, pre-loaded tension of the upper portion of the oak limbs. This violent release of tension projected the limbs of the oak downward and outward, contacting FC1 on the left temple area of his helmet. This contact propelled FC1 backward off the felled pine, and downslope into a field of tree litter. FC1 was knocked unconscious by the initial impact. P1, S2 and S3 all heard a loud "crack", and since they were training within view of FC1 and S1, they each turned toward the sound. P1 immediately noted that FC1 was down, and could hear his chain saw idling. S2 and S3 were also able to see that FC1 was down, lying on his left side. P1 yelled FC1's name as he proceeded to his location. P1 traversed approximately 500 feet across slope to reach FC1's location. S2 and S3 also made their way to FC1. P1 was the first to arrive and found FC1 unconscious with agonal respirations and an actively bleeding head wound. At approximately 1429 hours, P1 reported "man down" to the designated C-Faller Course Safety Officer (SOF) via the assigned tactical frequency. With the report, the SOF instituted the "Incident within an incident" (IWI) protocol in order to collect accurate and sufficient information. P1 reported "traumatic head injuries with entrapment". The SOF immediately contacted the CAL FIRE Tulare Unit ECC (Visalia) to report the injury. He ordered an air ambulance to the CAL FIRE Bear Creek Fire Station (pre-designated medivac location in the course IAP) and an Advanced Life Support (ALS) ground ambulance to the scene. Meanwhile, P1 was not able to fully access FC1 because the oak limbs had fallen and was lying on top of FC1. P1 noted that there was still so much tension on the oak limbs that he was unable to lift them. By this time, S1 had made his way up the hill from the stump having heard the loud crack, as well. He assisted P1 in cutting the still-tensioned oak limbs from above FC1 so that they could further assess his injuries. FC1 remained unconscious with agonal respirations as they completed an assessment of his injuries. Both S2 and S3 arrived to assist in the care of FC1. All personnel at the site worked to control the bleeding, and care for the injured FC1. After approximately 2-3 minutes, FC1 regained consciousness. He was confused, and became combative with the personnel working on him. Moments later, FC1

Figure 3: Uphill view from the base of the tree showing the debris field.

- Maintain situational awareness, and validate as conditions change
- When possible, clear the intended lay prior to initiating the felling operations to prevent unexpected or adverse effects of other materials during the fall.
- When engaged in chain saw operations, it is imperative to work in teams in order to maintain personnel accountability and safety.

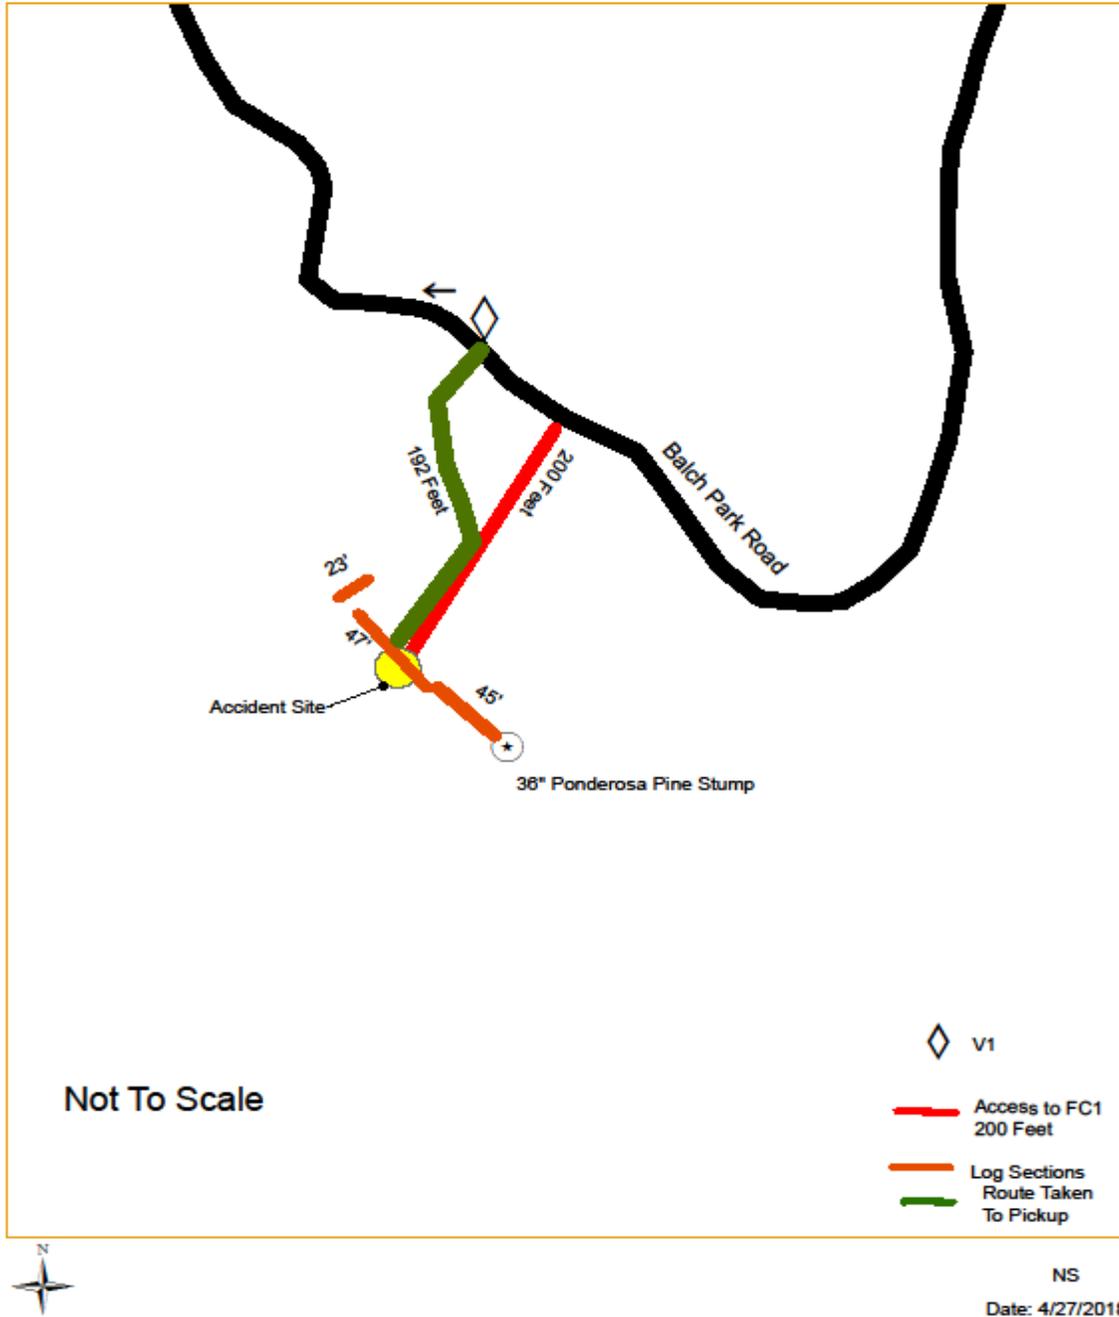
Figure 5: Diagram of accident site.
