Rapid Lesson Sharing

Event Type: Type 6 Engine Driver Side
Dual Dismounts

Date: June 18, 2020

Location: Wyoming

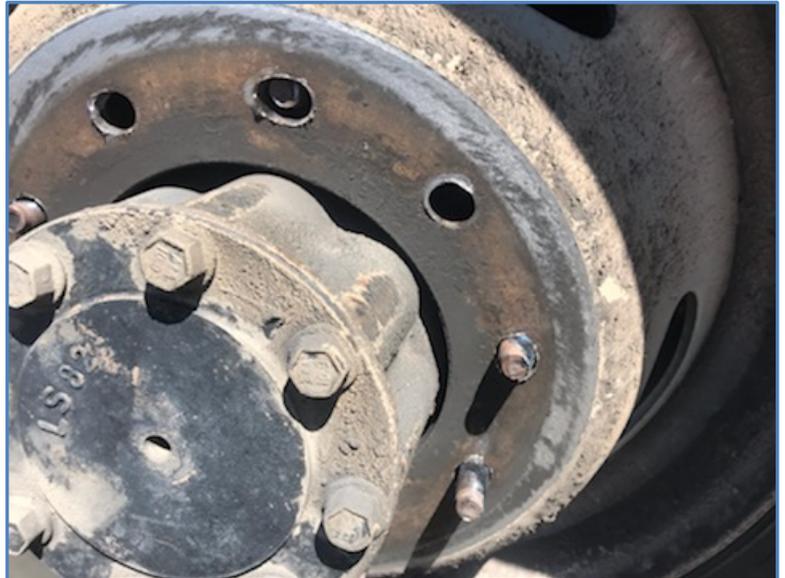
Top Photo – The back dual tire still on the engine.

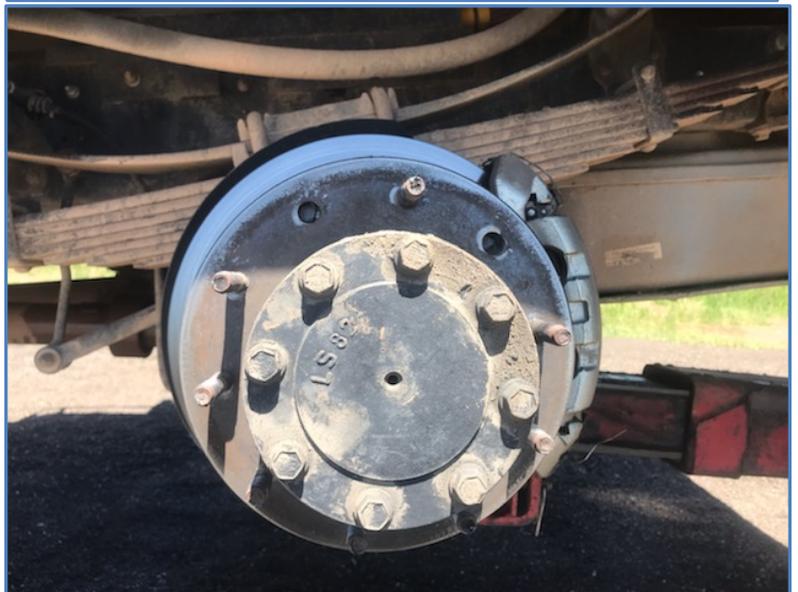
Bottom Photo – Both tires off, showing the hub with two missing stud bolts. The remaining stud bolts still on the hub are damaged. The rims on both tires received minor damage.

- ❖ The use of lug nut torque indicators (see photo on right) would help to visually check your lug nuts to see if they are still properly torqued to the manufacture's specifications.
- ❖ When a lug nut is overtightened, it causes the shaft to stretch and elongate. After each successive overtightening, it then takes more torque to "tighten" the lug—causing further damage. This causes a repetitive overtightening cycle that causes the lug(s) to fail by shearing, bending, or simply rattling loose.
- ❖ It only takes one incident of overtightening to damage a lug. After it is damaged, even if an operator consistently uses a torque wrench, the lug is still damaged and prone to failure.

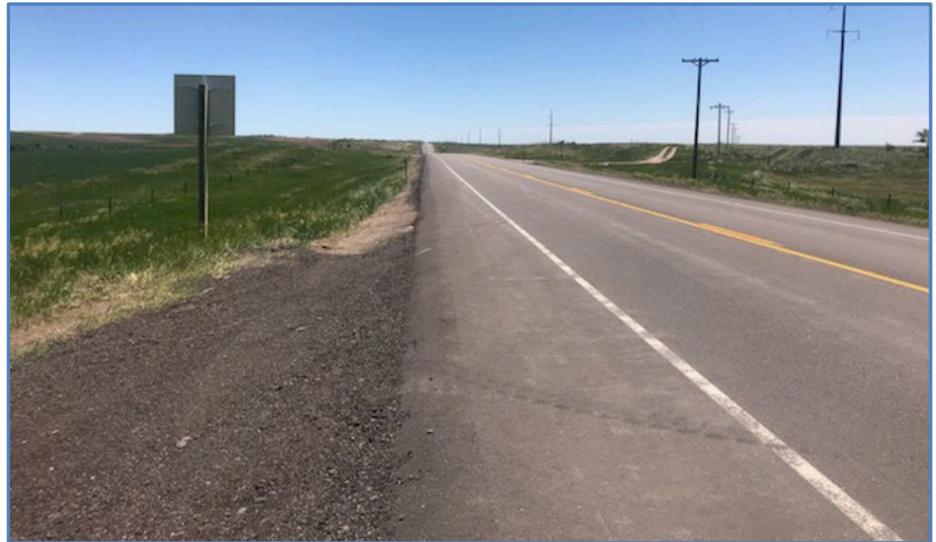
Photo shows the engine's final location where it was parked on the north side of the highway.

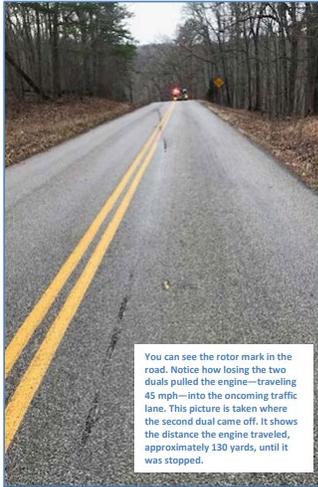
You can see the rotor mark in the road. Notice how losing the two duals pulled the engine—traveling 45 mph—into the oncoming traffic lane. This picture is taken where the second dual came off. It shows the distance the engine traveled, approximately 130 yards, until it was stopped.
