Event Type: Feller/Buncher Rollover

Date: August 7, 2021

Location: Elbow Creek Fire
Wallowa, Oregon

Feller/Buncher Operator Walks Away from this Rollover Incident Without Injuries

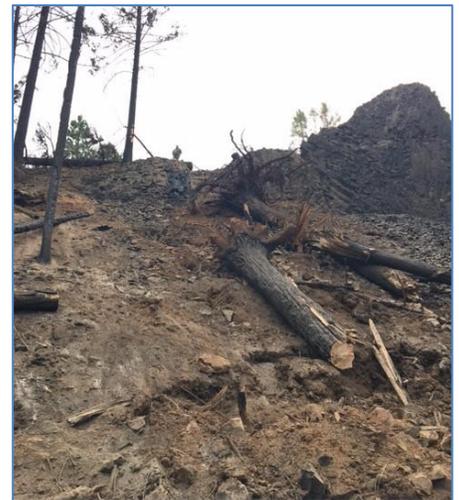
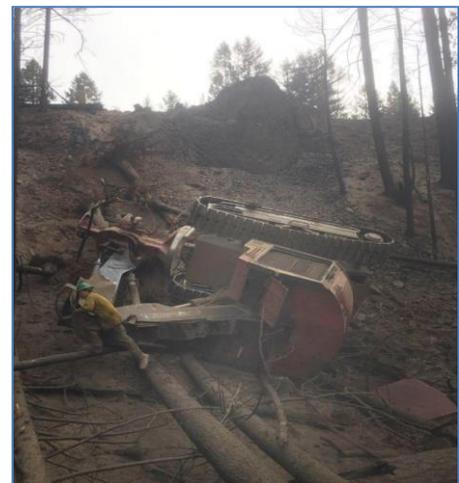
The operator said that when he cut this third tree, the tracks started sliding downhill on the loose rock. When he released the tree from the cutter head, the machine started sliding faster downhill. Next, the machine hit and uprooted a stump, which caused the machine to roll the first time with the operator cab section of the machine hitting the top of a rock ledge.

The machine then rolled over the rock ledge, landing approximately 30 feet downhill, rolled one more time, knocking over a pine tree and coming to rest cab-side down approximately 150 feet downhill from the start of the slide.

Top Photo – Path of rollover, showing the tree knocked over by the machine as it fell. The person above is standing where the cab first hit the rock ledge. Bottom Photo – Machine resting cab-side down after rolling down the cliff.

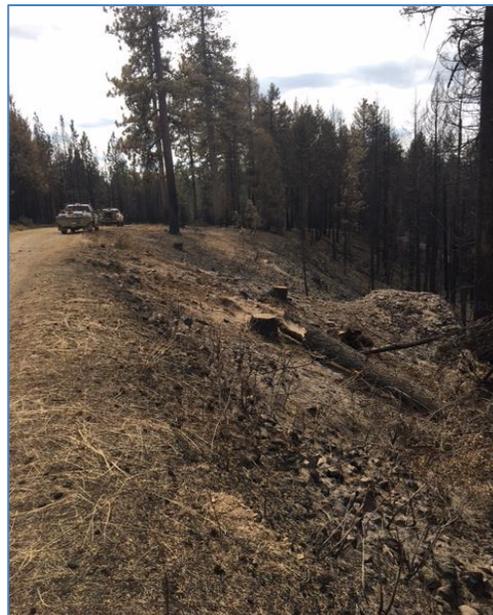
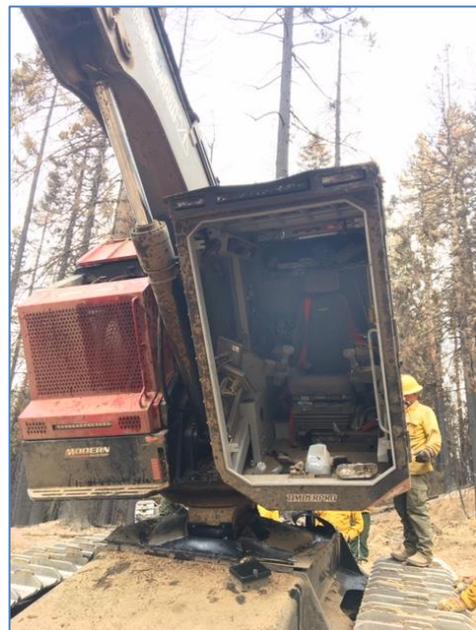
After the rollover, the operator and the incident's Safety Officer had a conversation about how the first two passes to cut the trees had disturbed the ground, exposing numerous rocks. These rocks most likely acted like marbles under the tracks—initiating the machine's slide. They therefore discussed how—in hindsight—it was not a good idea to cut trees at the top of a steep, rocky gully.

Top Photo – The rollover site. The stump/tree in foreground is the third tree the operator was cutting when the machine starting to slide in loose rock. Bottom Photo – Shows how the operator's cab remained intact.

The quality of design and strength of the cab most likely saved the operator's life. In addition, the machine's cab had a high-quality form-fitting seat with a four-point lap/shoulder seat belt system which the operator said he used—and always kept it tight.

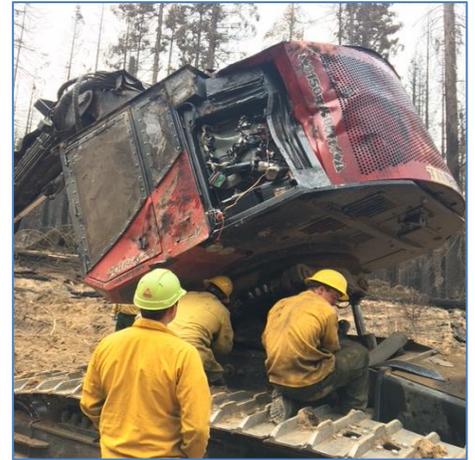
The next morning, the Feller/Buncher was pulled upright by two other Feller/Bunchers. Damage to the machine was assessed by the owner. There was damage to the engine compartment, the batteries had been pushed in, the cowling was damaged, as well as various other engine damage.

Damage to the engine compartment.
