Informational Summary Report of Serious or Near Serious CAL FIRE Injuries, Illnesses and Accidents

GREEN SHEET

Fire Shelter Deployment

North Complex West Zone

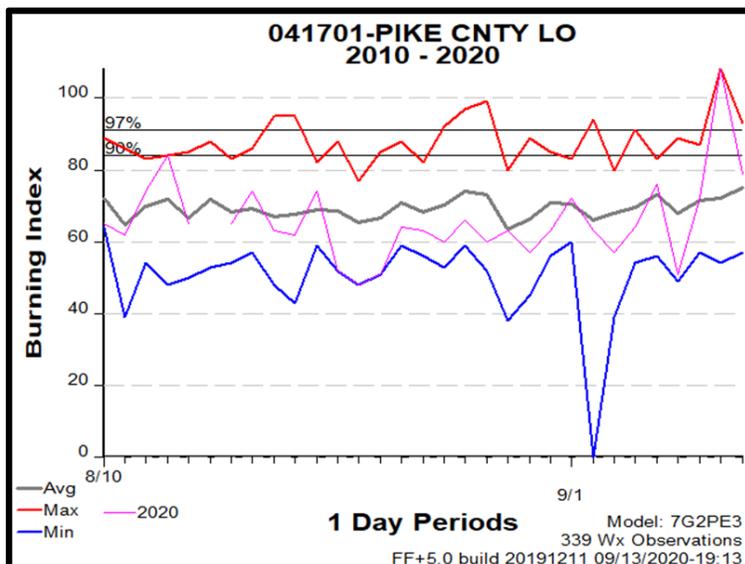
Diagram 1- The BI had just seen a seasonal record

The Northern California Geographic Coordination Center (GACC) issued a Fuels and Fire Behavior Advisory on September 7, 2020 for low fuel moisture, high ERCs and above normal fine fuel loading. This anomaly during a Severe Drought exists due to the timing of late spring moisture during the growing season. Overall, the fuel situation was at critical fuel levels, primed by weeks of record heat and dry air.

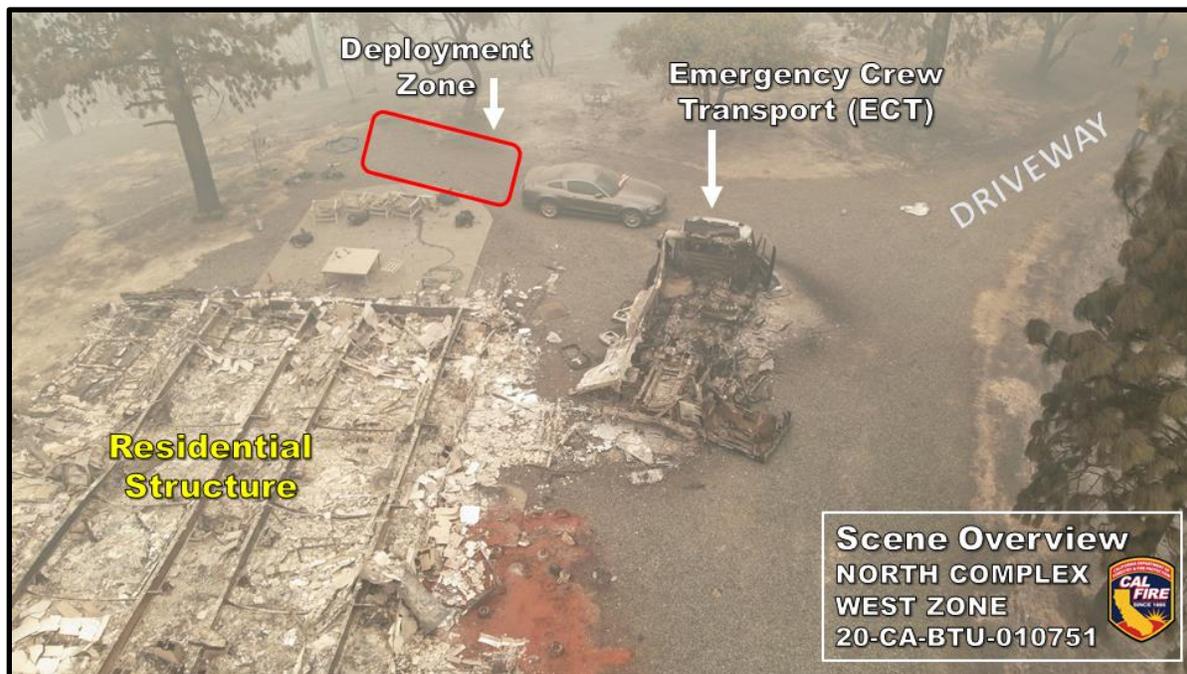
Photo & [Video](#) - Aerial overview of ECT, residential structure and deployment location. Burnout operations reduced fuel loading around house prior to fire front impact.

At approximately 1:25 PM, FC1 drove down the driveway toward Lumpkin Road. He noticed his egress route was compromised due to the flaming front. FC1 turned around and drove back to the residential structure which he previously identified as a temporary refuge area. FC1 planned to take refuge in the ECT as the fire burned over their location. As the fire impacted them, there was limited visibility due to the smoke, strong gusty winds, and a noticeable increase in the amount of radiant heat coming into the ECT. Within minutes of parking, FC1 and the swamper noticed black smoke billowing into the cab of the ECT. Crew members in the rear of the transport noticed the walls of the ECT beginning to warp due to radiant heat.

Conditions in the vehicle were no longer tenable. FC1 instructed his swamper to direct the handcrew members to take shelter in the structure. They exited the ECT and FC1 forcibly entered the house through the front door. Once inside, he conducted a head count and then instructed the crew to look through a pile of mail in order to locate the address number of the house. FC1 radioed the Strike Team Leader that the handcrew was taking heat, the ECT was on fire, and they were taking refuge in a house. Priority traffic was established by the Division Group Supervisor and the Branch Director was notified. Fire suppression resources in the area began to respond to Handcrew 1's location as fire conditions along Lumpkin Road abated.

Within minutes the house ignited at the B/C corner and the fire extended into a bathroom. FC1 instructed his crew to close the bathroom door in order to isolate the fire. Conditions in the house declined to the point of becoming unsurvivable as the interior became charged with smoke. FC1 directed his crew to prepare for a fire shelter deployment. Handcrew 1 exited the house.
