Informational Summary Report of Serious or Near Serious CAL FIRE Injuries, Illnesses and Accidents

GREEN SHEET

Engine Burnover

Brushy Mountain VMP

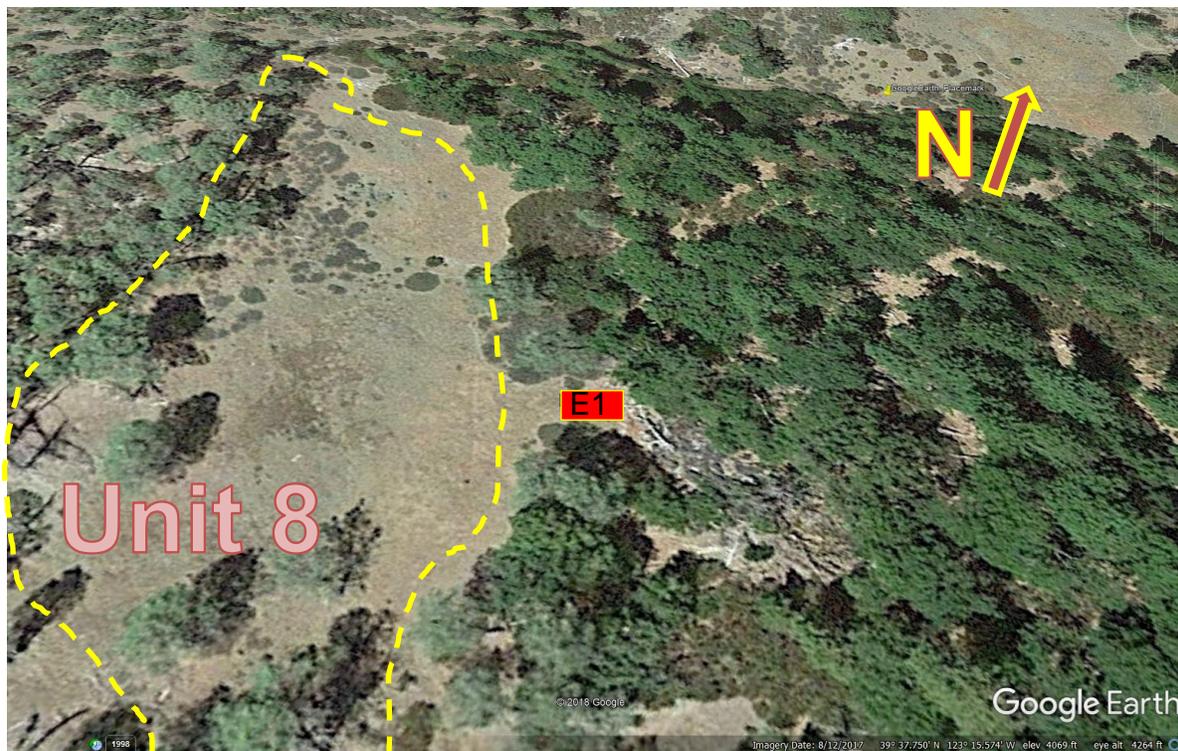
Dashed yellow line is VMP boundary line. Red box is E1.

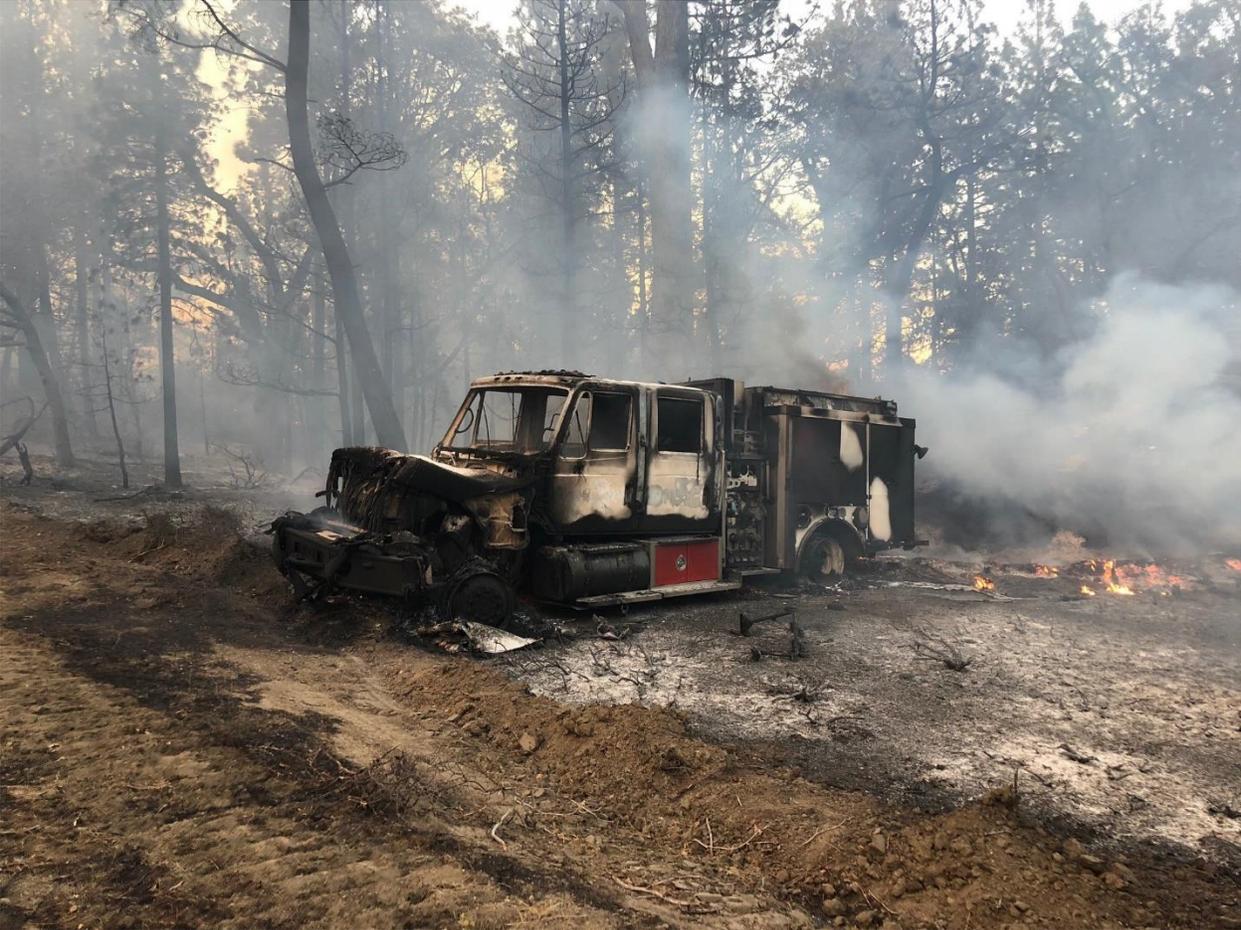
Resources contained the spot fire at approximately two acres. E1 was consumed by fire, resulting in a total loss of the engine.
