Lesson Sharing

Fall from a Ladder

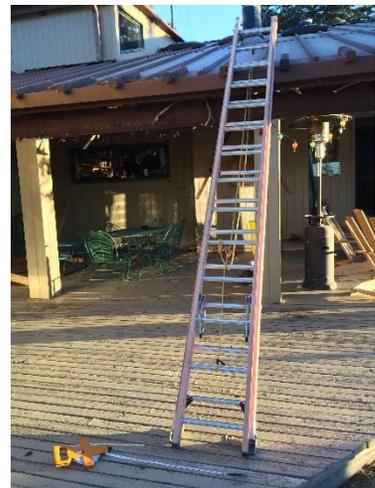
Crewmember 2 positioned the ladder at about a 45 degree from the wooden deck to the top of the roof, with the feet and extension sitting on the deck. He jumped on the bottom rung a couple of times to ensure it would stay in place before proceeding up the ladder. As Crewmember 2 climbed the ladder and approached the roof's edge (at about the 7-foot-high rung), the ladder began to slide away from the structure rapidly. When the ladder slipped, Crewmember 2's left foot became caught in the rung of the ladder. The impact to the deck, combined with his body weight landing on the ladder, caused his lower left leg to break. He immediately yelled out "My Ankle" to alert other firefighters working in the area of the urgent need for help.

- ✓ Be aware of the equipment you are using – is it the right tool for the job?
- ✓ Consider more in-depth ladder training on pre-use inspections and setup procedures for extension ladders. If anyone is on ladder, have someone hold the feet.
