Johnson Bar Fire - Fireline Learning Opportunity

August 16, 2014

Nez Perce - Clearwater National Forests

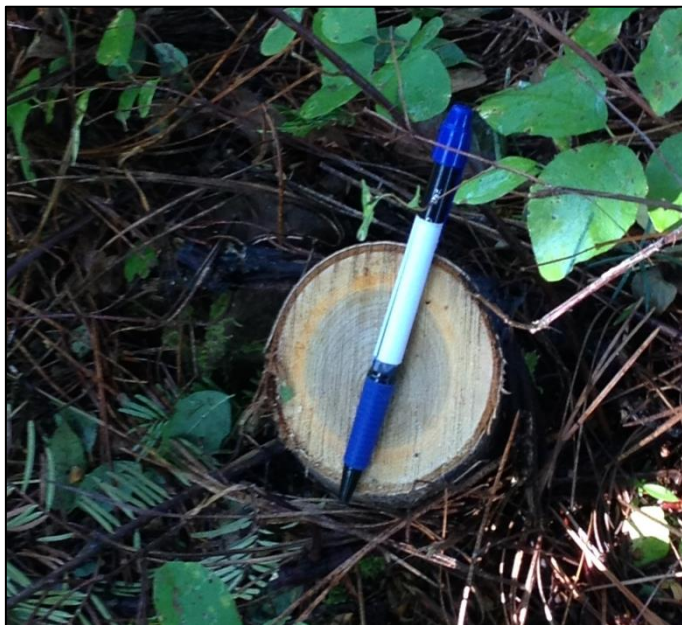
Figure 1. Stump of tree that struck injured fire fighter.

We had only been working for about 10 or 15 minutes when Joe was struck on the hardhat by a small diameter green tree that was being felled while creating the fuel break. The tree that struck him was only about 4" in diameter and 20' tall. The part of the tree that struck him was about as big around as your wrist. Initially after the incident we acknowledged what had just happened; and things seemed fine, so we started back to work.

- "It is ok to have a few folks standing around waiting until we get spread out doing our task". "It is possible that there is a mentality that we all need to start working right away". "After the incident we toned things down and slowed up a bit, making sure folks were talking, communicating, etc."
- "It may be better to have two saws up front doing all the falling, and having two other saws behind doing the bucking for folks chaining the debris". "This would build in the distance needed between the fallers and the crew".
- "Bottom line..., 2½ tree lengths is something we say we do, but do we always do it?" "We do with big trees but maybe not so much when dealing with small trees". "We need to stay vigilant".
- Take the time to size up small trees and the cutting situation.
- Maintain communications throughout the cutting assignment.

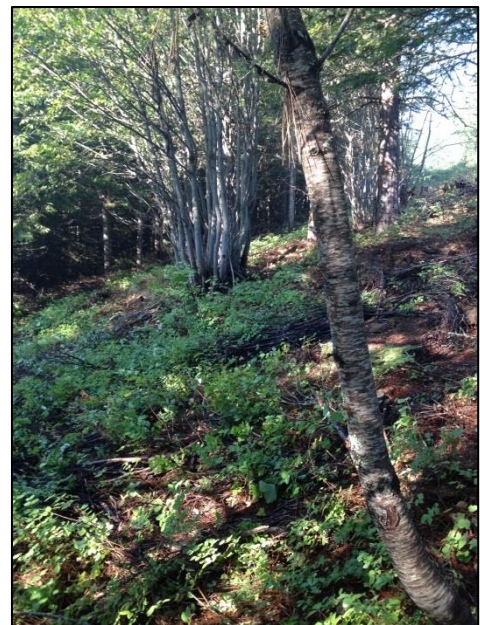
Figure 2. View of shaded fuel break adjacent to dozer line.
