A Career Fire Fighter was Killed and a Career Captain was Severely Injured During a Wildland/Urban Interface Operation - California

SUMMARY

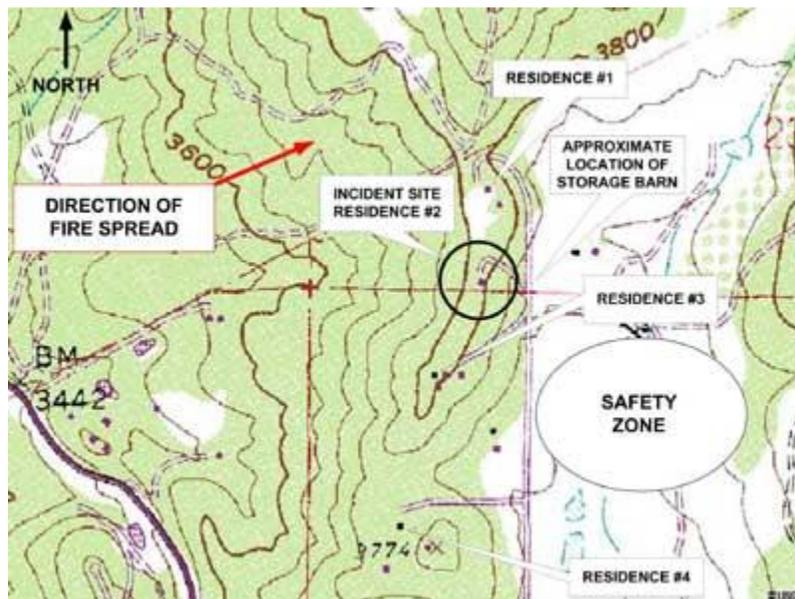
Map 1. Aerial view of drainage and incident scene.

Topography – The incident site was located on a ridge at an elevation of 3,800 feet, 400 feet above the bottom of the drainage, with west facing slopes ranging between 12-20% ([Map 1](#)).

At approximately 1200 hours, most of the crews arrived at the ridge where they would provide structure protection ([Map 1](#)). The single lane dirt road runs along the east side of, and parallel to, the ridge top. There is a large open field to the east (designated as the safety zone). There were four separate residences (Residence #1, #2, #3 and #4), a water tower near Residence #1, and a storage barn along the east side of the road ([Map 1](#)). The Task Force Leader determined that he was going to red flag^a Residence #1 and Residence #3 as he deemed them “not saveable.” Engine 334 was not with the Task Force at this time as they had headed into the nearest community searching for a hydrant to refill their Engine’s water tank. The Task Force Leader drove to the end of the single lane dirt road to conduct his size-up in determining where to deploy his crews. The CDF FAE begins firing out around Residence #1 while the Captain proceeds in Utility 3444 down the dirt road.

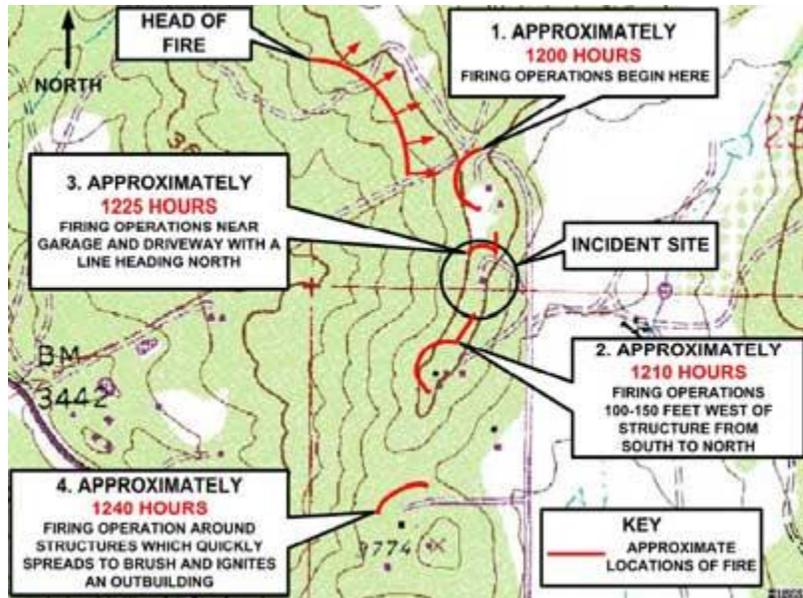
Map 2. Sequence of firing operations

Sequence of Firing Operations ([Map 2](#))

Residence #1 – CDF FAE (fire apparatus engineer) began firing out around the structure while the CDF Captain drove down the dirt road where he met up with Engine 334. He then instructed them to proceed to Residence #1 to support the firing operation.

Residence #3 – CDF Captain and FAE arrived and began firing out operations approximately 100-150 feet to the west of the structure. The FAE laid fire on the ground, from south to north, in the shape of an arc. He continued in a straight line from the top of the arc toward the structure at Residence #2. Fire quickly spread to the east but was knocked down by a bucket drop from Helo 523EH. The FAE discontinued his firing operation at Residence #3.

Residence #2 – The CDF Captain and FAE drove their vehicle to Residence #2 and parked near the garage. The Captain instructed the FAE to begin firing out from the garage toward the driveway and to continue in a northerly direction toward the unimproved lot to the south of Residence #1.

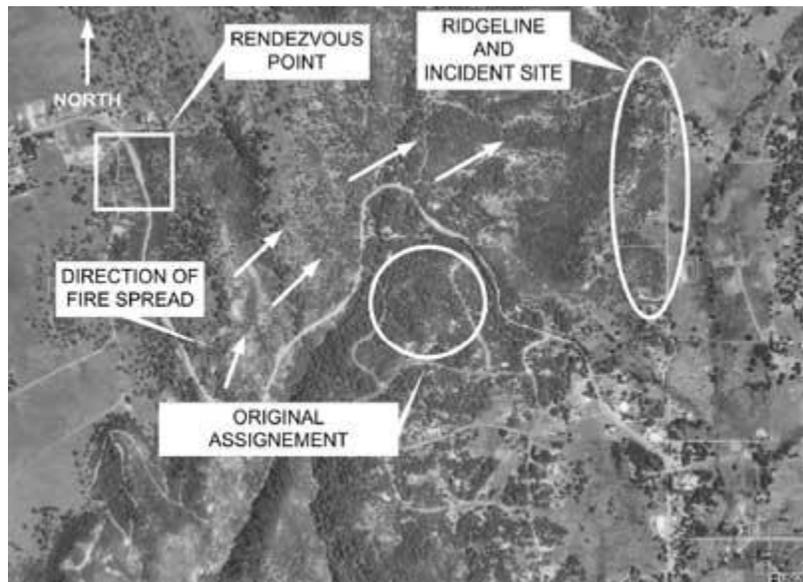
Photo 1 Aerial view of spread of fire and incident site

On October 29, 2003, the Task Force leader attended the morning briefing at 0700 hours. The crew was assigned to a Branch and Division on a flank of the fire. The Task Force Leader met with the Division Supervisor at this time for any additional instructions and information. The Task Force Leader then met with his crews and briefed them on their assignment before proceeding to the rendezvous point (approximately 40 miles from the staging area) where they would meet with the rest of the Division ([Photo 1](#)). The task force arrived at the rendezvous site and was assigned to provide structure protection. The Task Force Leader then received a map and debriefing from a Strike Team Leader that had been working in the area. Fire fighters reported to NIOSH investigators that the fire at this time was moving slowly with spot fires on both sides of the state road. The crews began mopping up operations in a small subdivision on the south side of the road before receiving a new assignment at 1100 hours ([Photo 1](#)).

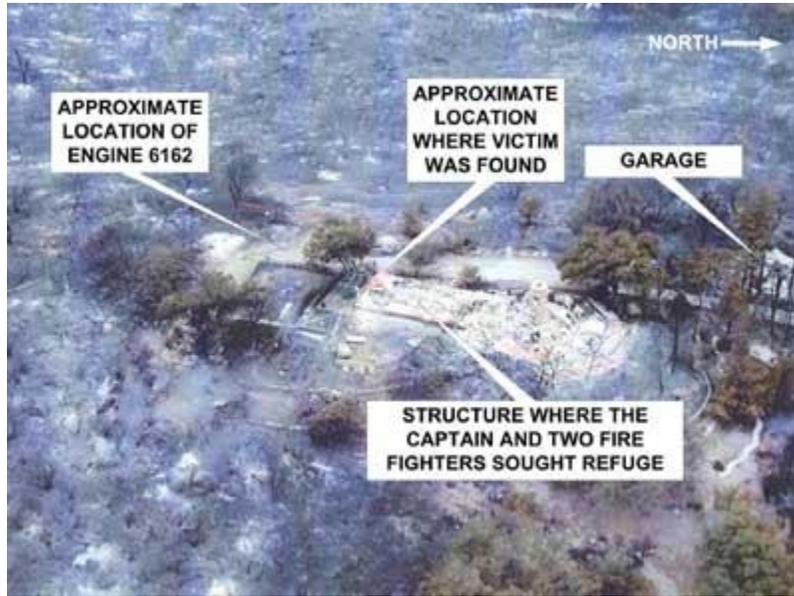
Photo 2. Aerial view of incident site

member cleared overhanging brush near the driveway. The driver positioned Engine 6162 approximately 60 feet to the south of the structure ([Photo 2](#)).

The Captain of Engine 6162 determined that the site was defensible due to the large cleared area (approximately 150 feet of brush) around the west side of the residence ([Photo 2](#)). The Engine 6162 crew had a clear view of the west and northwest. Tall brush and drifting smoke obscured their view to the southwest. They observed smoke from the fire to the north which was flanking towards them and posed the greatest threat to their position. Small runs of fire were taking place across the canyon on the west side of the drainage ([Map 1](#) and [Photo 1](#)). The crew also noted an up-canyon and up-slope wind, at about 7-10 miles per hour. The crew decided to clear the grass and brush (manually and with fire) below the house. Two fire fighters from Engine 6162's crew were now using drip torches to burnout the grass below Residence #2 ([Photo 3](#)). The victim manned a 1 ½-inch handline while burning a brush pile near the Engine while the Captain used a drip torch to burnout the vegetation near the driveway. Fire could be seen to the north and west of their position where three helicopters were making bucket drops.

At approximately 1225 hours, the CDF Captain and FAE arrived in a pickup truck and began lighting fire near the garage without speaking with the Captain from Engine 6162 ([Photo 2](#) and [Map 2](#)). The Captain from Engine 6162 saw the CDF Captain and fire fighter and believed that they had seen him near the house. Approximately 15 minutes later, the crew noticed that the fire activity below them was beginning to increase.
