Rapid Lesson Sharing

Event Type: Engine Burn Damage/Fire Behavior in Exceptional Drought

Engine Burn Damage Date: July 14, 2021

Engine Burn Damage Location: Log Fire, Oregon

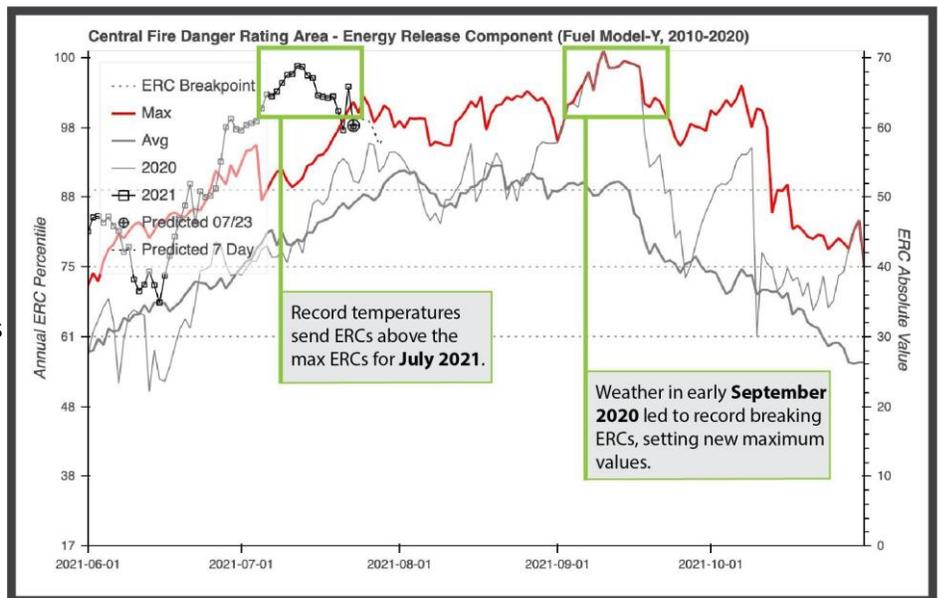
Figure 1. Emergency Release Component (ERC) relates live and dead fuel moistures to potential fire intensity. Indices climbed late August into September 2020, setting new records and culminating in explosive fire growth during a rare east wind event around Labor Day. In late June 2021, the Pacific Northwest experienced record-breaking high temperatures, causing a steep increase in ERCs just before the start of the Bootleg Fire.

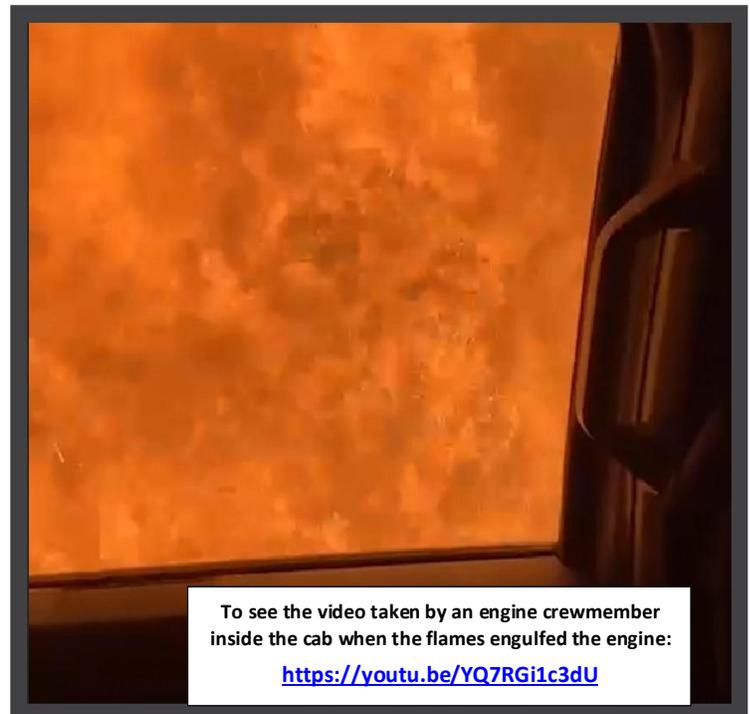
Image 1. A screen shot from a video taken from inside the engine. The engine’s back passenger described the flames like a “cloud of fire coming around the engine” and said that it looked like liquid.

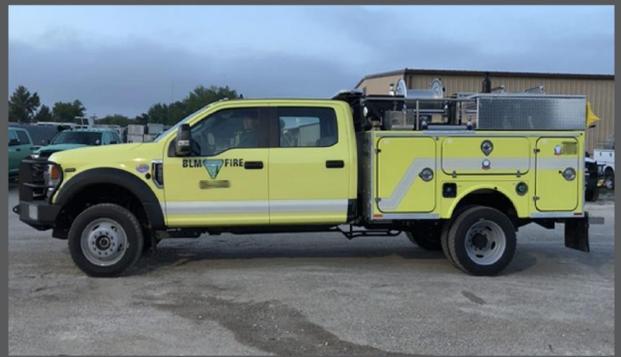
- ❖ Most plastic and rubber composite components on the driver's side melted to some degree from direct flame impingement. These damaged items include: trim molding, vehicle plug-in charging port, fender flare, diesel and DEF (Diesel Exhaust Fluid) caps, door handles, mirror assembly, and weather stripping. The following were discolored, blistered, and/or melted: lighting components including the driver's side headlight, marker lights, overhead scene light, and lightbar.

- ❖ The following were either delaminated, blistered, and or scorched: non-plastic components such as the chassis paint, flame resistant gel coating, package fiber composite, reflective stickering, and the stainless-steel storage compartment. The driver-side front and rear windows had cracked but remained intact due to the factory applied glass film tint coating. Multiple aluminum panels on the chassis body lost structural integrity and warped.

Image 2. Photo of engine taken during initial vehicle inspection.

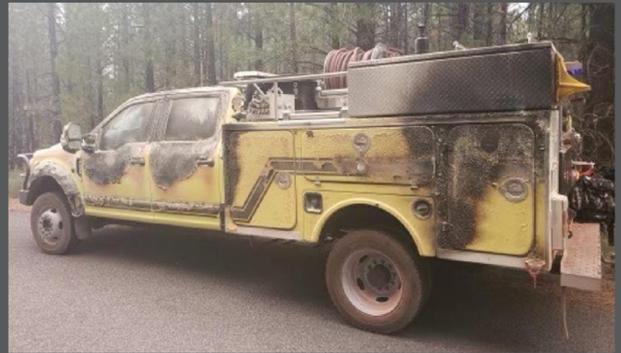
Image 3. Taken on FS Road 28 shortly after the engine was impacted by flames.

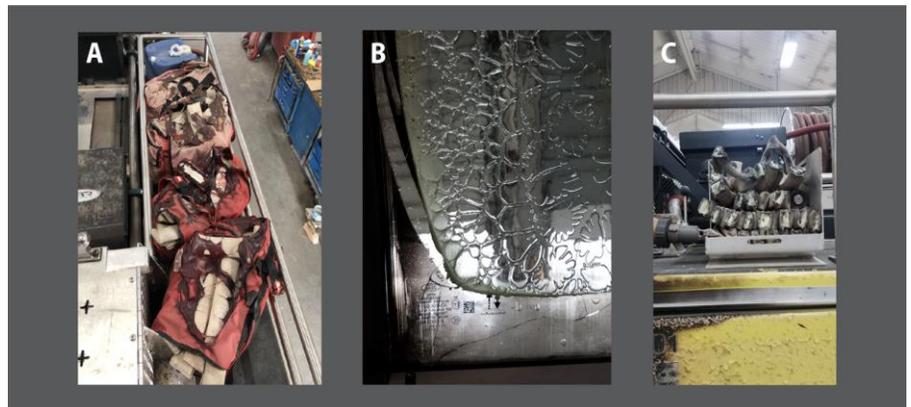
- ❖ 2 IA packs positioned on rear step: heat damage, melted fabric, need replacement.
- ❖ 4 hose packs positioned on top of the passenger side of the truck: heat damage to bag, need replacement.
- ❖ Driver side protection hose: hose sections facing flame front melted, need replacement.

Image 4. (A) Hose packs on the passenger side of the engine were damaged. (B) A glass treatment bubbled the driver side windows, but the windows stayed intact. Additional cracking occurred when the vehicle was transported. (C) The driver side protection hose was burned.
