Rapid Lesson Sharing

Event Type: Type 6 Engine Damage
from Heat on a Prescribed Fire

Date: March 17, 2019

Location: West Canal Prescribed Fire
Malheur National Wildlife Refuge
near Frenchglen, Oregon

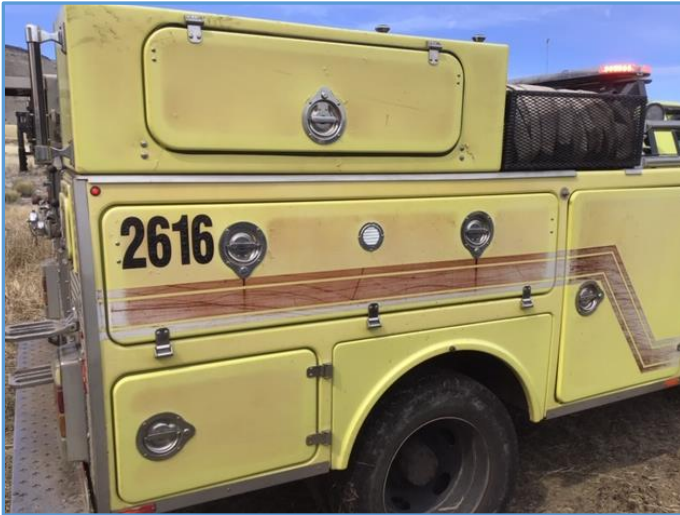
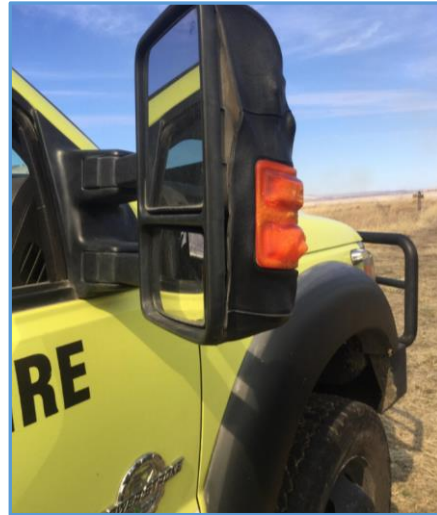
Heat damage to Engine-616 occurred to its top compartment fiberglass box, the front door passenger gear box, and the passenger side mirror. All of these components will need to be replaced. In addition, the Engine's entire rear package will need to be repainted and restriped.

Local personnel have assessed the damage and foresee the need to replace: the top compartment fiberglass box; the door of the front passenger gear box (this door was warped); and the passenger side mirror of truck. In addition, the repainting of the entire rear package of the Engine (both sides to avoid a two-tone look) is required—followed by reapplying the striping to the Engine.

Furthermore, it's also possible that the Engine's long rectangular box door will need to be replaced. The Engine was taken to a local body shop that will make the final determination regarding what parts will need to be replaced versus those that will just need to be repainted.

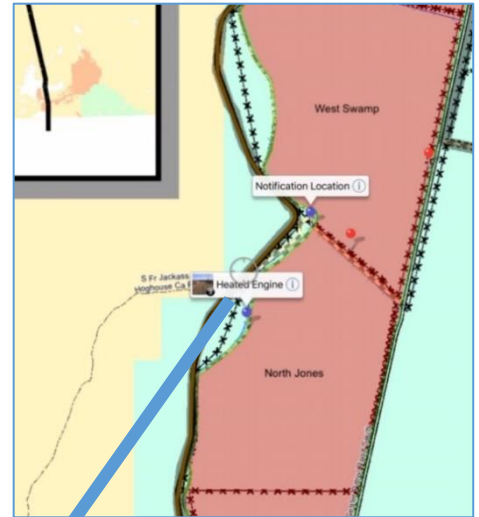
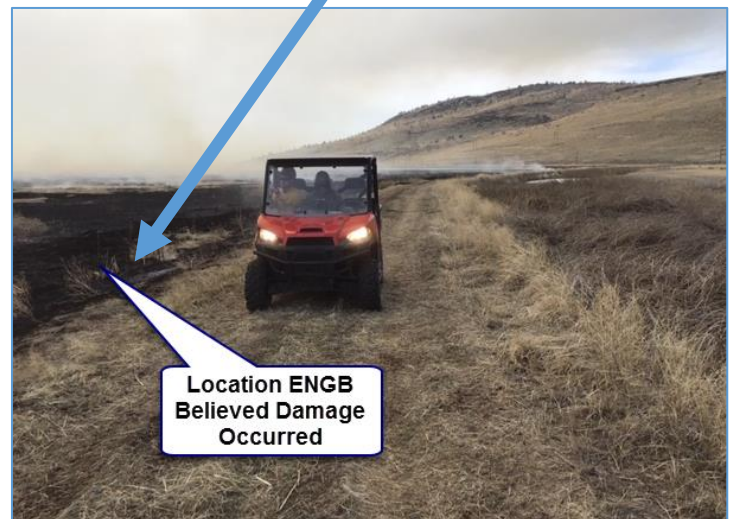
An accident form was filled out by the crew in which the Engine Boss and crewmember explained what had happened. From the crew's discussion with the Holding Boss, the damage had likely occurred around 1240 when ignitions moved into the heavier fuels that were more dominated by tules. (For specific location, see the "Heated Engine" pin on the map on right and the photo on right.)

When ignitions became established in this area with the heavier fuels, the flame lengths quickly increased from approximately 2 feet to 10 feet. This is when the Engine heat damage incident occurred.

Once the heat dissipated, the crew progressed on with their holding duties. Initially, they were unaware of the heat damage to their Engine. (Reference the "Notification Location" pin on map above to see where this damage was first identified.) At this time, at this location, they notified the Holding Boss Trainee of the damage.
