## Fire Behavior Analysis

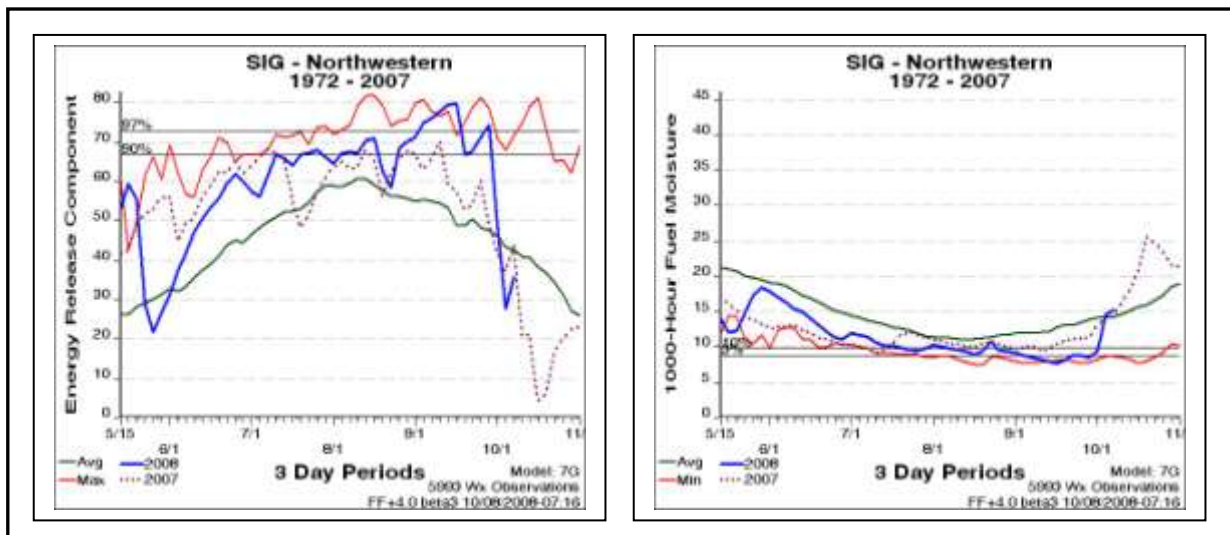
Fire danger indices for the Northwest Predictive Services Area (PSA) showed that ERCs were tracking near the 90<sup>th</sup> percentile most of July, while 1000-hour fuels moistures were above the 10<sup>th</sup> percentile, but were well below historic averages for this time of year.

Figure 1. Energy Release Component and 1000-hour fuel moisture trends for the Northwestern Predictive Services Area. The Northwest PSA is representative of the Panther fire area.

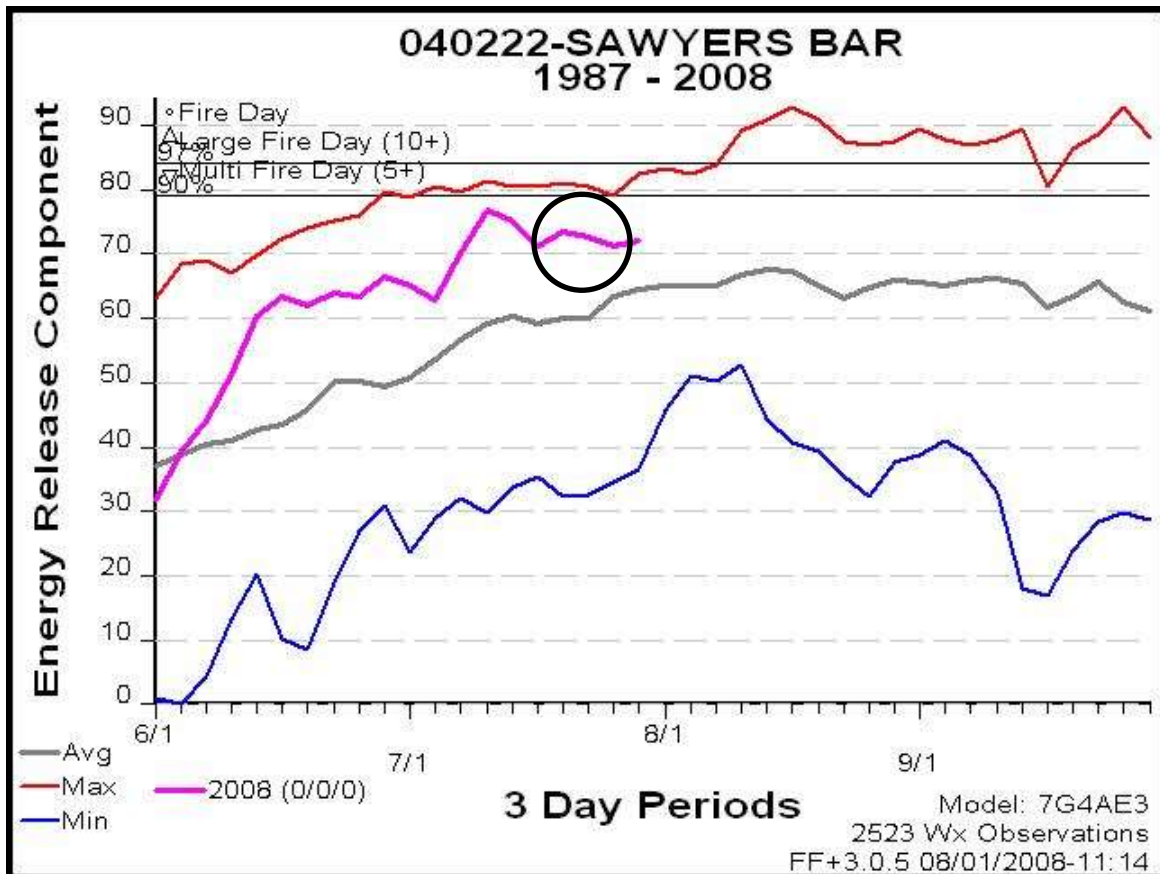
Energy Release Component (ERC) is the most appropriate National Fire Danger Rating System (NFDRS) indices to capture seasonal fire severity. The ERC is a number related to the available energy (BTU) per unit area (square foot) within the flaming front at the head of a fire. The ERC is considered a composite fuel moisture index as it reflects the contribution of all live and dead fuels to potential fire intensity. The ERC has “memory”. Each daily calculation considers the past 7 days in calculating the new number. Daily variations of the ERC are relatively small. The ERC trend for the Sawyer Bar RAWS is shown in Figure 2. The three-day average ERC for July 25 through July 27 was 71. This is approximately the 77<sup>th</sup> percentile for these dates.

Figure 2. Energy Release Component (ERC) based on a three day average of ERCs from Sawyers Bar Remote Automated Weather Station (RAWS). The circle indicates the three day average ERC associated with the entrapment.

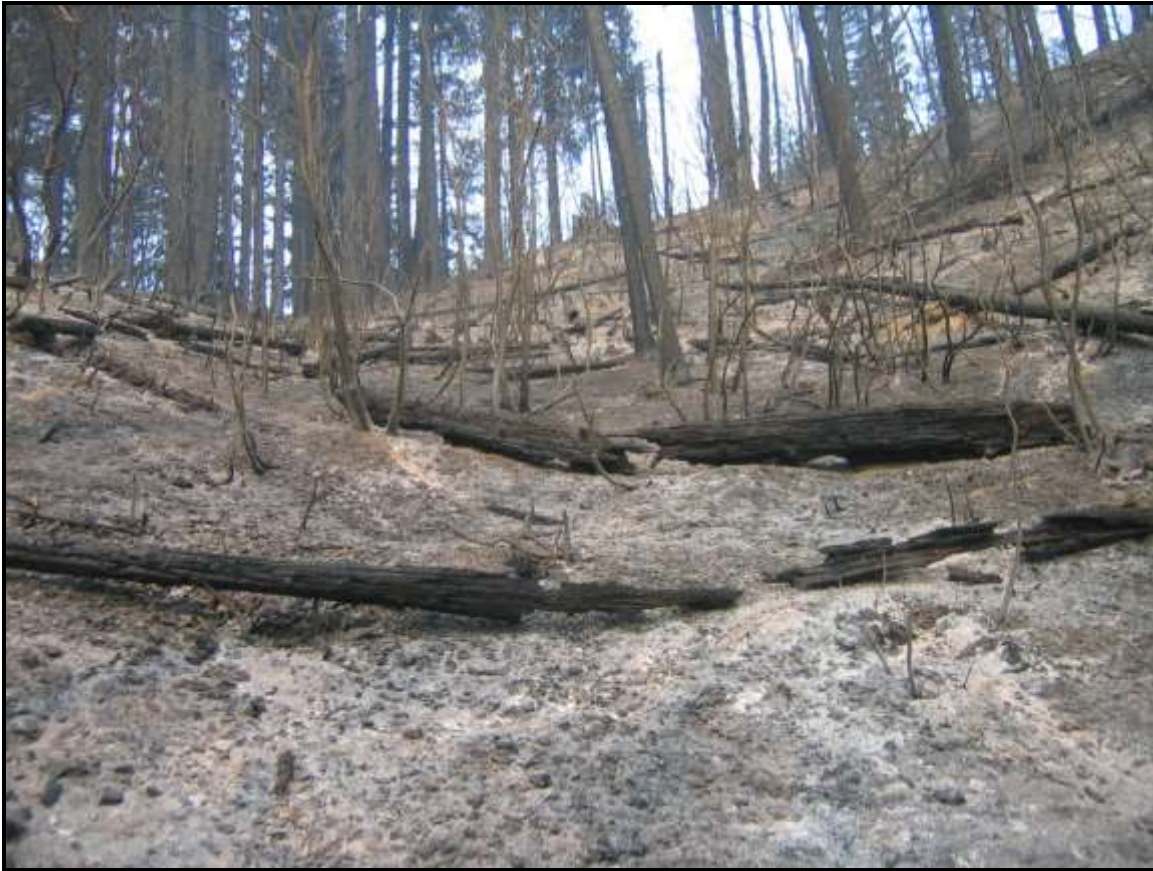
A field evaluation indicated that a crown fire did occur in the unnamed drainage beginning near the point where the fire crossed the unnamed drainage, upslope to the saddle. The crown fire event was limited in scope to the drainage itself, as areas on either flank of the drainage retained significant portions of their canopy. Consumption on the north side of the entrapment location was moderate, with the canopy being retained and brush species retaining many of their leaves. The level of consumption continued to decrease as the fire reoriented into backing alignment after the crown fire run up the unnamed drainage. Figure 3.

*Figure 3. Looking upslope from below the saddle and the deployment site. Surface fuels and heavier dead and down material mostly consumed, however note the retained overstory vegetation at the skyline, indicating that the crown fire did not sustain itself after exiting the drainage.*

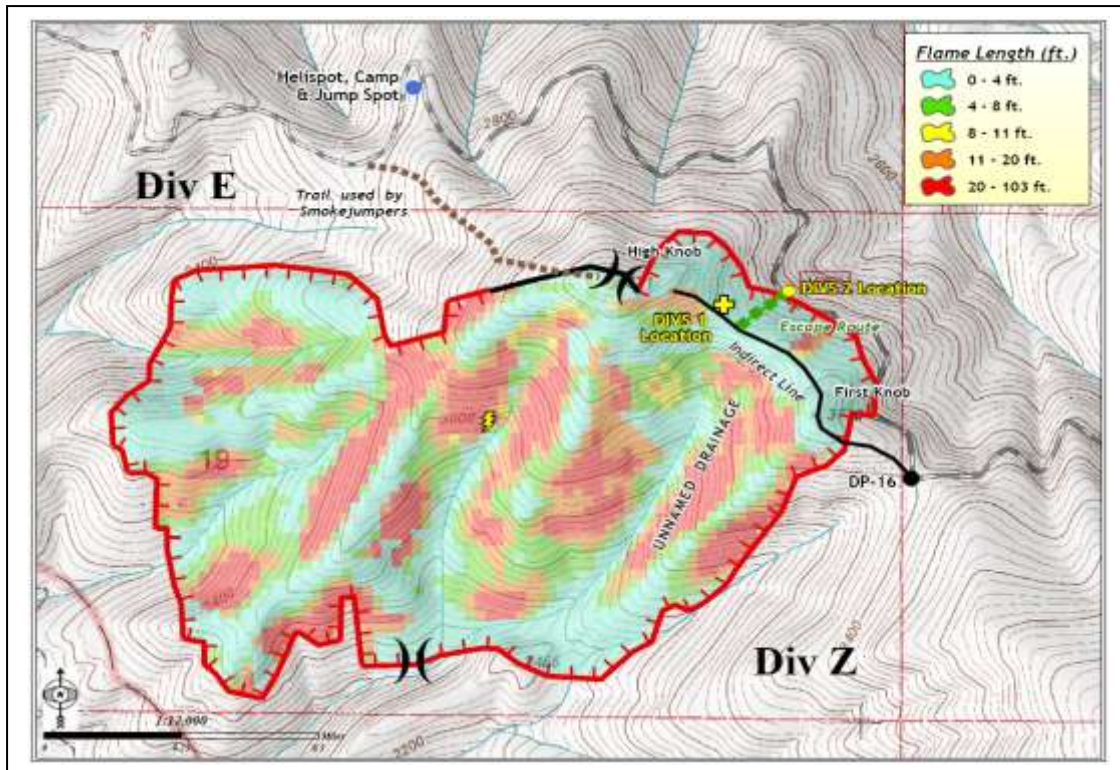
The FlamMap simulation projected a surface fire at the deployment site; however passive crown fire activity was modeled within 100 feet of the deployment site and active crown fire was modeled within 400 feet of the location. The model classified surface fire flame lengths at the deployment site as 4 feet or less, with modeled flame lengths of greater than 20 feet within 100 feet of the deployment site. See Figures 4 and 5.

Figure 4. Modeled flame lengths determined from FlamMap for the general fire area.

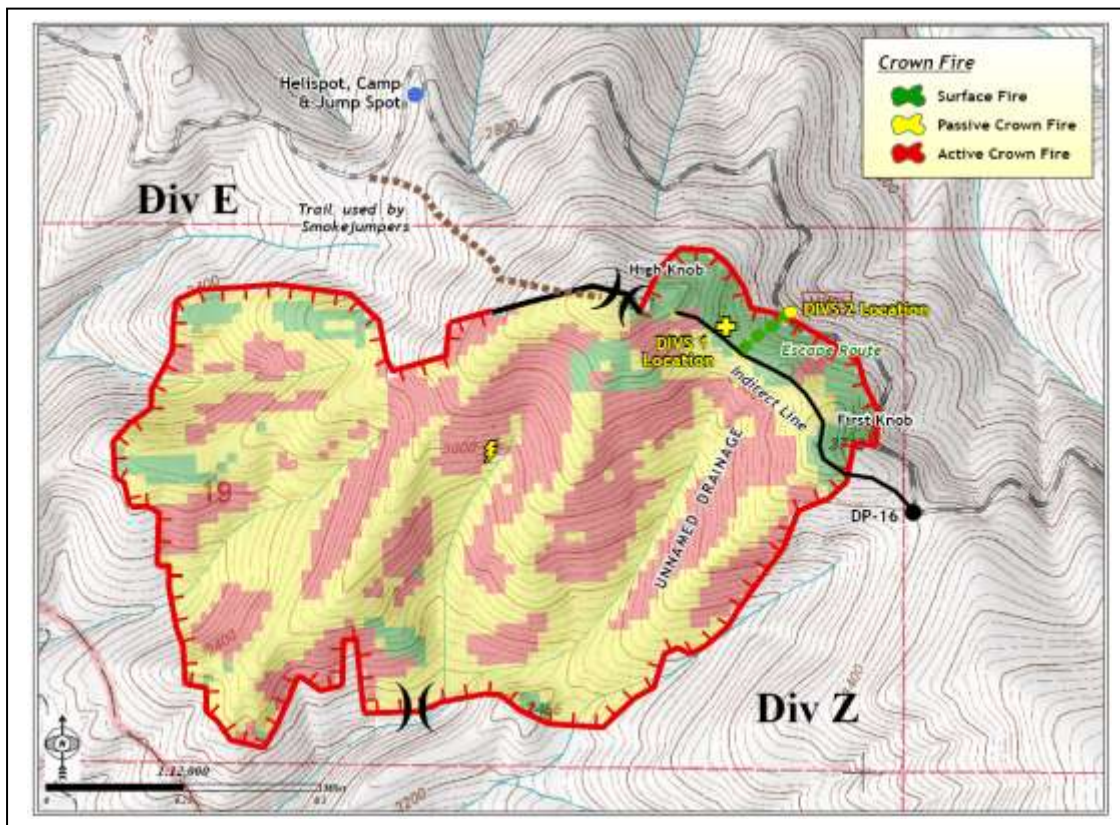
Figure 5. Modeled crown fire potential from FlamMap for the general fire area.

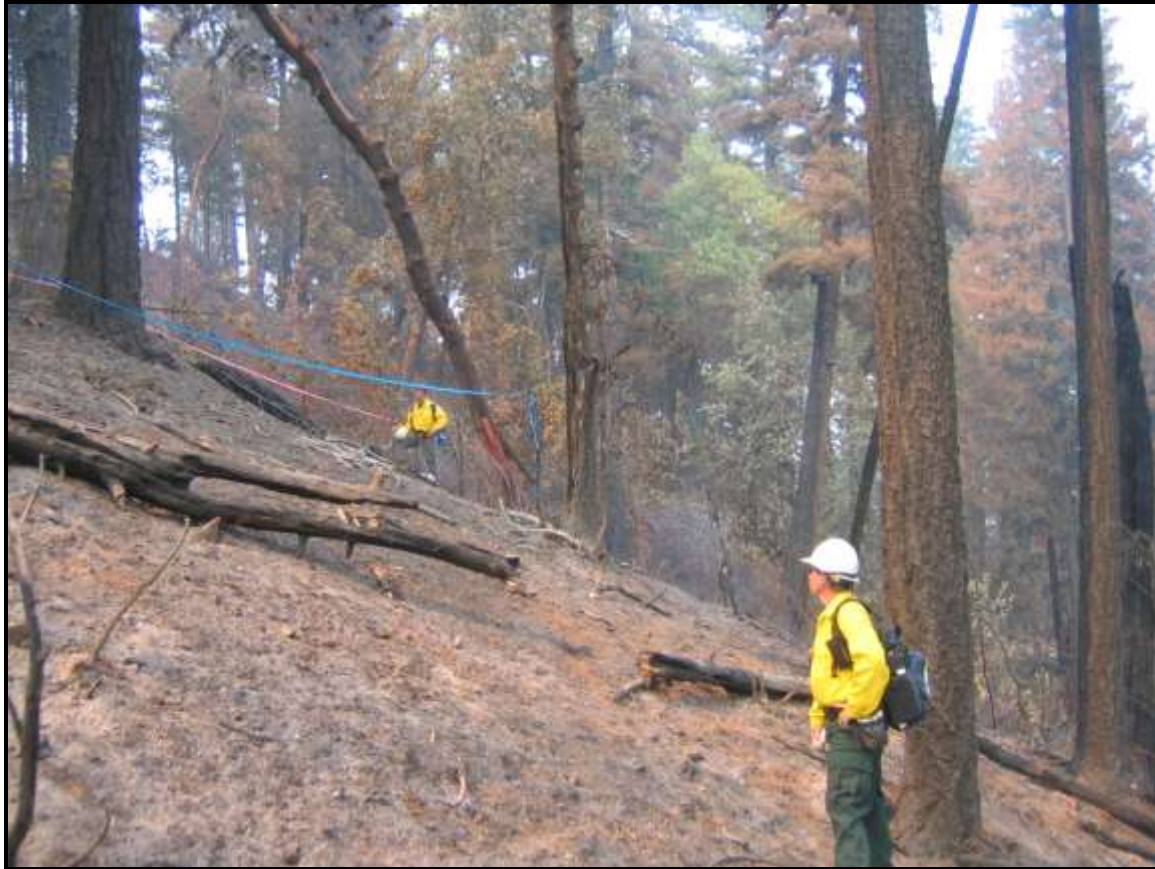
A site visit confirmed many of the modeled outputs for the fire area. A crown fire did occur in the unnamed drainage below the entrapment location, however as the fire crested the ridge, it lost energy and rapidly dropped to the surface. The canopy on the larger conifers was retained near the entrapment location and the brushy vegetation near the entrapment, while having scorched leaves, still retained leaves on the individual plants. Figure 6.

*Figure 6. Fuels north of the entrapment location while having scorched leaves still retained their leaves. The overstory canopy was mostly intact adjacent to the entrapment location.*

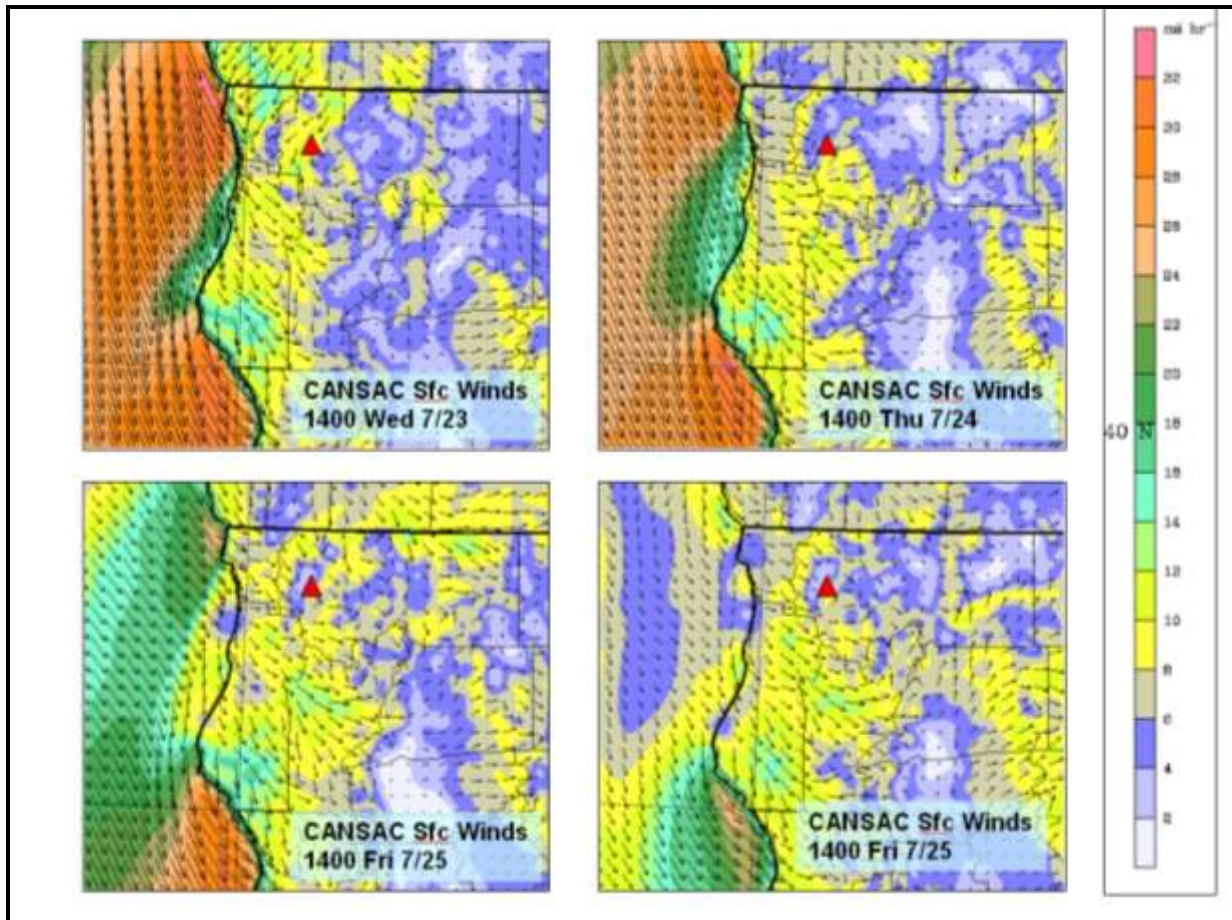
Figure 1. California and Nevada Smoke and Air Council (CANSAC) surface wind map for July 23 to July 25, 2008. The approximate location of the Panther Fire is represented by the red triangle.
