Ice Canyon RX Burn Injury

Non-Serious Wildland Fire Accident Investigation

Farmington District Office - Bureau of Land Management

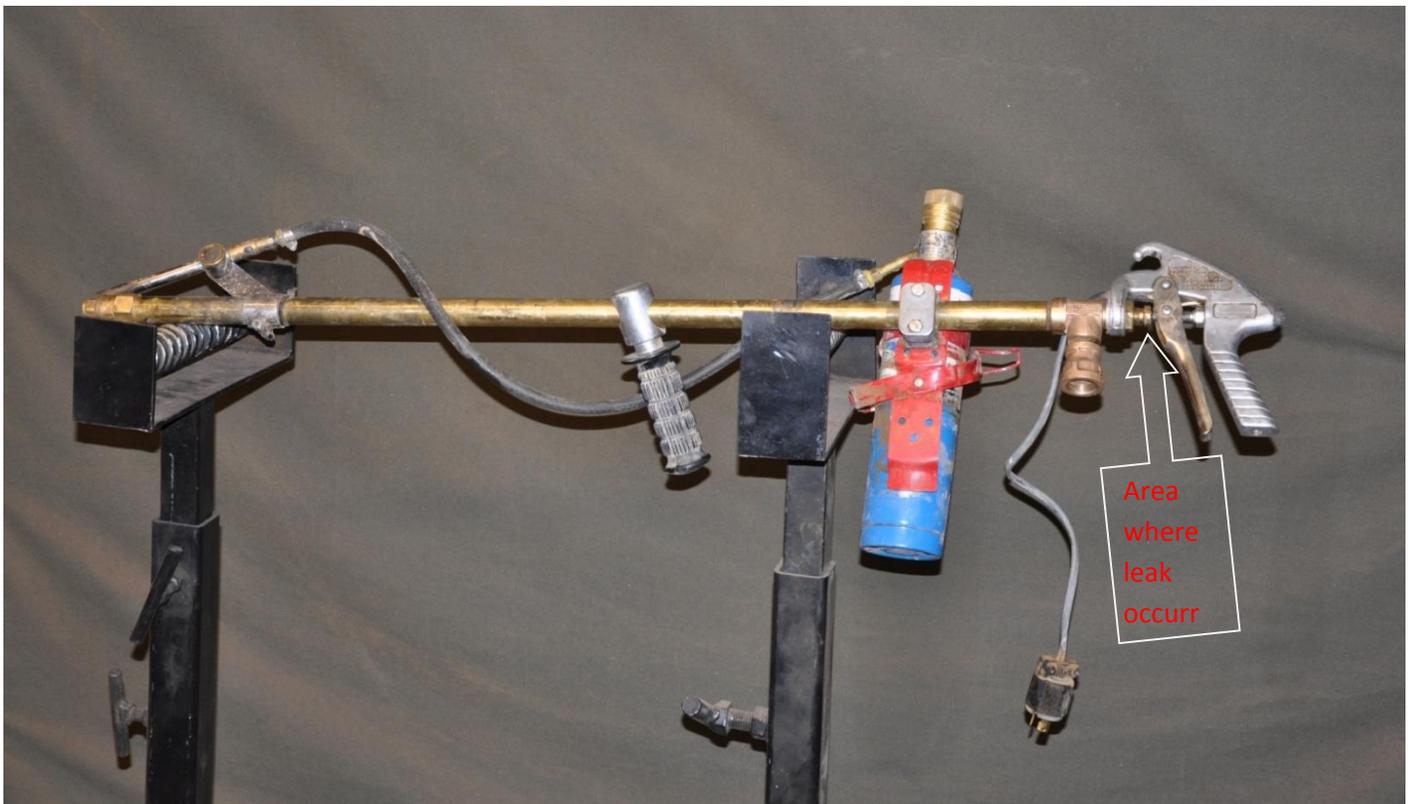
A district firefighter was operating a Terra Torch for ignition of the RX. The Terra Torch wand started leaking burn mix near the trigger handle. Burn operations were halted at 1623 to fix the leak.

The wand was taken apart to assess what was causing the leak. After replacing some O rings the leak was apparently stopped. At 1805, it was decided to continue ignitions with the Terra Torch. The Terra Torch operator began ignitions and within 30 seconds the wand began leaking again in the same area and spilled some burn mix on the operators right pant leg which he did not notice. The operator told the crewmember assisting with the Terra Torch to close the supply valve to the wand to stop the wand from leaking and notified the driver to stop. The driver pulled forward an additional 100 feet, which is normal operating procedures to get the torch away from active flames. The crewmember could not understand directions given to him by the Terra Torch operator due to engine noise of the Terra Torch and thought that the operator wanted him to close the recirculation valve. This caused burn mix to

1. Ensure that all personnel assigned to the Terra Torch operation review the operator's manual, are trained on proper use and operation, emergency shutdown and emergency response procedures before operation of the Terra Torch.
2. Setup a maintenance schedule for Terra torch, to ensure that all recommended parts are used and in proper functioning order.
3. Purchase spare wand and parts for Terra torch from the manufacturer that experience high wear and tear. No other parts should be substituted for repair. Recommended tools and spare parts to be located on the vehicle with the Terra Torch.

4. When doing field maintenance on Terra torch conduct a dry run with torch (No flames) to make sure machine is operating properly. Follow the recommended checklist startup procedures (Exhibit D) provided by the manufacturer.

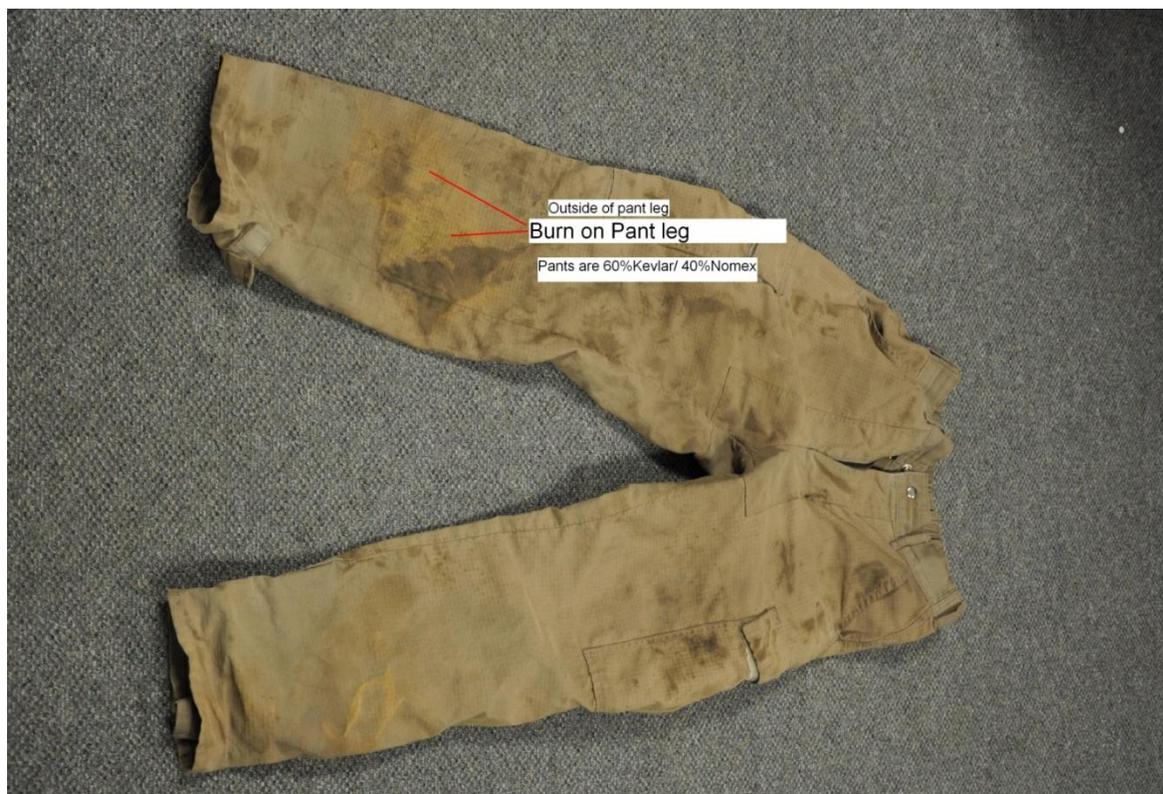
continue to drip and make a trail to the vehicle, instead of closing the valve to the wand which would have stopped the wand from leaking.

At 1806, when the vehicle stopped the operator stepped off the vehicle to close the supply valve. He stepped in the trail created by the leaking wand, which then ignited from the fire they had just lit. This trail of fire then ignited the burn mix on operator's pant leg.

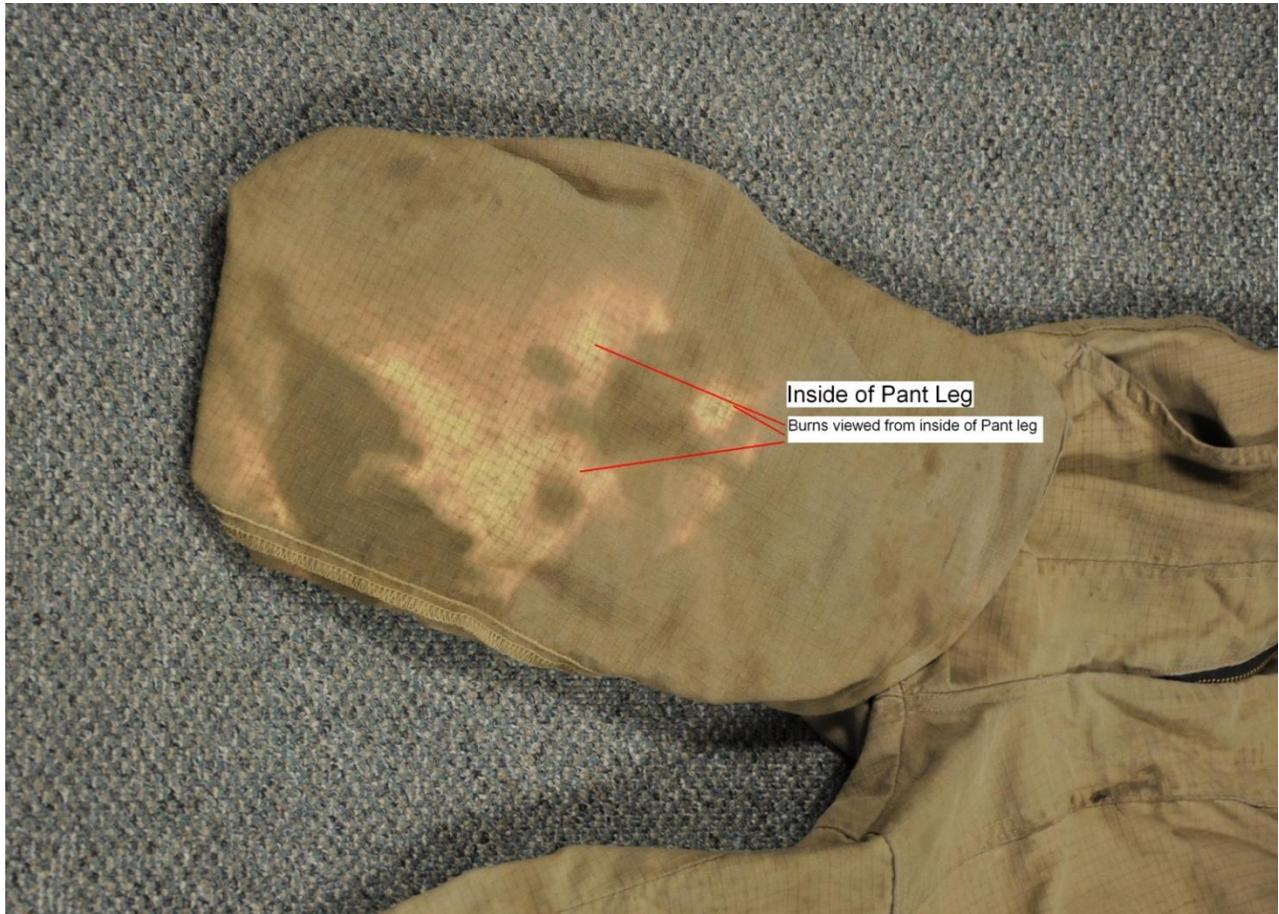
EMTs from the engines assessed the Terra Torch operator for injuries and determined that he had received a 2nd degree burn to his right calf. Medical emergency procedures as discussed in the burn briefing were put into place and the EMT in charge took over the medical incident. The burn was cleaned and wrapped. It was determined that the individual needed to be transported to the hospital.
