Alice Lake Canoe Incident Facilitated Learning Analysis

**Kawishiwi Ranger District
Superior National Forest**

November 2011

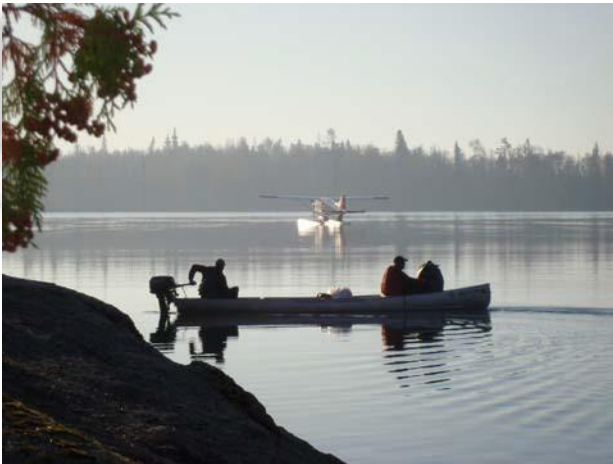
Figure 2. Square stern canoe with outboard motor – Beaver floatplane in background.

To meet the aerial transport, the DIVS and TFLD were to be transported to the float plane in a 19 foot square stern canoe outfitted with a 15hp outboard motor (Figure 2). The Division Supervisor Trainee (t), a local Forest resource, skilled in the use of this type of watercraft was scheduled to be the boat operator for this mission.

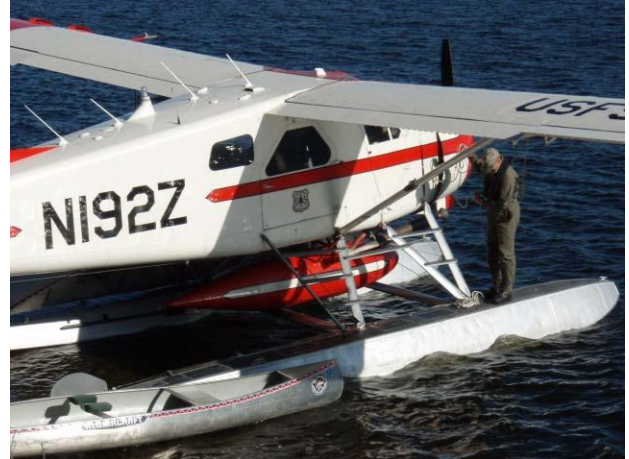
Figure 1. Beaver deHavilland Floatplane in lake during canoe pick-up
