5100 Fire
September 1997
9751-2817-MTDC

Surviving Fire Entrapments

Comparing Conditions Inside Vehicles and Fire Shelters

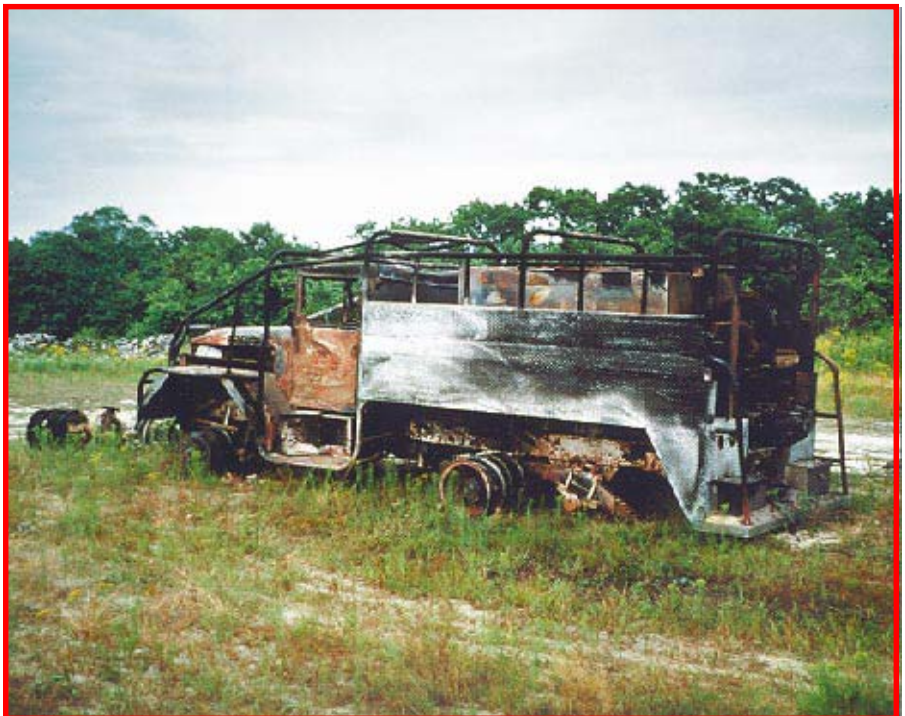
Figure 1—This engine burned during the 1995 fires on Long Island. Although many engines were destroyed, all firefighters escaped without injuries.

◆ In 1995, many engines were destroyed by a fast-moving timber fire on Long Island, NY. All firefighters abandoned their engines and survived (Figures 1 and 2).

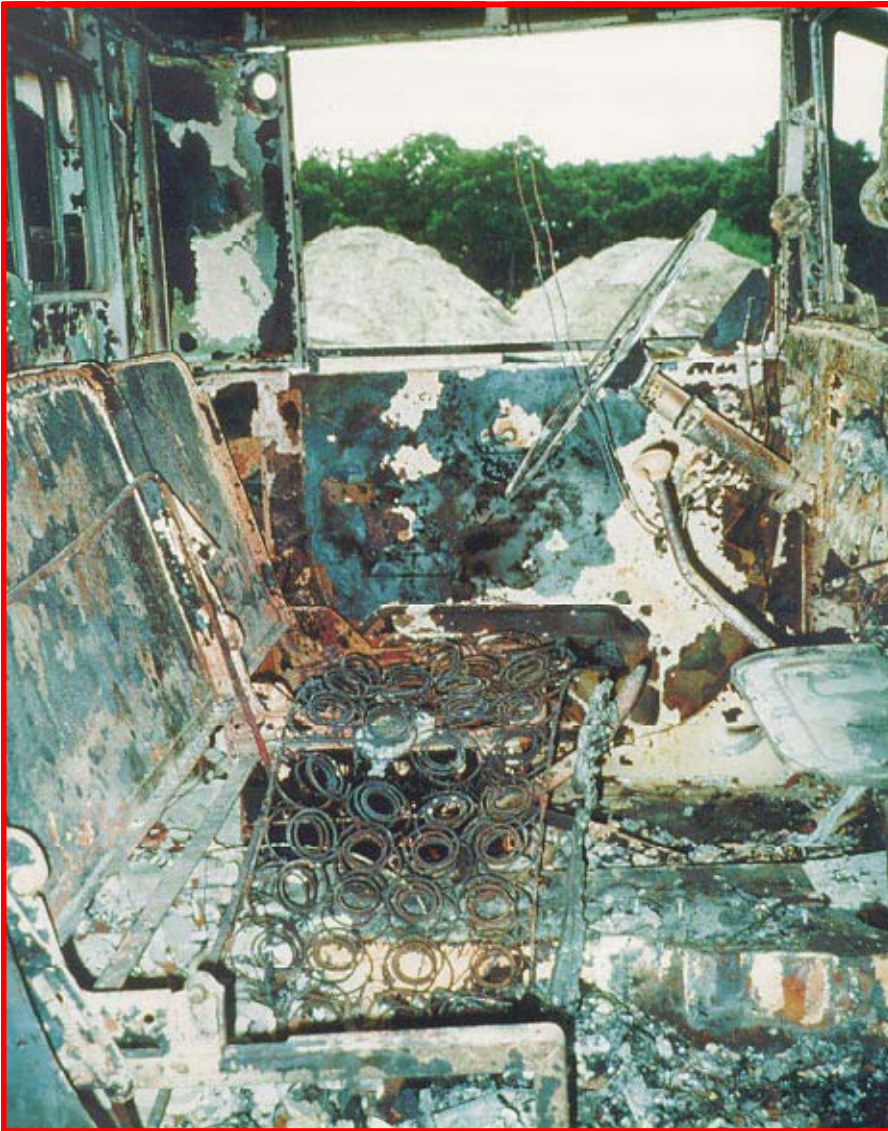
Figure 2—The cab interior of the same engine burned during the 1995 fires on Long Island.

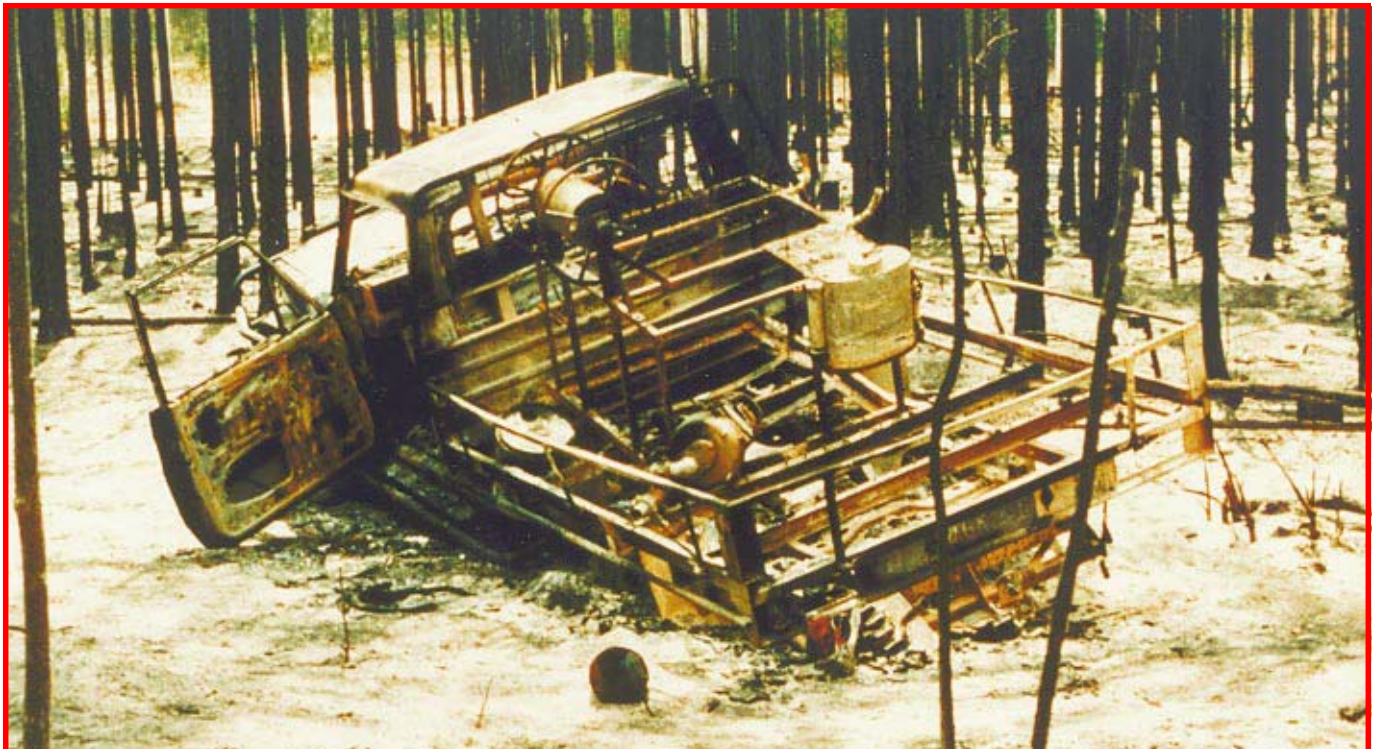
Figure 5—This engine burned during the 1990 Toolara Fire in Australia. Three firefighters were trapped, one of whom was badly burned when he ran for safety. The other two men stayed in the vehicle, spraying themselves with water until the tires caught fire. Then they too ran for safety.

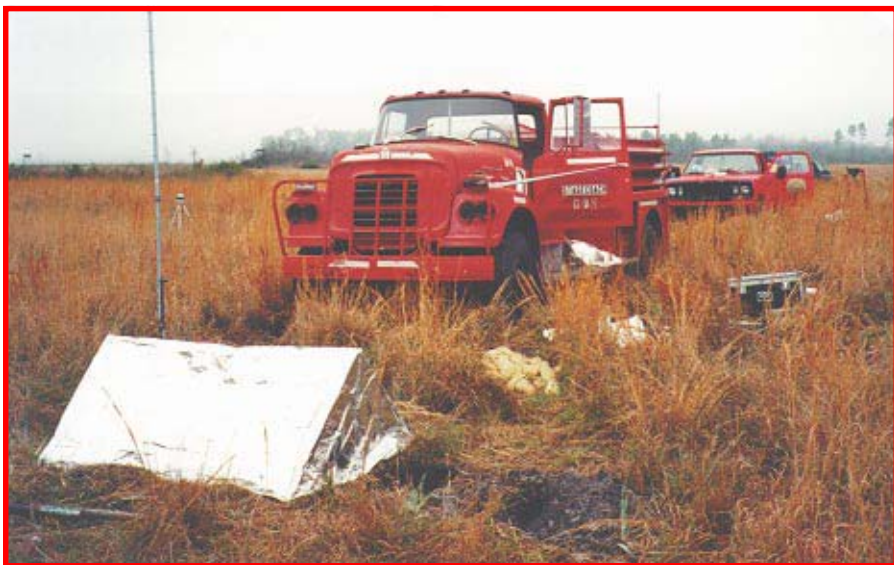
Figure 6—Cooperators provided vehicles used in the tests, such as this engine and pickup provided by the Florida Division of Forestry.

The availability of engines that could be destroyed when subjecting them to the full effects of direct flame was critically important. In response to requests over the Internet, personal contacts, and inter-agency contacts throughout the wildland fire community, surplus engines were identified at the Florida Division of Forestry, Los Angeles County Fire Department, and the Montana Department of Natural Resources and Conservation. These engines enabled MTDC to fully implement the test plan as designed, with the engines and fire shelters exposed to a flaming front of fire for varying durations in a variety of fuel types.

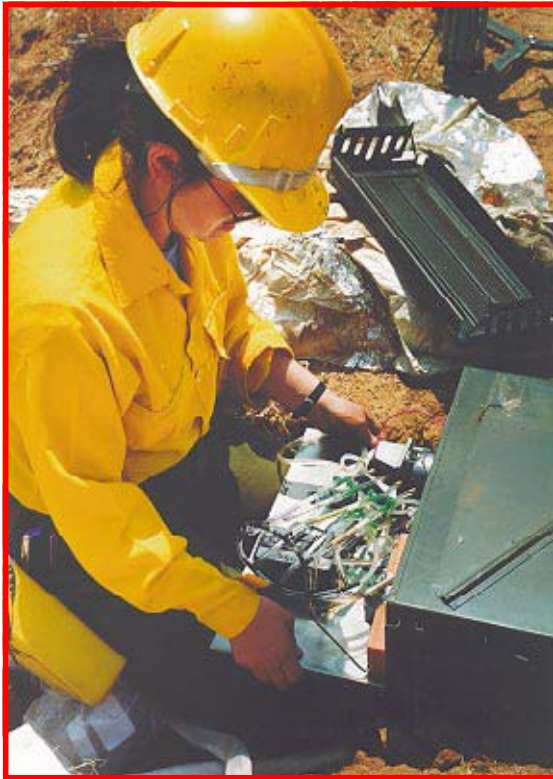
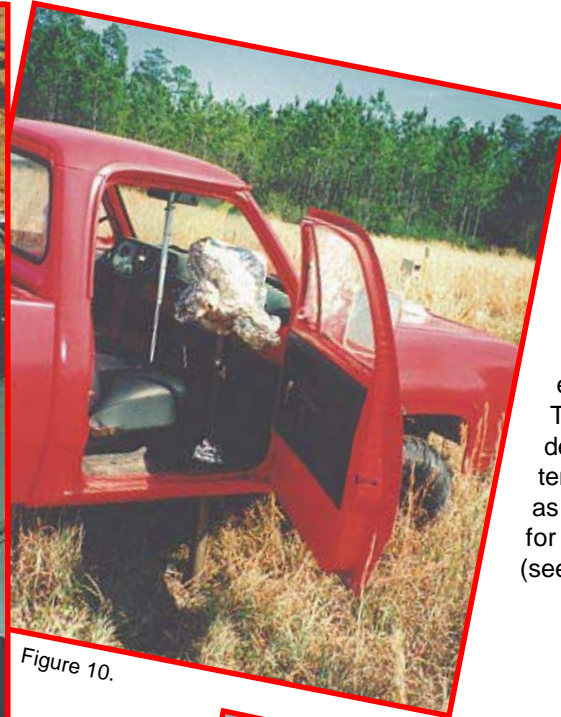
Figure 10.

Figures 9 and 10—Gas collection devices sampled gases inside vehicle cabs. Instrumentation was buried inside ammunition boxes so that it would survive the fire.

Both the engines and fire shelters had gas collection devices (Figures 9 and 10) placed inside to measure gases that could be harmful or fatal to an entrapped firefighter. The breakdown of materials inside the engine cab, such as the volatilization of petroleum-based plastics and sound-deadening materials inside the door panels, were a special concern, as was the off-gassing of the fire shelter adhesive that bonds the aluminum foil to the glass cloth. Detailed documentation of the gas collection system used on these burns—and on the gases collected—can be found in Appendix B.

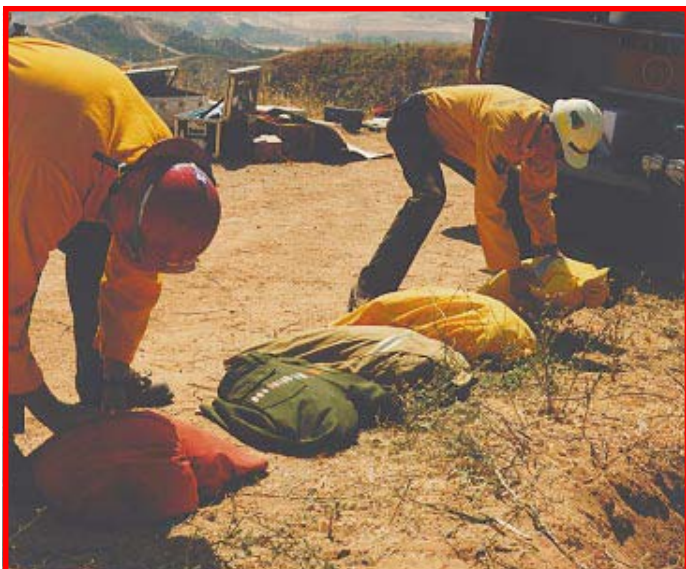
Figure 11—Personal protective clothing was laid out to observe the fire's effects on it.

Personal protective clothing (Figure 11), equipment, and other items commonly used by wildland firefighters were laid out near the fire shelters to visually evaluate their protective value during an entrapment. Items included the standard Forest Service Nomex shirt and trousers; leather firefighter gloves; hardhat; military-issue flight suit; and various outer garments such as brush coats, FR coveralls from Canada and Australia, and shirts from various cooperators. Clothing was tested as though it were on a firefighter. Five-gallon water bladders were filled with water and covered with 100% cotton undershirts. The shirts and jackets (or flightsuits) were placed over the undershirt. The bladder filled out the garments and simulated a heat sink, not unlike that of the human body. While some of these items were not instrumented, we felt visual observation of damage would offer valuable lessons for firefighter training. Specialized fireproof video photography equipment (Figure 12) was developed to take closeup shots of the

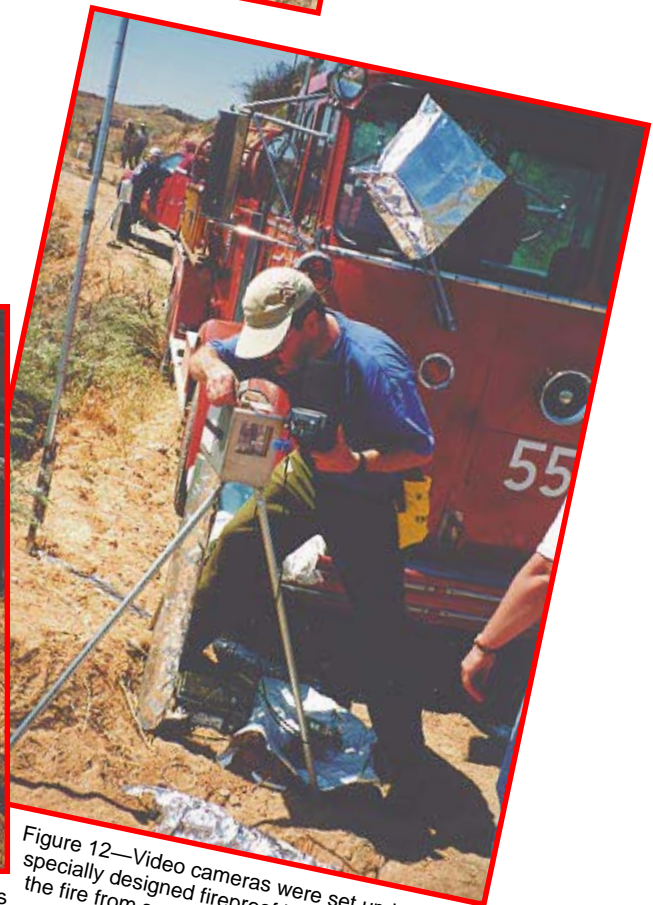
Figure 12—Video cameras were set up inside specially designed fireproof boxes to observe the fire from several vantage points.

fire's effects on the engines and shelters. These boxes were designed to withstand temperatures as high as 2300 °F (1260 °C) for extended periods (see Appendix C).

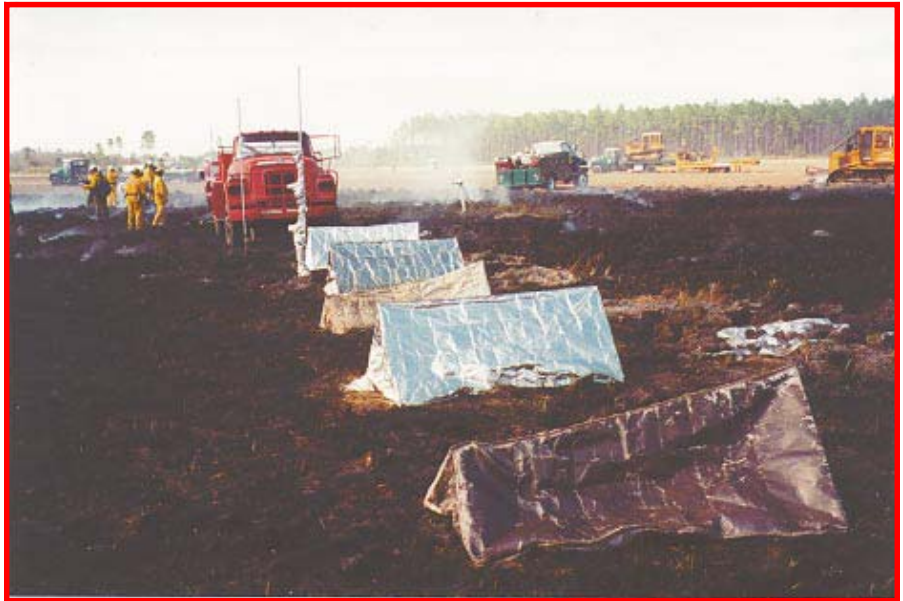
Figure 13—The Florida burn was not intense enough and did not burn for long enough to seriously test survivability inside either the shelters or the vehicles.

The first burn was conducted on February 27, 1996, on an open, grass-covered field that had dry, cured bunchgrasses 30 to 36 inches (76 to 91 cm) tall, with a 2- to 4-inch (5 to 10 cm) mat of cured grass and thatch on the ground. The burn was in late afternoon with a 3- to 5-mile per hour wind. It was over in less than 1 minute, and had neither the intensity nor the duration to seriously test the survivability of the shelters or the engines (Figure 13).

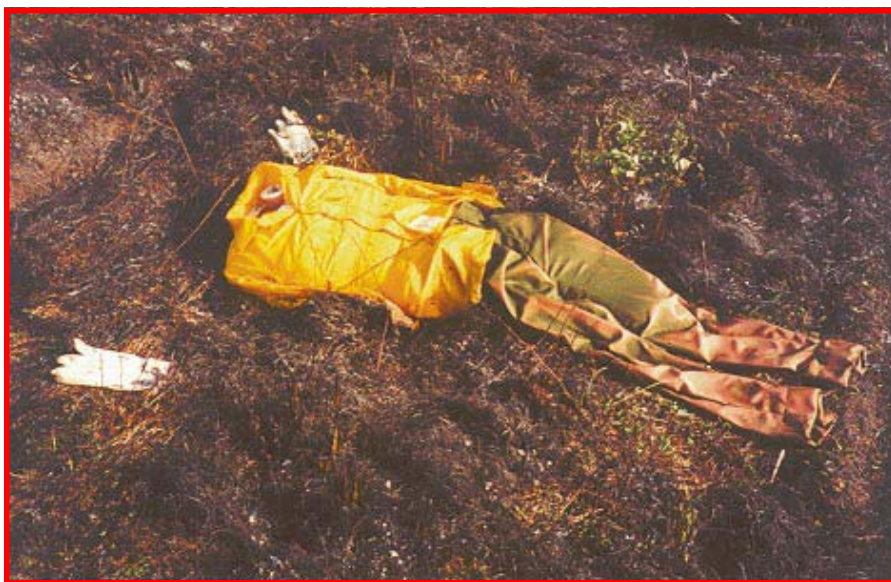
Figure 14—The change in color of the pants shows the effect of heat. Water bags inside the fire shirt and upper pants served as a heat sink, keeping them from becoming as hot as the pant legs.

- ◆ Personal protective equipment laid out in the fuels suffered varying degrees of damage: the Military Nomex flight suit was badly damaged, as was the FR cotton brush coat. The standard FS Nomex shirt and trousers showed signs of the heat, but were not destroyed. They would have offered some protection from serious burns (Figure 14).

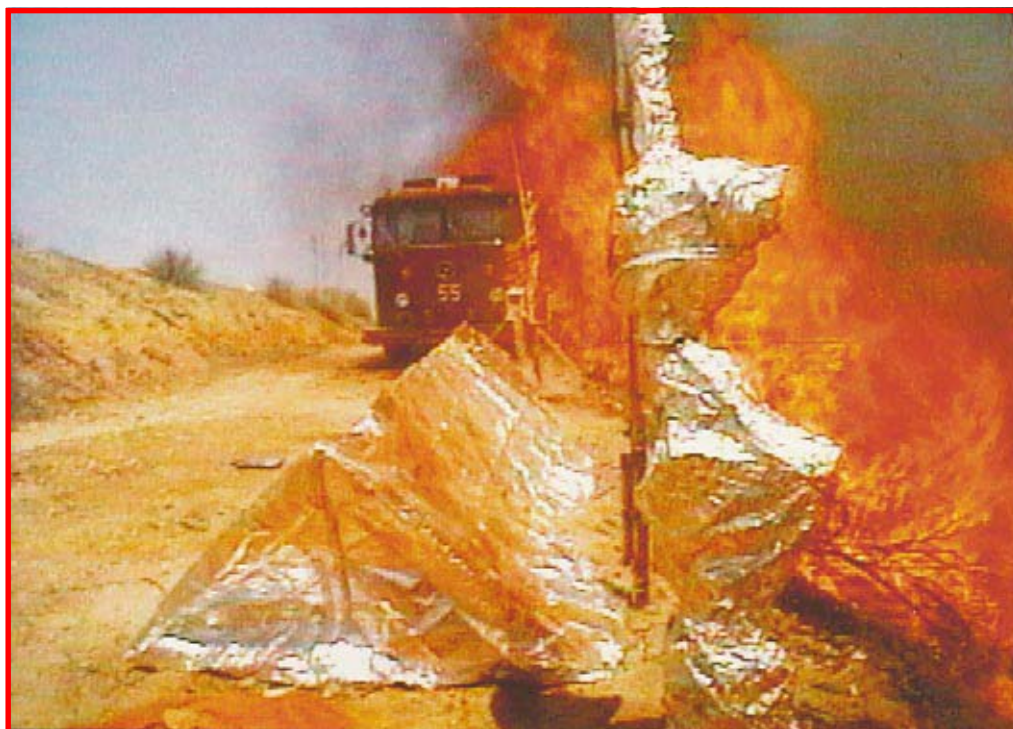
Figure 15—This image (taken from video) shows the intensity of the June 5 burn in Los Angeles County.

The June 5th burn took place on slopes averaging 70%. The engines, fire shelters, and PPE were on a road near the top of the slope (Figure 3, page 3). Flames came in direct contact with the engines and shelters, since they were positioned at the road’s edge to receive the maximum effect of the flaming front (Figure 15).

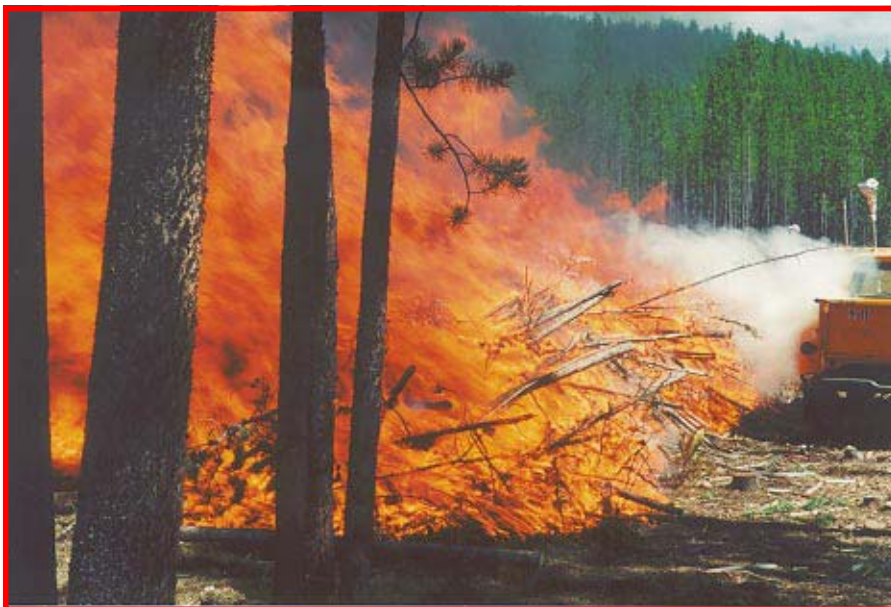
Figure 22—Wind prevented flames from directly contacting vehicles during the test burn near Dillon, MT.

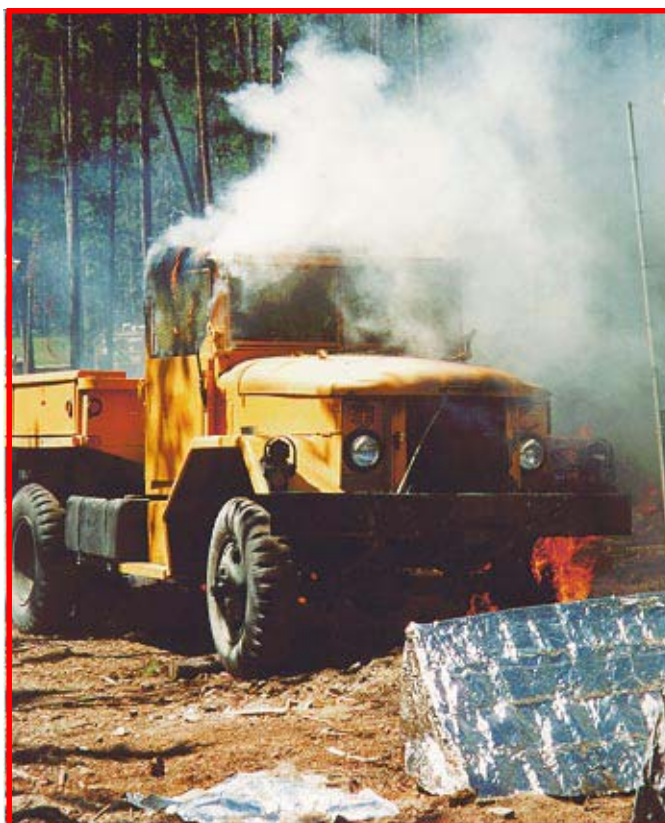
Figure 23—Even though flames did not directly contact the 2½-ton truck, its cab caught fire.

- ◆ Maximum air temperature outside the 2½-ton engine was 400 °C, while temperatures inside the cab exceeded 700 °C. The inside of the engine cab caught fire (Figure 23) and burned, resulting in the higher temperatures.
- ◆ The crew cab truck outside air temperatures were less than 200 °C. Air temperatures inside the cab exceeded 250 °C because the interior caught fire.
- ◆ Surface temperatures on the fire shelter at the rear of the 2½-ton engine reached 150 °C, although they generally

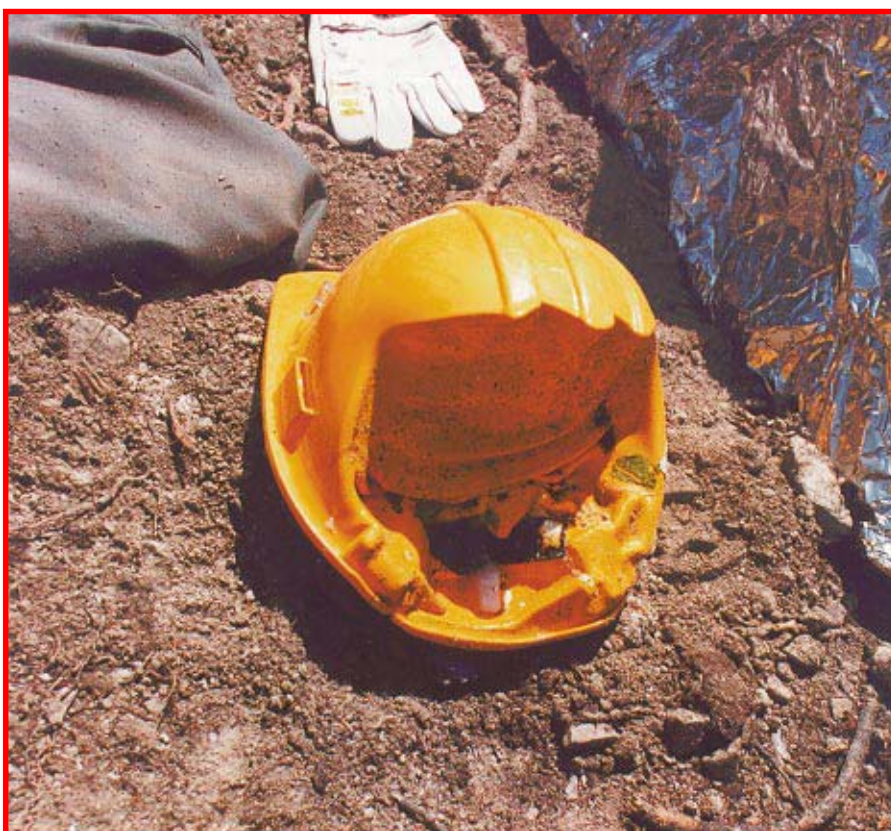
Figure 24—This hardhat shows the difference a few inches can make at ground level. The hardhat melted where it was closest to the fire, but wasn't damaged just a few inches away from the heat.

–A GSA firefighter's hardhat (Model 5100-P) was placed on the ground beside the fire shelter in front of the crew cab engine. It showed significant melting for about 5 inches (13 cm) from its edge, but the rest of the helmet showed no melting or damage (Figure 24).

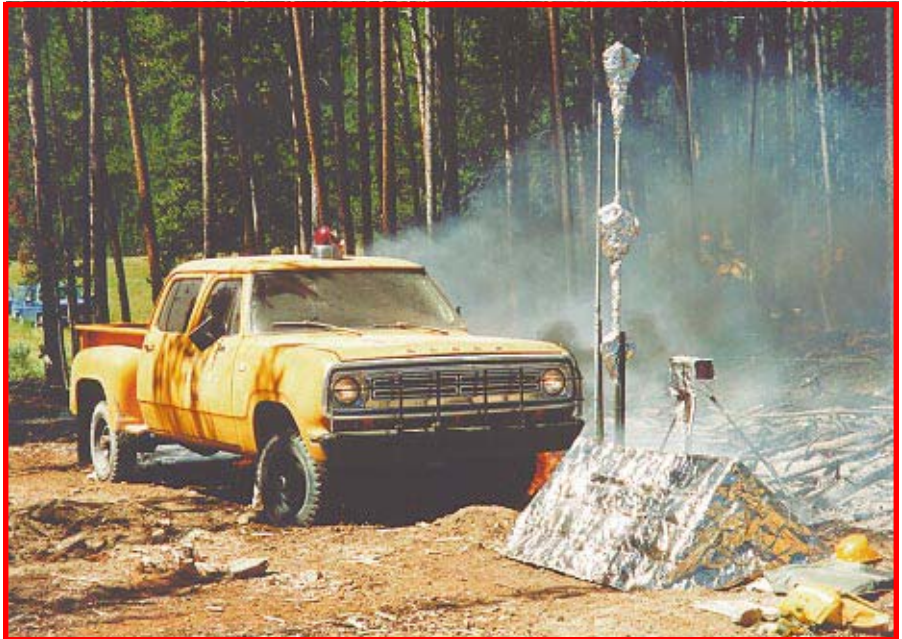
Figure 25—Even after a fire has passed, a vehicle retains heat, acting as a "heat sink."

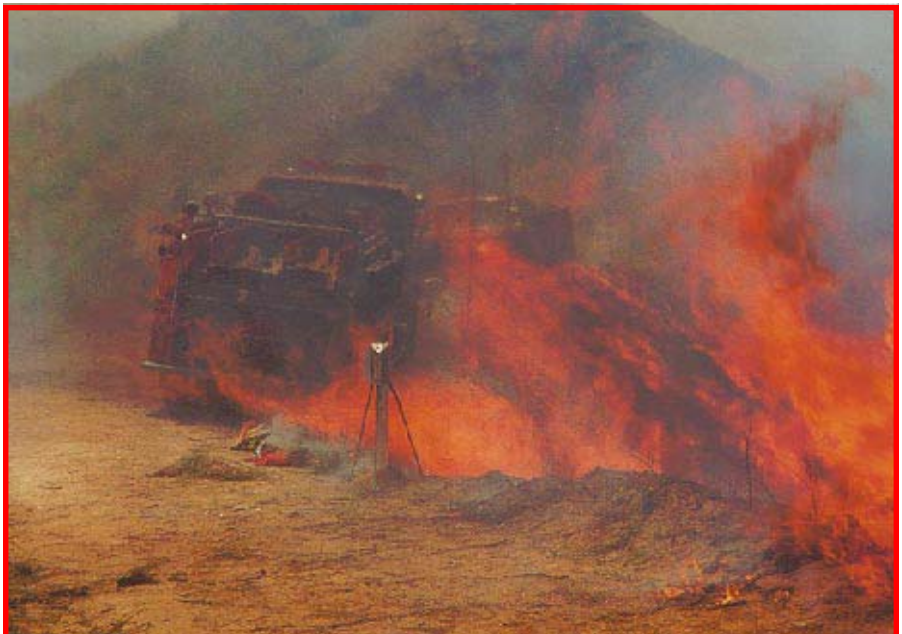
Figure 26—When a fire comes up a steep sideslope, it appears to go over and under the engine, creating an eddy on the back side that draws heat and flame.

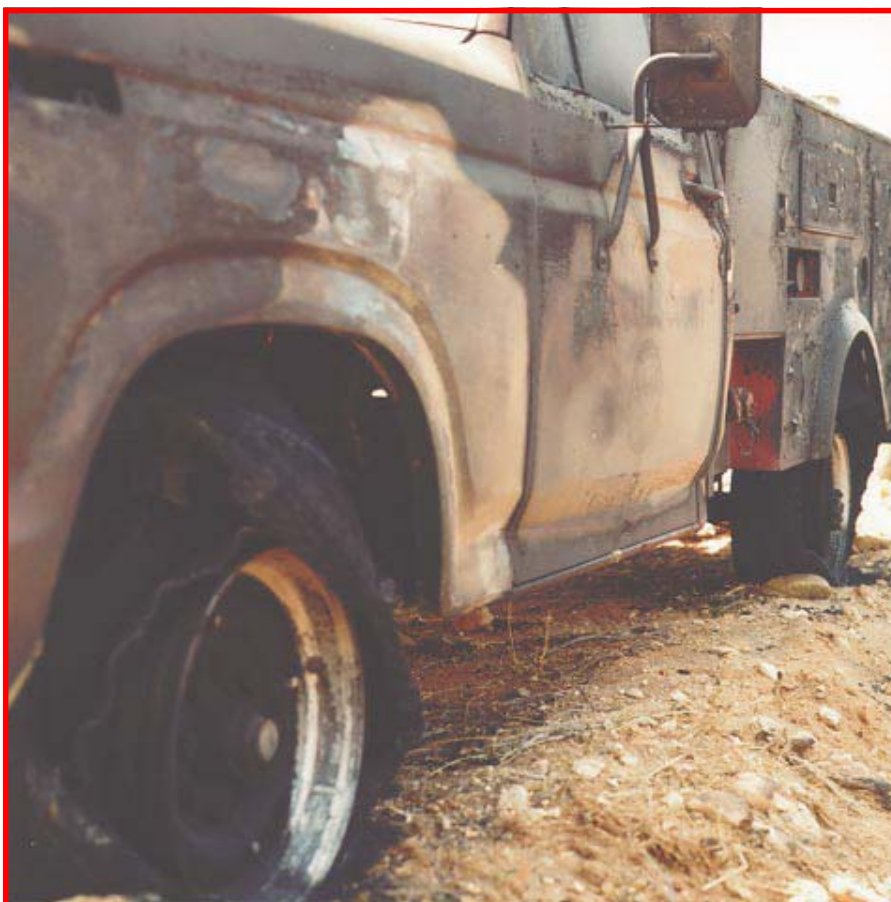
Figure 28.

Figures 27 and 28—Items on an engine's exterior may catch fire during moderate-intensity, short-duration fires.
